## A METALLOGRAPHIC EXAMINATION OF A FRACTURED CONNECTING ROD

Roman Celin, Boris Arzenšek, Dimitrij Kmetič

Institute of Metals and Technology, Lepi pot 11, 1000 Ljubljana  
roman.celin@imt.si

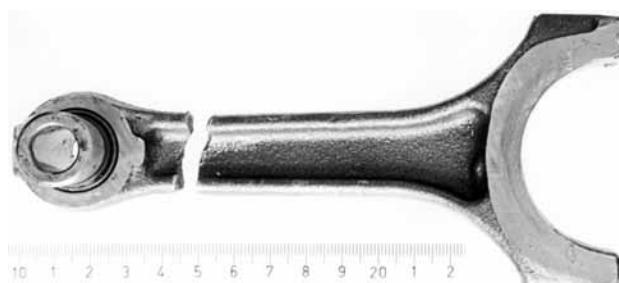
irreparable. There are many reasons for such a failure, e.g., the overheating of the engine, cracking, deficiency of the bearing lubrication, poor maintenance, etc. A catastrophic failure occurred for one of the four connecting rods of a 1.8-litre 16-valve internal combustion car engine while travelling at 100 km/h on a motorway. The side of the crank-case was ruptured and the corresponding piston was very deformed. Both parts of the fractured connecting rod are shown in **Figure 1**.

Figure 1: Connecting rod's fractured shank

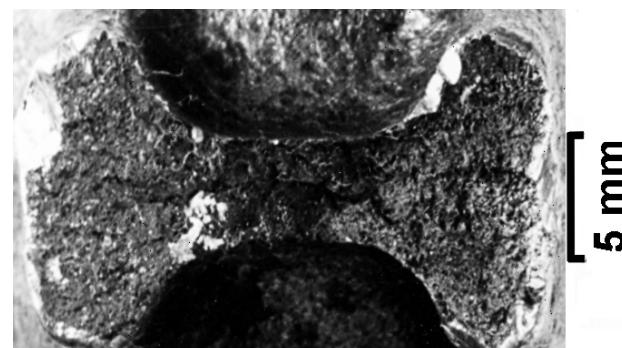
Figure 2: Fractured surface near the small end of the connecting rod's shank

near the fracture surface. The double-T cross-section of the shank's fractured surface is shown in **Figure 2**, and the rod's microstructure is shown in **Figure 3**.

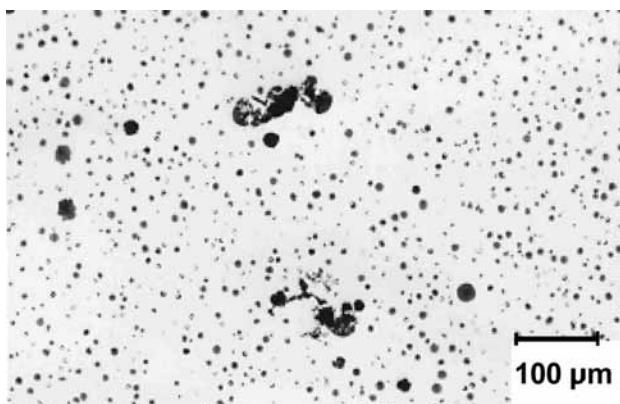
**Figure 3:** Specimen's microstructure (unetched)  
**Slika 3:** Mikrostruktura vzorca ojnice (nejedkana)

The microstructure in **Figure 3** is typical for ductile iron (nodular graphite iron), with a fine lamellar pearlite matrix and small inserts of ferrite (approximately 5 %) around the graphite nodules (**Figure 4**).

According to the graphite classification, the microstructure in **Figure 3** corresponds to graphite form VI and graphite size 8<sup>3</sup>. The graphite nodules are small

(Figure 3), and this is evidence of an efficient process of nodulation with the probable addition of magnesium or cerium to the melt<sup>4</sup>.

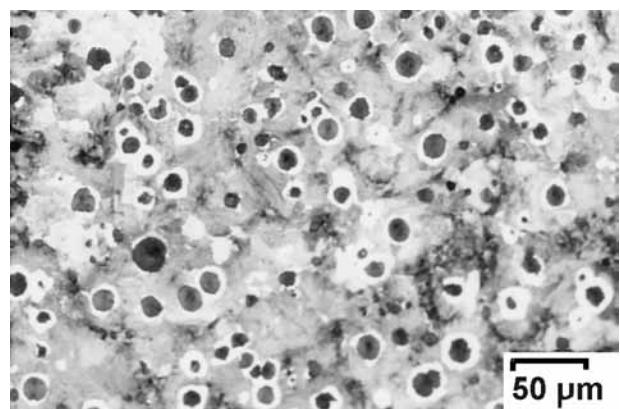
**Figure 4:** Specimen's microstructure (nital etched)  
**Slika 4:** Mikrostruktura jedkanega vzorca (nital)

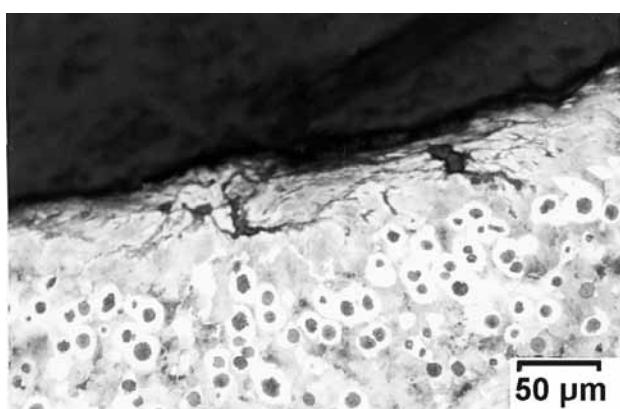
**Figure 5:** Casting defect on the surface of the connecting rod  
**Slika 5:** Lijarska napaka na površini ojnice

The whole surface of the connecting rod's two halves was examined carefully and numerous surface-casting defects were found. One of which is shown in **Figure 5**.

The surface of the connecting rod was sandblasted to increase the strength with strain hardening and to close the casting defects (Figure 5). The connecting rod supports a complex fatigue load, with repeated loading during every crankshaft revolution, and because of this loading, every casting defect has the potential to become the initial point for fatigue-crack initiation, where the local stress in the defect tip is increased because of the "notch effect". After an initial propagation, with each crack opening the crack advances by one striation, at a critical crack size the rupture occurs. On the investigated fracture surface the striations were not sufficiently clear to reliably determine the initiation point. The final fracture surface has marks of plastic straining and from their microscopic appearance it is concluded that the final fracture occurred with a very small plastic deformation preceding the opening of the crack. The final

The fractured connecting rod had a microstructure of pearlite ferrite ductile iron with a normal size and shape of graphite nodules as well as a normal hardness of 280 HB. The share of ferrite is approximately of 5 %. The morphology of the fracture surface indicates that the fracture occurred instantaneously. Near the fracture surface several casting defects with a shape partially changed by sandblasting were found on the connecting rod's shank. It is concluded that one of these casting defects was probably the initiation point for the connecting-rod shank's fracture. Connecting rods made of ductile cast iron must have proper mechanical properties and microstructural characteristics, and should be without any manufacturing defects, because ductile iron is a notch-sensitive material. The rapid in-service failure of the examined connecting rod with surface defects is clear evidence that the foundry's and/or the engine manufacturer's quality control were in this case insufficient to detect the surface defects and prevent the use of the connecting rod in the car's engine.

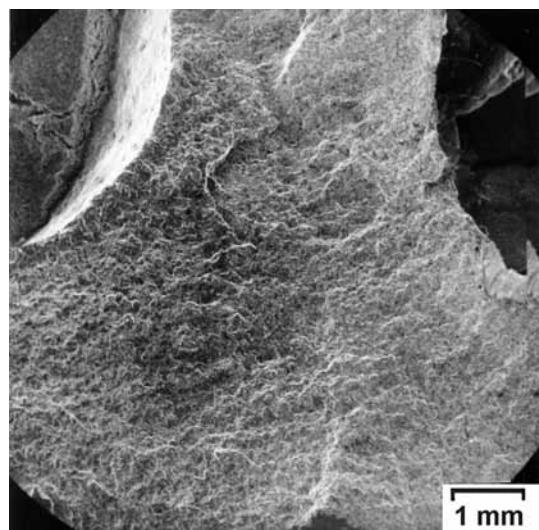
**Figure 6:** SEM image of the small-end fracture surface  
**Slika 6:** SEM-posnetek preloma na strani glave ojnice

The fracture surface of the connecting rod was examined in the SEM, and the small-end fracture surface is shown in **Figure 6**.

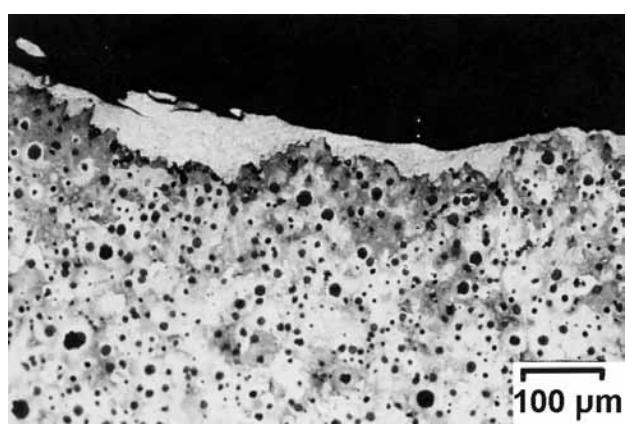
**Figure 7:** Residue of aluminium on the big-end fracture surface  
**Slika 7:** Ostanki aluminija na površini preloma na strani noge ojnice

**Figure 7** shows the microstructure of the big-end fracture surface. Residues of aluminium were found; a result of the connecting rod being pushed through the aluminium crank-case. The aluminium can be seen in **Figure 7** as structure on the edge of the fractured surface.

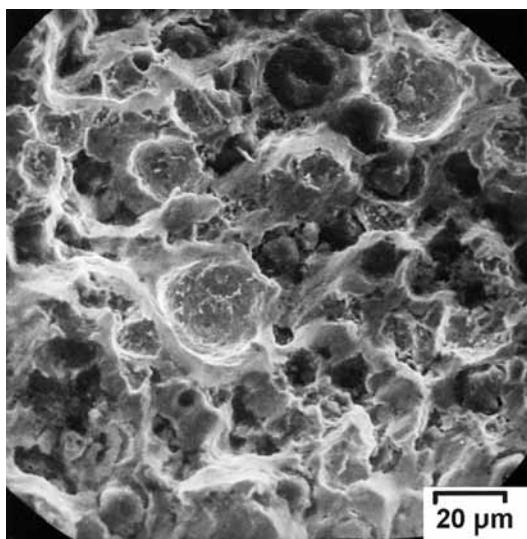
**Figure 8:** SEM image of small-end fracture surface  
**Slika 8:** SEM-posnetek površine preloma pri glavi ojnice

The small end of the connecting rod's fracture surface was examined with the SEM. On the fracture surface there are numerous dimples with embedded graphite nodules or where the nodules had fallen out (**Figure 8**).
