# **Karakterizacija napak v ulitkih iz aluminija, proizvedenih z nagibnim gravitacijskim litjem, v povezavi s procesnimi parametri**

## **Characterization of Defects in Aluminum Castings Produced by Tilt Gravity Casting in Relation to Process Parameters**

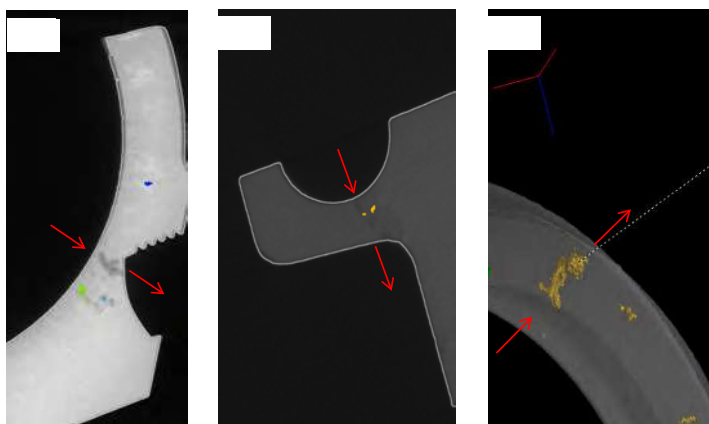
CT analysis was performed on several samples, which showed that leakage occurs due to inclusions and shrinkage porosity. Figure 2 shows three different occurrences of leakage which we detected on CT. In Figure 2a the CT does not recognize the defect as porosity. However, there is a visible defect that looks like inclusion. Figure 2b shows a combination of inclusion and porosity. In the third case, we detected a leak due to a large pore (Figure 2c).

**Figure 2.** Images of Computed Tomography cross-section of samples displaying the leak location,

- a) inclusion in samples;
- b) porosity + inclusion;
- c) shrinkage porosity

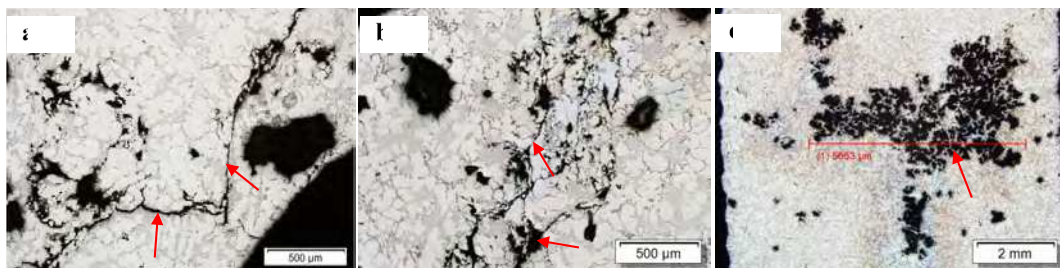
On locations where we detected defects using CT analysis, we performed a metallographic examination. Results are presented in Figure 3. Figure 3a shows a crack (leakage path - red arrow) or oxide skin. A similar situation is presented in Figure 3b, however, there is also a noticeable porosity. A combination of the two effects causes leakage of the cast part. Figure 3c confirms the large pore which has been seen on the CT scan. A large shrinkage porosity in the wall of the casting causes the leakage of the cast part.

**Figure 3.** Results of the metallographic examination of the cast parts by the tomographic scan; a) oxide crack or skin; b) oxide skin + shrinkage porosity; c) large porosity

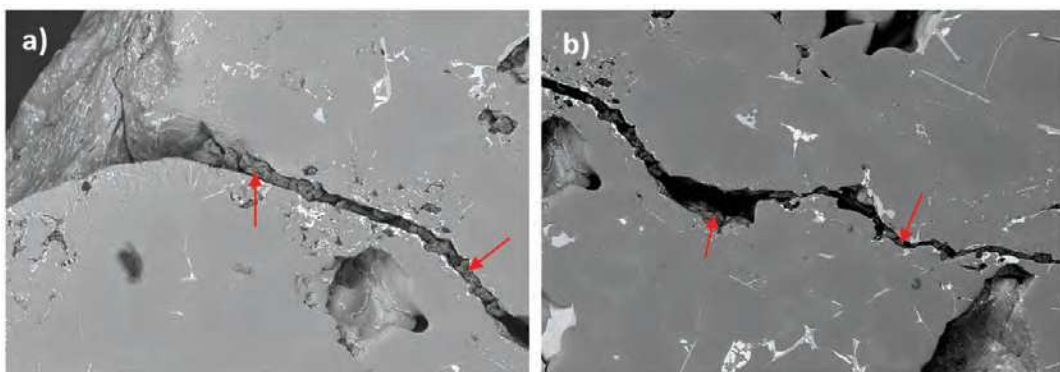
The main goal of the characterization technique with Scanning Electron Microscopy (SEM) was to analyse the morphology of cracks and porosity and define the type of inclusions. We performed EDX analysis on the cracks. Figure 4 presents locations where we measured the chemical composition of defects. EDX measurement (Figure 5) revealed the chemical composition of inclusion consists of carbon (C) and oxygen (O). This result confirms our assumptions from OM

**Figure 4.** SEM microstructure of defect: a) crack with inclusions; b) crack + shrinkage porosity

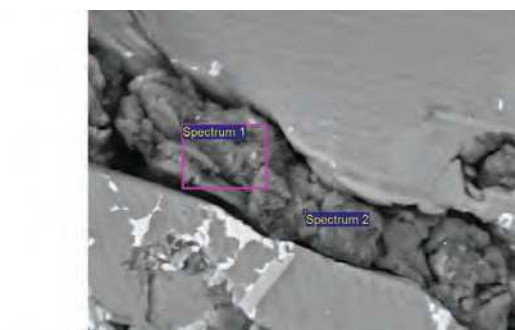
**Figure 5.** Chemical analysis with SEM EDX of the inclusion

examination there is oxide film or oxide skin in the cast part.

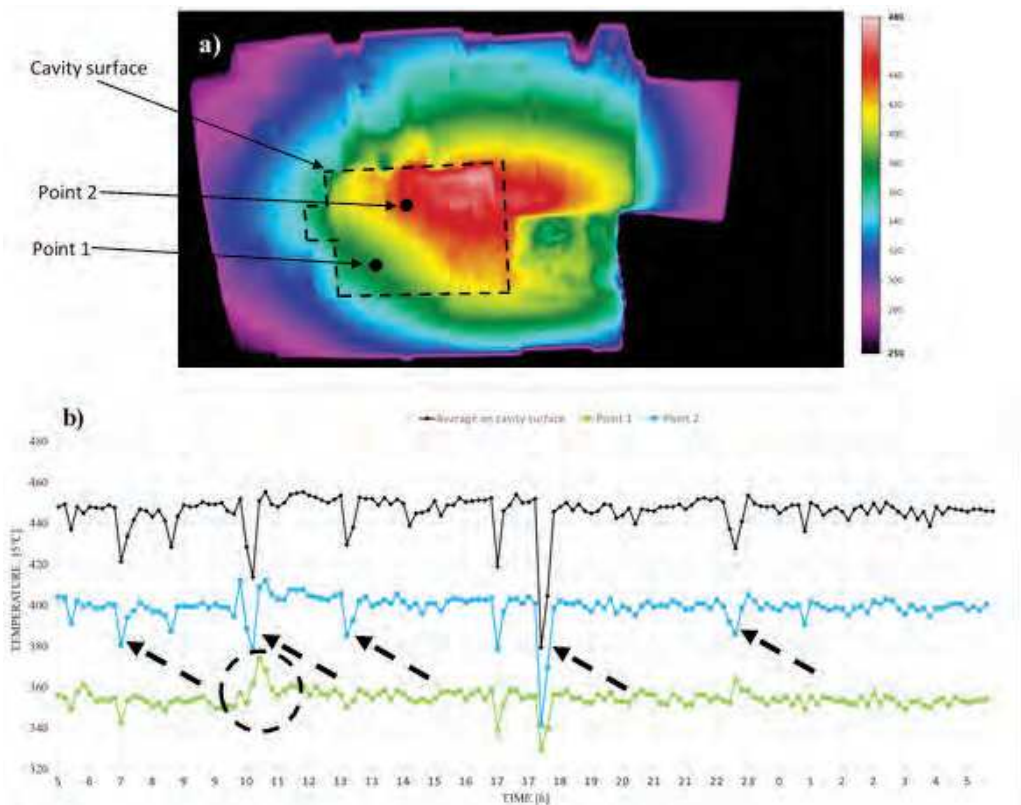
a single casting day showing average temperature on cavity surface and two points with a risk of leakage of the cast part. Dashed arrows in Figure 6b mark peaks where major maintenance interventions were performed on the casting tool. These were the reason for the drop in temperature of the casting tool. We observed relatively stable temperatures during separate cycles in the graph. In stable cycles, it was observed that the temperature at points 1 and 2 varied by an average of 5 to 10 °C. The graph indicates that in some cases,

**Figure 6.** a) Surface temperature distribution of the casting tool with marked characteristic locations for monitoring of temperatures; b) Graph of temperatures on the characteristic locations for separate cycles (single casting day)

after major maintenance work, temperature rises (dashed circle) at a characteristic location (point 1). Thermal analysis showed the unstable temperature at characteristic locations when the casting operator performed maintenance interventions.

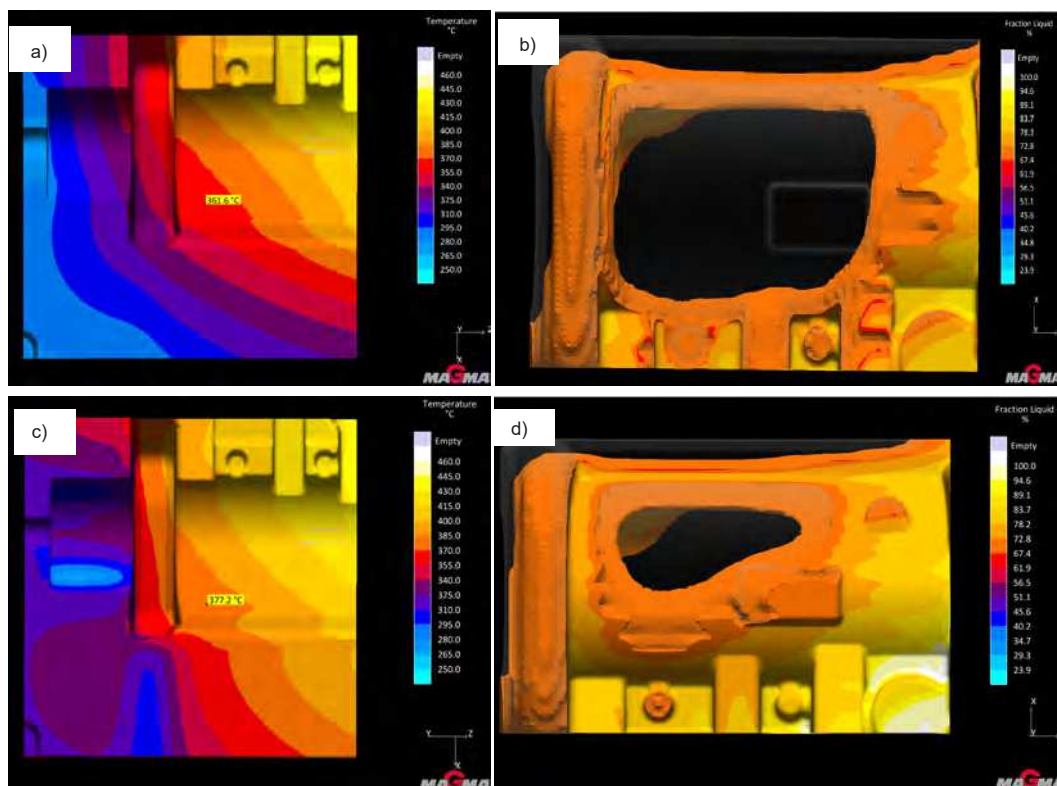
We performed casting simulations with normal mold temperature at 380 °C and with a temperature above normal. Figure 7b shows solidification fronts on the characteristic location (Point 1 in Figure 6a) with a temperature at 361 °C (Figure 7a). Figure 6b (graph) indicates a deviation at other locations where the temperature increases up to 380 °C. For this reason, we simulated mold temperature at 400 °C whereby we achieved a temperature near 380 °C at the characteristic location (Figure 7c). Figure 7d shows solidification fronts that are changed compared to the normal cycle. Higher mold temperature influences slower solidification of the cast part. This

**Figure 7.** Casting simulation of casting part; a) mold temperature 380 °C with temperature 361 °C on the characteristic location; b) solidifications for mold temperature 380 °C; c) mold temperature 400 °C with temperature 377 °C on the characteristic location; d) solidification for mold temperature 400 °C

change in the solidification front can lead to the formation of shrinkage porosity at the characteristic location.

Large shrinkage pores which can be formed due to many process parameters are a different issue. In the present paper, we focused only on the mold temperature. By the thermovision camera, we observed there are changes in mold temperatures up to 20 °C at characteristic locations. With a casting simulation, we simulated a change in mold temperature to examine the influence on solidification. We observed a change in the solidification front that can have an impact on the formation of shrinkage porosity. For this reason, it is important to control the mold temperature at tilt gravity casting although this represents a major challenge in an industrial environment.
