## **Ultrazvočna preiskava metalurških spojev na kompleksnih ulitkih**

### **Ultrasonic Investigation of Metallurgical Bonding in Complex Castings**

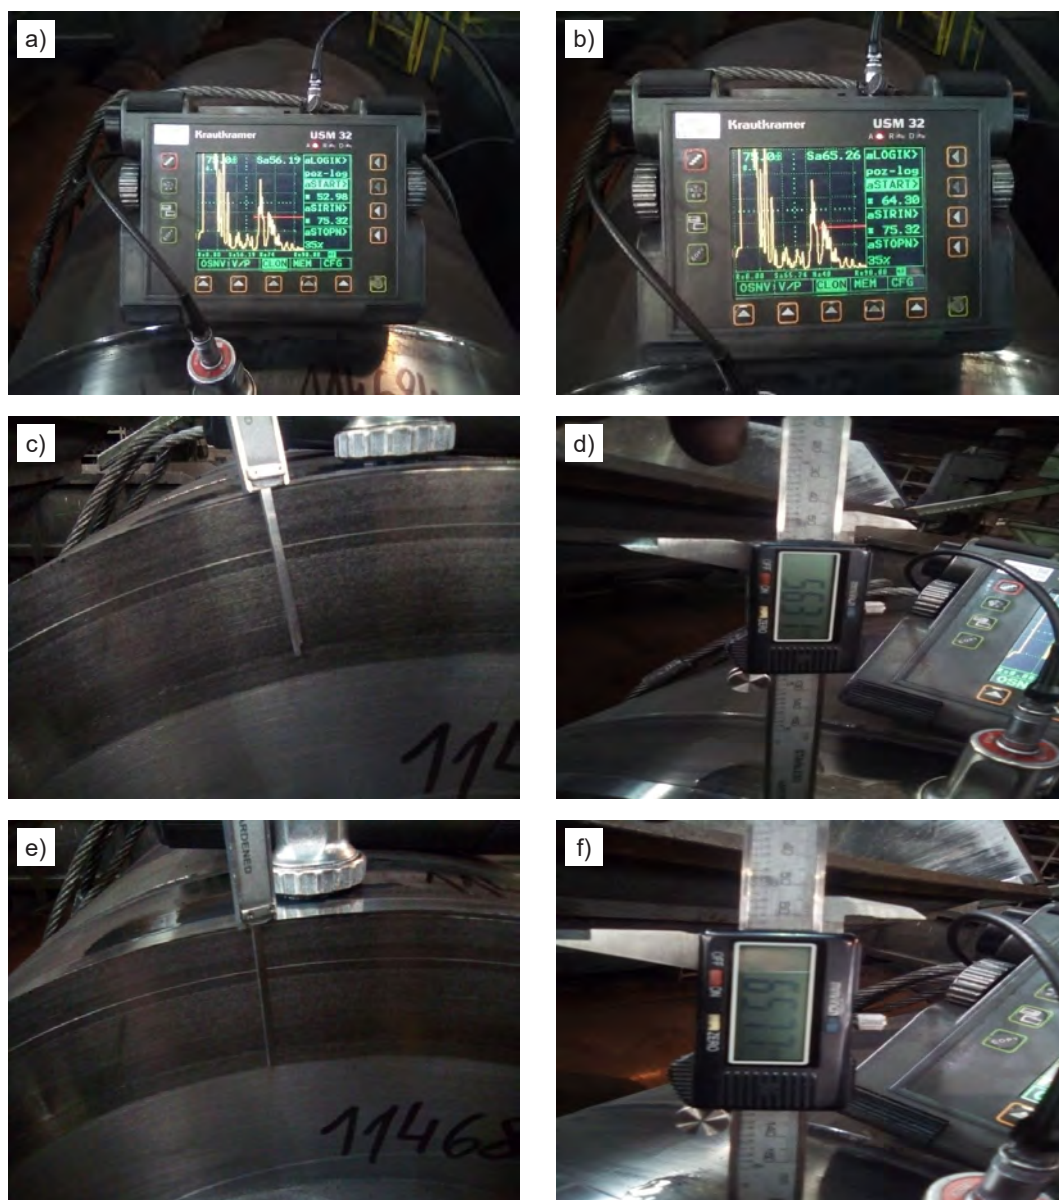
Na robovih trupa valja so bili zaznani večkratni odboji na območju prehoda plasti. Sliki 2a in 2b kažeta rezultate preiskave z ročnim ultrazvočnim aparatom.

Prvi odboj z ročnim ultrazvočnim aparatom je bil zaznan na globini 56,19 mm, drugi odboj pa na globini 65,26 mm. Meritev s kljunastim merilom je potrdila ultrazvočno zaznane globine plasti. Prvi prehod (plašč / vmesna plast) je bil izmerjen pri 56,31 mm, Sliki 2c in 2d, drugi prehod (vmesna plast / jedro) pa pri 65,77 mm, Sliki 2e in 2f.

Multiple echoes from the bonding area were visible almost through the entire roll body. Figure 2a and 2b presents the results of the hand portable ultrasonic investigation.

It is visible that the first echo is detected at the depth of 56.19 mm, while the second one is at the 65.26 mm depth. Same results were obtained when we measured the value of the depths with the caliper. First interface (shell / intermediate) was visible at the 56.31 mm, Figure 2c and 2d and the second interface (intermediate / core) on 65.77 mm, Figure 2e and 2f.

**Slika 2.** Določanje globine plasti z ročnim ultrazvočnim aparatom: a) detekcija in intenziteta prvega odboja; b) detekcija in intenziteta drugega odboja; c) meritev prvega prehoda (plašč / vmesna plast); d) globina prvega prehoda (plašč / vmesna plast); e) meritev drugega prehoda (vmesna plast / jedro); f) globina drugega prehoda (vmesna plast / jedro)

**Figure 2.** Manual depth investigation: a) detection of the first echo and its intensity; b) detection of the second echo and its intensity; c) measuring the first interface (shell / intermediate); d) depth value of the first interface (shell / intermediate); e) measuring the second interface (intermediate / core); f) depth value of the second interface (intermediate / core)

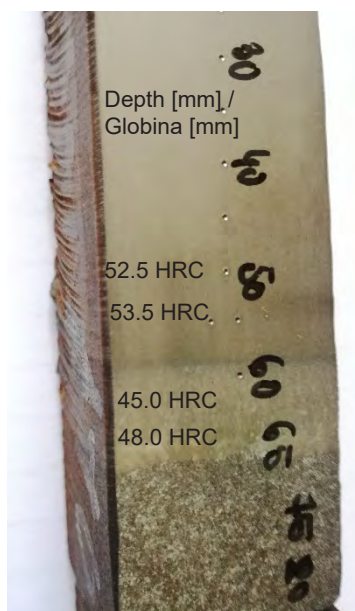
Jedkan metalografski vzorec plasti je razkril podobne rezultate globin/debelin plasti. Meritev trdot po Rockwellu je dodatno potrdila že na pogled opazen prehod, Slika 3.

Similar values were obtained when we analyzed the etched sample taken from the roll ring. Visual interfaces were confirmed with the hardness measurement in Rockwell, see Figure 3.

**Slika 3.** Metalografski vzorec delovne plasti valja z dvema žema na pogled opaznima prehodoma. Na prehodu v vmesni plasti je izmerjen znaten padec trdote

**Figure 3.** Depth of the working layer with two visual interfaces. Hardness drops in intermediate layer

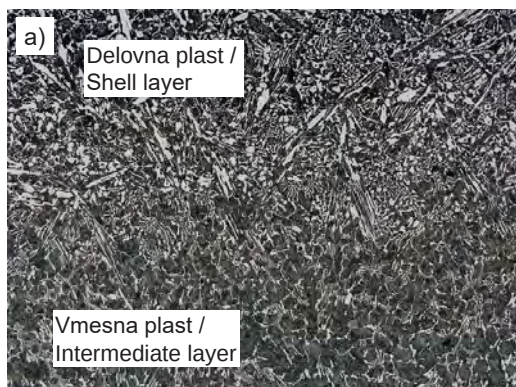
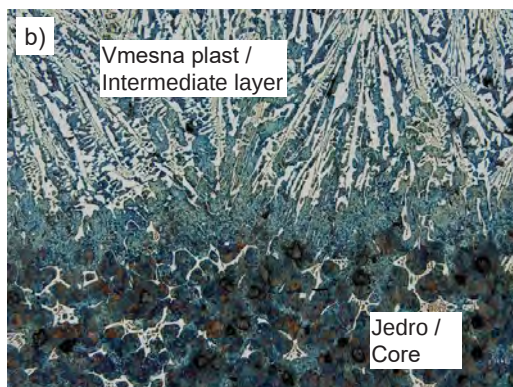
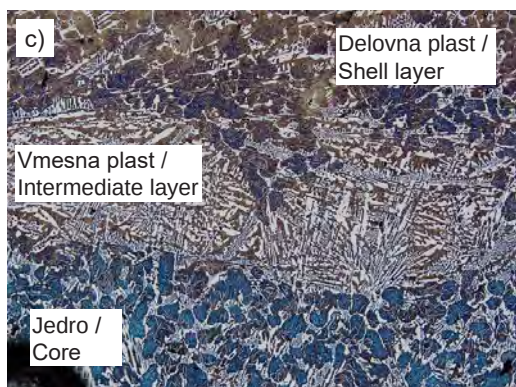
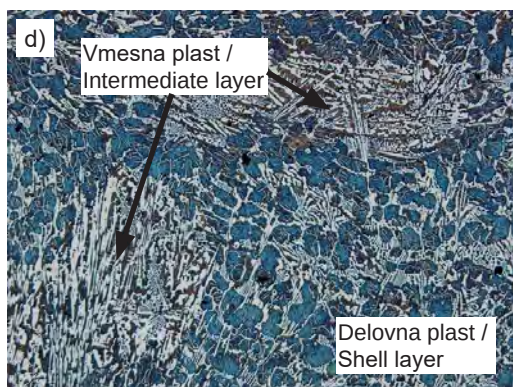
**Slika 4.** Mikrostruktura na območjih prehoda: a) prvo območje: delovna plast / vmesna plast; b) drugo območje: vmesna plast / jedro; c) obe območji prehoda; d) mešanje plasti - možen vzrok za pojav treh odbojev

**Figure 4:** Difference in microstructure in the interfaces zones: a) Shell / intermediate; b) intermediate / core; c) both zones; d) possible cause for three echoes observation

ne prihaja do napak, je bila izvedena podrobnejša analiza mikrostrukture. Mikrostruktura prvega prehoda je prikazana na Sliki 4a. Prehodno območje na prvem spoju je zelo enakomerno za razliko od drugega prehoda med vmesno plastjo in jedrom. Na tem mestu groba mikrostruktura z večjimi bloki cementita preide v perlitno matrico z grafitom in posameznimi otoki ledeburita, Sliki 4b in 4c. Opisani ostri prehodi bi lahko bili razlog zakaj na določenih mestih zaznamo višje ultrazvočne odboje; hitrost širjenja zvoka med močno karbidno mikrostrukturo in perlitno matrico z grafitom je različna.

V redkih primerih je moč zaznati tudi tretji odboj. Slika 4d kaže del vmesne plasti, ki se je ujela v delovno plast. Tako mešanje plasti, do katerega lahko pride na različnih globinah prehoda, lahko privede do pojava tretjega ultrazvočnega odboja. Posledica omenjenega pojava je tudi neenakomerna porazdelitev trdote preko prehoda. Prav tako lahko na takih mestih pride do nastanka razpok, ki so posledica visokih kontaktnih napetosti po Hertzu med delovnim in podpornim valjem, ko se valj med obratovanjem približuje končnemu premeru.

zone, a microstructure analysis was made. Microstructure of the first interface between the shell and intermediate material is presented on the Figure 4a. It can be observed that the transition zone is quite smooth, and it is totally different as is in the case of second interface zone between intermediate layer and the core. In Figure 4b and 4c, it is observed that within 1 mm of the depth a coarse huge ladder shape carbide area is transformed into the pearlite microstructure with the cementite and graphite phase. These rough transitions could be the reason why in some instances a high echo is detected. Carbide nets have different sound velocity properties as the matrix and graphite.

In some rare cases also a third echo could be detected. A layer can be trapped around another one at different depths, what could lead to a third echo participation. This phenomenon is clearly visible in Figure 4d. Hardness distribution inside the transition section is consequently not equal and can cause a crack initiation problem when a roll is near scrap diameter due to the high Hertzian contact fatigue stresses between work and back up roll.

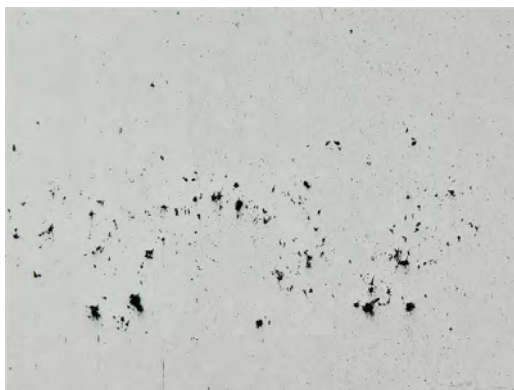
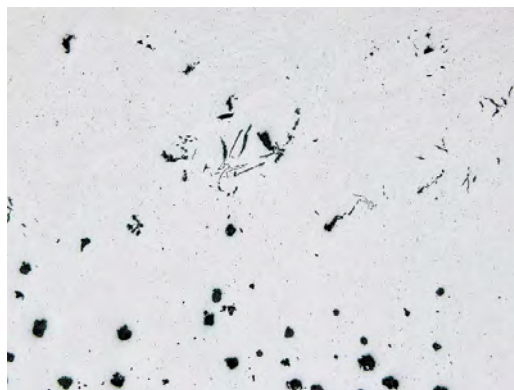
**Slika 5.** Mikropore v vmesni plasti

**Figure 5.** Micropores in the intermediate layer

Na poliranih metalografskih vzorcih se je razkrila mikroporoznost na obeh prehodnih območjih, Slika 5. Z ultrazvočno preiskavo ni mogoče nedvoumno potrditi prisotnosti tako majhnih por, saj je širina ultrazvočnega snopa na tej globini preširoka, da bi jasno zaznala posamezne mikro-napake prikazanih velikosti.

Polished samples reveal micropores in both interface areas, Figure 5. With the ultrasonic method, a detection of presented small defects cannot be confirmed. We assume that the ultrasonic beam is too wide at these depths, to be able to clearly detect micro porosity.

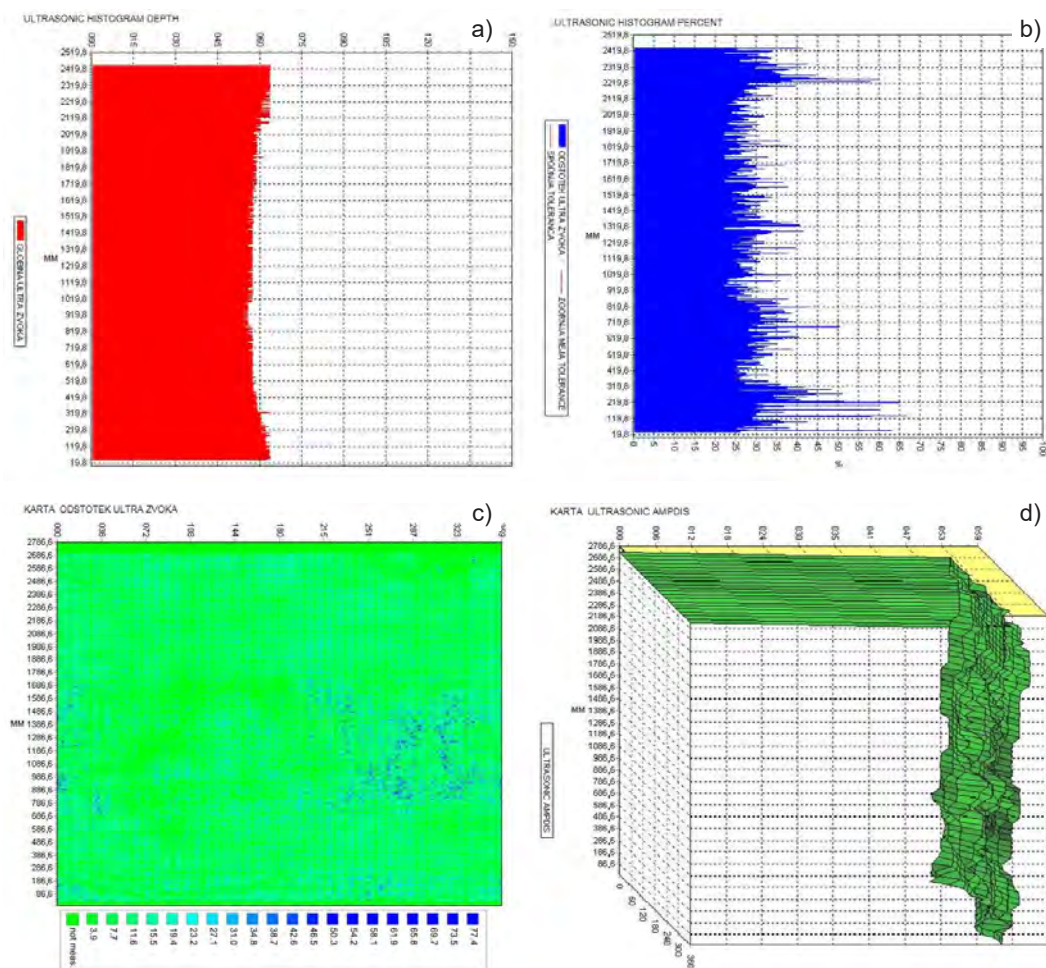
**Slika 6.** Izpisi ultrazvočne preiskave opravljene z avtomatiziranim sistemom Herkules: a) globina plasti; b) jakost odbojev; c) ploskovna preslikava odbojev; d) tridimenzionalen prikaz globine plasti in magnitude odboja

**Figure 6.** Reports from automated on-line ultrasonic system Herkules: a) depth; b) Z-chart; c) C – scan; d) flat pattern view of depth and echo

Izpisi iz avtomatiziranega sistema ultrazvočne analize so prikazani na Sliki 6. Slika 6a potrjuje prisotnost dvojnih odbojev na robu trupa, medtem ko je na sredini trupa zaznan samo en odboj. Sklepamo lahko, da na mestih z enim odbojem, zaznamo zgolj eno prehodno območje. Na mestu z enim odbojem je jedro v celoti natalilo vmesno plast, medtem ko je bila na robovih trupa debelina vmesne plasti rahlo debelejša zaradi izrivanja mase navzven kot posledica delovanja centrifugalne sile. Slika 6b prikazuje jakost odbojev od prehoda plasti. Prekomerno povišani odboji (preko 100 % skale) niso bili zaznani, kar potrjuje rezultate preiskave z ročnim ultrazvočnim aparatom. Na mestih, kjer so zaznani nekoliko povišani odboji, smo potrdili prisotnost blokastih karbidov cementita na prehodu med vmesno plastjo in jedrom. Sliki 6c in 6d prikazujeta drugačen način izpisa preiskave. Na Sliki 6c je prikazana ploskovna preslikava povišanih odbojev, ki se uporablja za natančno določanje lege morebitnih napak v plasti valja.

Reports from automated ultrasonic system are presented in Figure 6. From Figure 6a it is visible that double echoes are presented on the edges of the roll barrel, while in the middle part only one echo is detected. We can conclude that in case of one echo, only one interface zone could be noticed. This could explain that the intermediate layer was fully fused with the core during the static casting and that the centrifugal force moves the intermediate layer to the position of the end cores of the roll shell. Figure 6b represents the Z-chart of the echoes. No high echoes from the interface zone are detected, what was already confirmed with the manual ultrasonic device. Where higher echo is detected, a layer of ladder shape carbides in the area of intermediate / core interface was observed. Figures 4c and 4d represent another possibility how to print the report. Figure 4c is a C-scan image and it is very useful to get the exact location of the possible anomaly presented inside the roll.
