Critical Failure Analysis of Superheater Tubes of Coal-Based Boiler

Gagan Kumar Gupta* – Somnath Chattopadhyaya

This paper highlights a methodology for failure investigation of superheater tubes made of the material T-22 of a coal-based boiler. The process includes visual observation, the identification of sampling locations, the determination of the bulk chemical composition of the base alloy, microstructural investigation using optical microscopy, the exploration of finer structural details using a scanning electron microscope (SEM), the evaluation of hardness over samples obtained from different locations, the fractographic analysis of different failed locations, the X-ray diffraction (XRD) study of corrosion products adhered to inner surfaces, and the determination of the nature of the failure. Within a span of four months, three successive failures of superheater tubes were reported. The tubes were observed to have undergone significant wall thinning. Microscopic examinations using SEM on the failed region and a region some distance away on the as-received tubes were conducted in order to determine the failure mechanism. Layer-wise oxidation corrosion (exfoliation) in the in

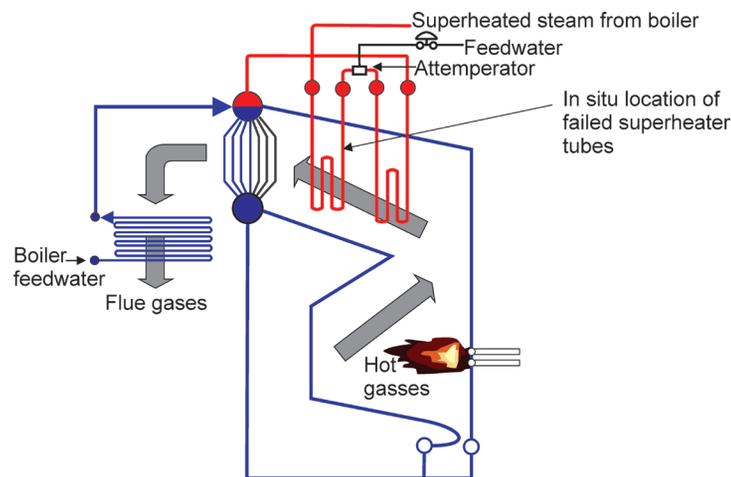
Fig.2. Arrangement of superheater tube with frequent failure zone in one panel

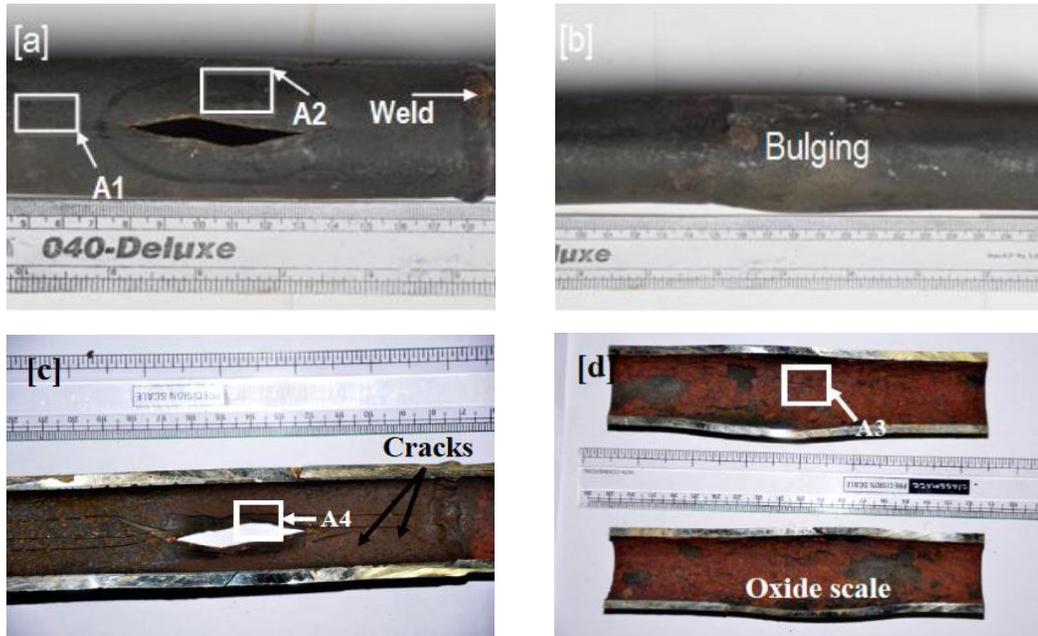
Failed tubes were observed in reflected light with naked eyes (Figs. 5 and 6). Two tubes were designated as Sample-A (P-14_T-6) and Sample-B (P-14_T-5). Both tubes were supposed to have been exposed to temperatures of 540 °C with stress level at 100 bar during operation. Sample-A exhibited fish mouth cracking on one side (Fig. 5a) and bulging at the opposite side of the weld (Fig. 5b). The cut length

of the tube was ~400 mm, and the wall thickness of non-deformed region was ~5.80 mm with ~36.8 mm outer diameter. From the weld seam, the distance of cracking was ~40 mm and the total crack length was ~50 mm with ~6.7 mm maximum opening. Layer-wise corrosion was observed near the open end of the crack, and the remaining wall thickness was reduced drastically (≤ 1 mm). Inner surface consisted of multiple crack formations along the longitudinal direction (Fig. 5c). However, crack formation was completely absent on the outer surface. The latter was blackened owing to thermal effect (Fig. 5a) and the inside surface was deep brown with numerous reddish spots (Fig. 5c). As pointed out already, bulging was observed on the lower half of the same tube. After bulging, the outer diameter became ~42.0 mm with the distance of deformation at ~12 cm from the weld

Fig. 5. Macro image and sampling location from damaged tube A: a) cracking over surface, b) bulged region, c) inner surface of tube, and d) inner surface of bulged region

seam. Thick scale (42 mg/cm^2) of oxide products were loosely stuck to the inner surface near the bulging (Fig. 5d). No significant layer of oxide products was found on the outer surface.

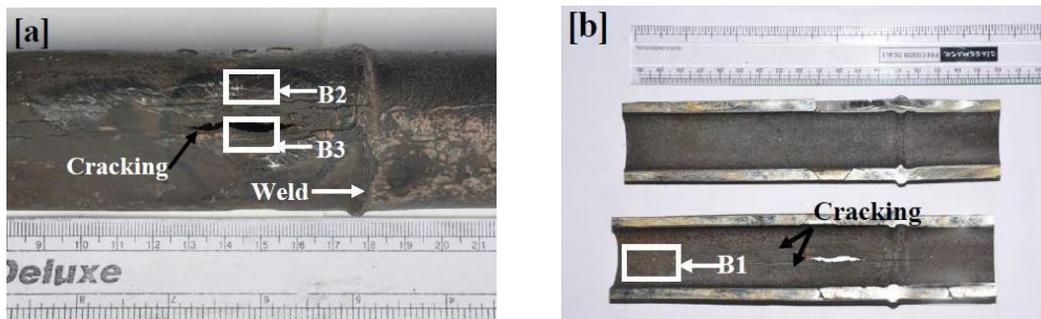
Fig. 6. Macro image and sampling location from damaged tube B: a) cracking over surface, and b) appearance of inner surface

Sample-B also contained fish mouth cracking on one part of the tube, and the other part exhibited no such degeneration. The total length of the cut portion of the tube was $\sim 250 \text{ mm}$, wall thickness was $\sim 6.2 \text{ mm}$ while the outer diameter was $\sim 39.0 \text{ mm}$. A crack developed adjacent to the weld seam with a length of $\sim 30 \text{ mm}$ and a maximum crack opening of $\sim 2.8 \text{ mm}$. Both the inner and outer surface contained longitudinal cracking of variable length (Fig. 6). The interior of the tube was loosely covered with fine brown whiskers, which were generated from oxidation corrosion (28 mg/cm^2) (Fig. 6b). However, no scale formation was observed on the outer surface of the tube. The fractured surface was dull in appearance and comprised a layered brown structure due to oxidation corrosion (Fig. 6a). Excessive thinning was found in the close vicinity of the failure. Thin lip fish mouth cracking with the presence of oxide scales at both the failed locations indicated two operating mechanisms of degeneration, i.e. oxidation corrosion followed by overload failure.

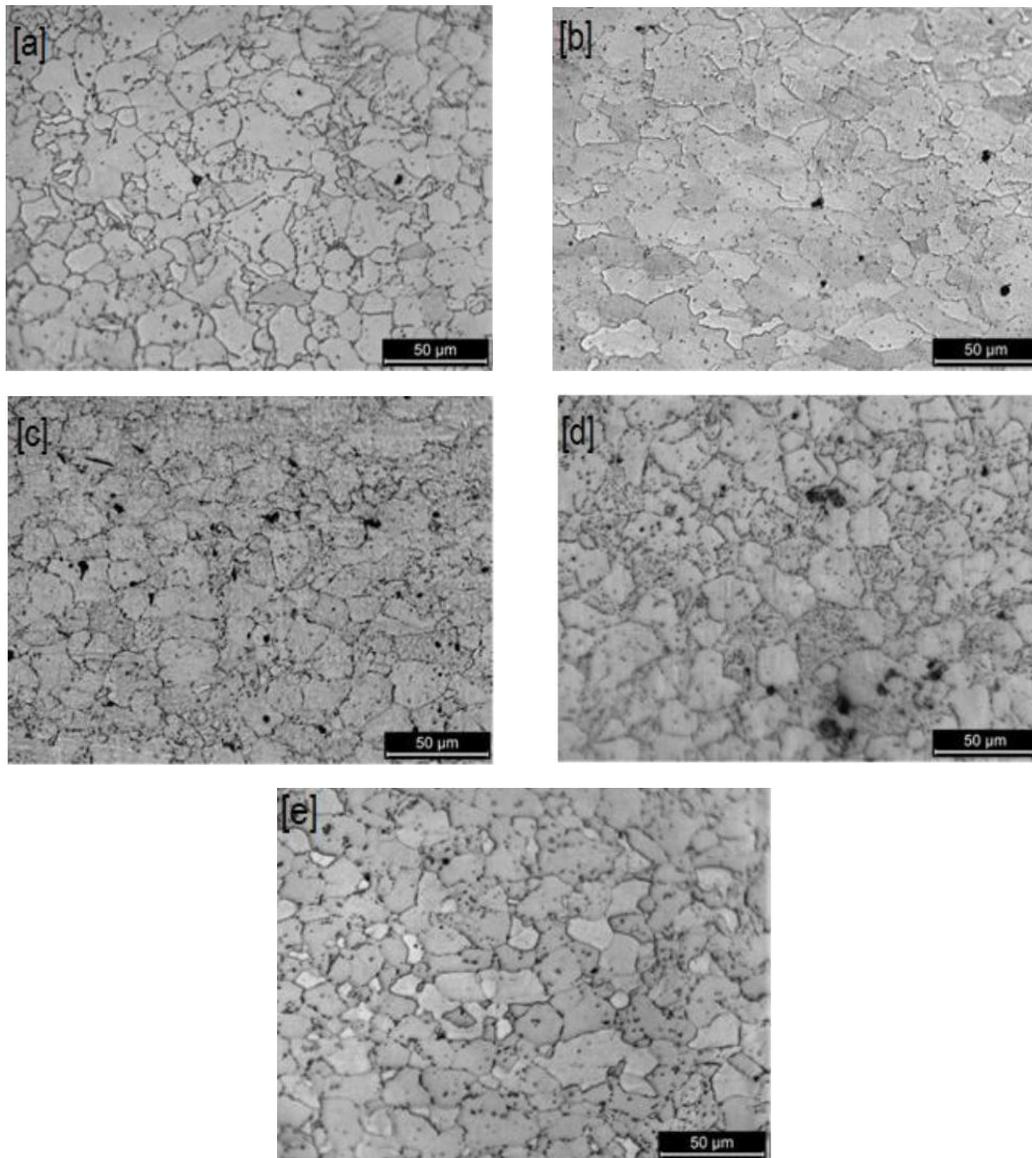
Fig. 7. Optical microstructure of transverse section of damaged tubes:
a) sample A1, b) sample A2, c) sample A3, d) sample B1 and e) sample B2; all samples exhibited ferrite matrices containing large voids, spheroidization & coalescence of carbides preferably along the grain boundary

The optical microstructures of the damaged components are shown in Fig. 7, which predominantly consists of polygonal ferrite. All parts of Fig. 7 showing the dark voids were observed close to the grain boundary. This is an indication of creep deformation. A few globular/elliptical/near-globular diffused shaded islands of variable size can also be found. These are perhaps globular carbide present due to spheroidization under high-temperature exposure (over the operating temperature i.e. $\sim 540 \text{ }^\circ\text{C}$). With respect to the non-deformed grain shape (Figs. 7a and d), the grain shape near the fracture (Figs. 7b and e) exhibits slight increment in aspect ratio with a loss of angularity. This is an indication of material flow under

stress at elevated temperature leading to further wall thinning after the initial reduction of thickness due to exfoliation.

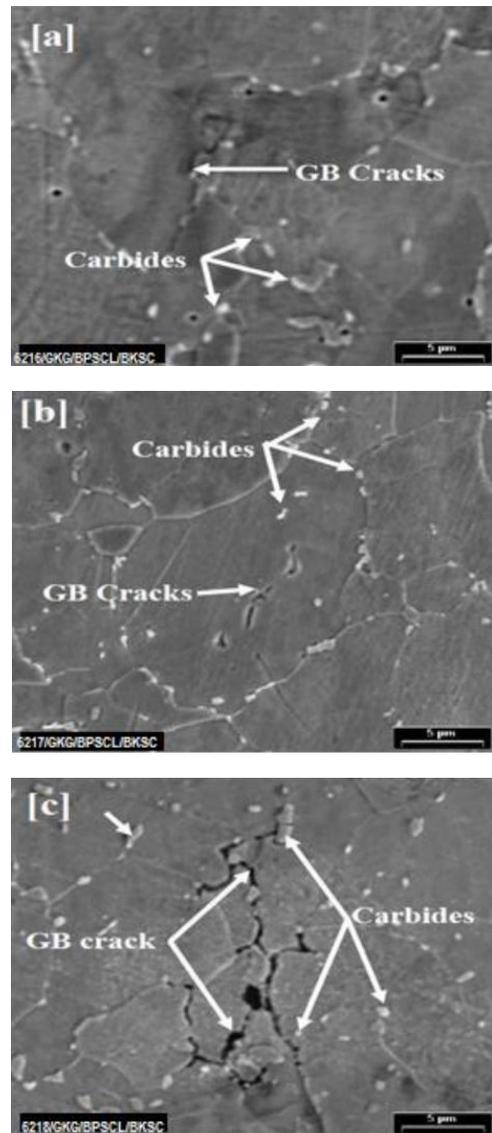
Fig. 8. SEM micrographs of transverse section of damaged tubes: a) sample A2, b) sample A3, and c) sample B2; g.b. voids / cracks and alloy carbides were visible along grain boundary

SEM micrographs confirmed the inferences drawn from optical imaging (Fig. 8). Along the grain boundary, bright islands indicated the spheroidization of carbides (indicated by arrows). Fig. 8 shows the void coalescence along the grain boundary, resulting in crack formation. The region close to bulging also revealed that interconnected voids that were generated during service exploitation. These voids area signature of creep damage developing at elevated temperature

under stress. The rise of local temperature beyond the designated/recommended limit over time, led to grain boundary sliding. The sliding generated decohesion/voids at the boundary. Overtime, the voids grew and became inter connected. This weakened the grain boundary strength, ultimately reducing the load bearing capability of the component. Hence, severe spheroidization of carbide and void generation are indications of local temperature rise. Therefore, temperature rises at high-stress levels cause three phenomena i.e. carbide spheroidization, creep damage to create voids, and material flow resulting in wall thinning.

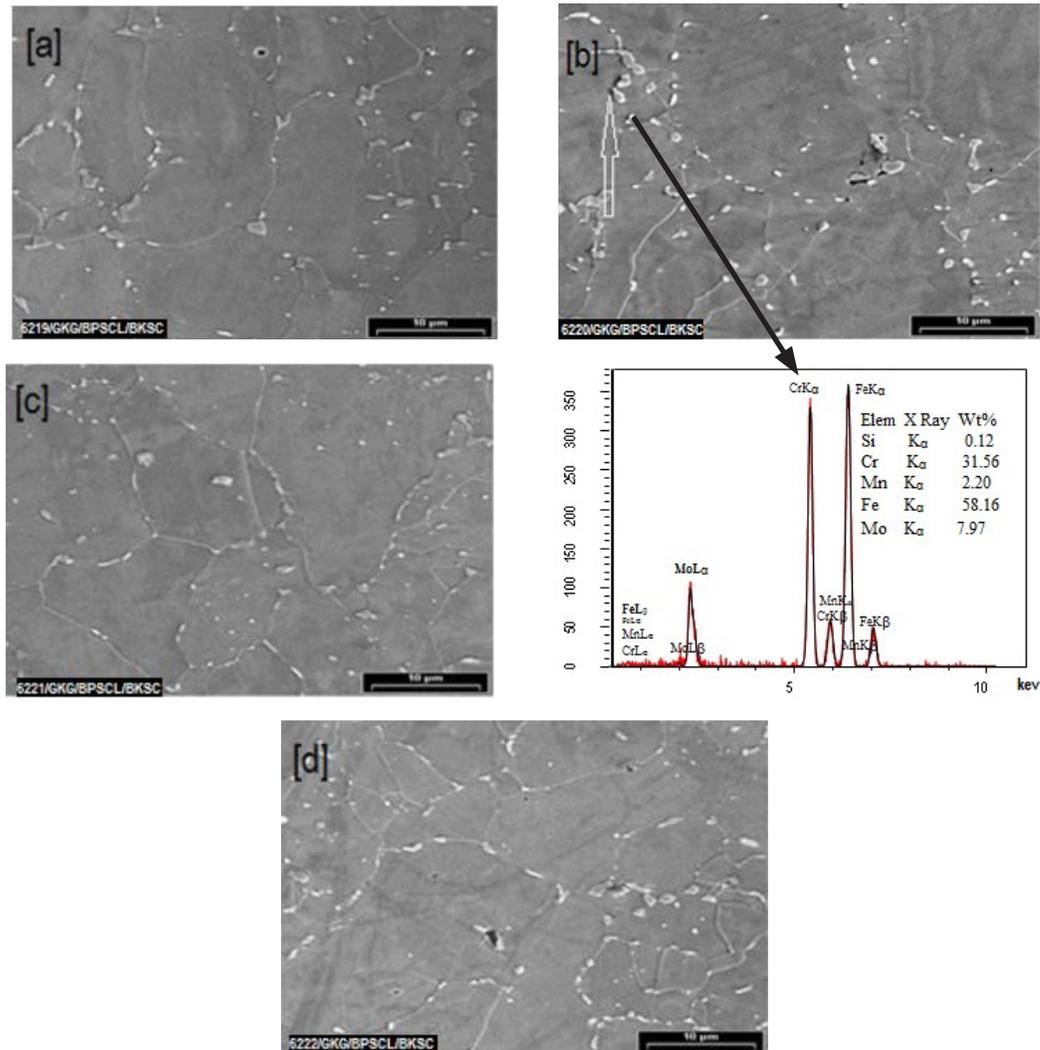
Fig. 9. SEM micrographs across inner to outer region of damaged tubes: a) inner - sample A4, b) outer - sample A4 with EDS spectrum from precipitate as shown in Figure 10b with quantification indicating Cr-Mo rich alloy carbide, c) inner - sample B3, and d) outer - sample B3

structural changes, if any, in tubes near the fracture (Fig. 9). Practically, neither the inner nor outer region close to the fracture exhibit any significant change with respect to Fig. 8. The EDS spectrum was obtained from one of the precipitates along the grain boundary. Semi-quantitative analysis revealed that the precipitates were complex mixed-alloy carbides with Cr and Mo as major constituents.

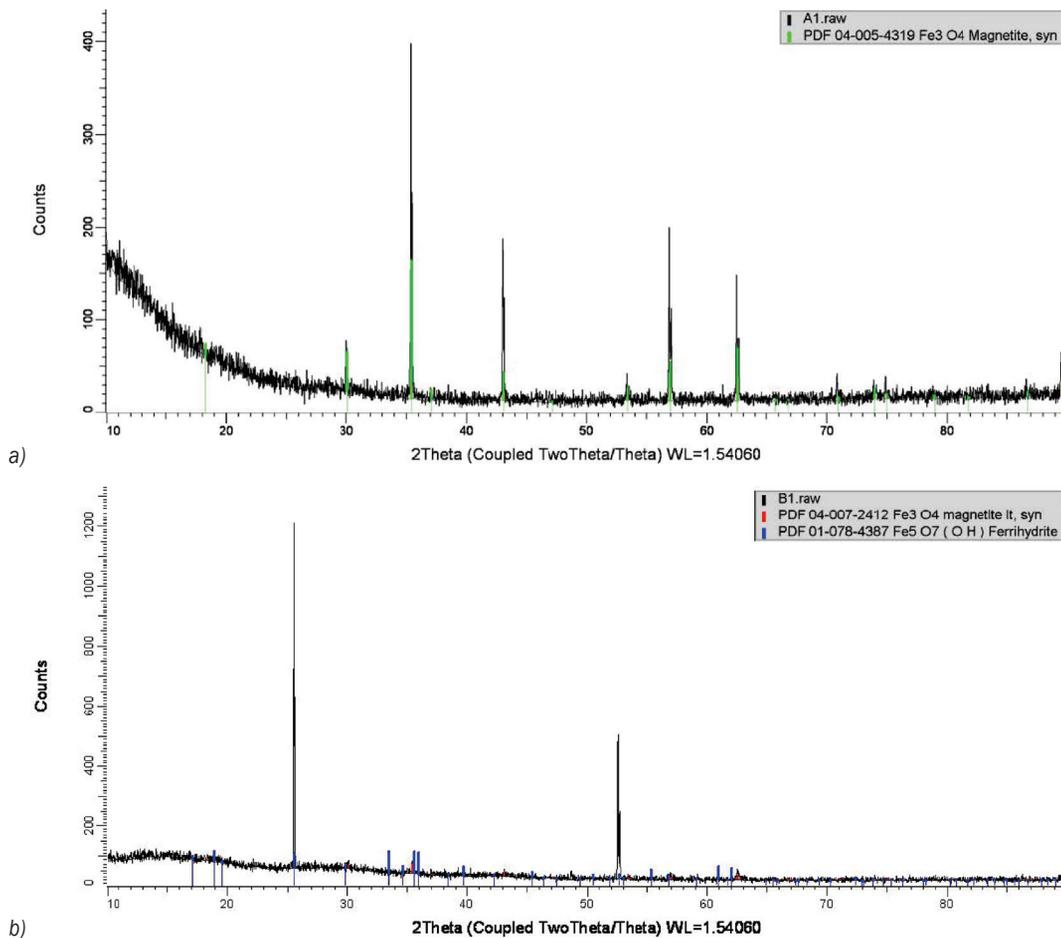
X-ray diffraction analysis revealed the presence of different Fe-oxides and hydroxides as products of

corrosion. The bulk composition of such deposits was also examined in EDS to qualitatively determine the constituents (Fig.10). Major peaks in illustration indicate the presence of iron and oxygen. Corrosion products mainly comprise iron oxide in association with small amounts of other chemical species of steel.

Fig. 10. X-ray characteristic spectrum from the deposits of oxidation corrosion; a) Tube - A, and b) Tube-B; corrosion products were mostly iron oxides and hydroxides of different grades

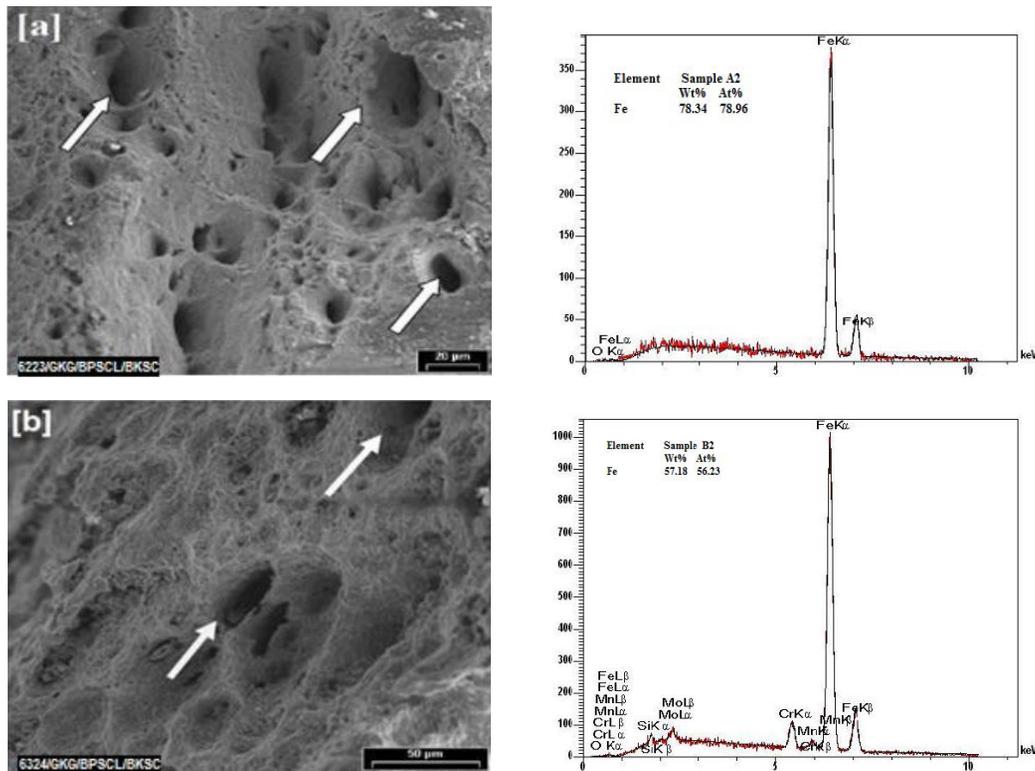
SEM fractographs of both tubes are displayed in Fig. 12. Large micro-voids/dimples can be observed indicating softening of the tube material (Fig.11). The softening of the alloy was established with the reduction in bulk hardness (which is lower than 200 HB) as indicated in Table4. Ductile fracture signifies micro-void coalescence resulting in overload failure. For Sample A, the fractured surface is mostly covered with oxides, and it is difficult to explore specific features underneath, apart from the ductility failure

(Fig. 11a). However, most of the area of the fractured surface indicated ductile dimple fracture (Fig. 11b).

Fig. 11. SEM fractographs of damaged tubes near sample with qualitative EDS analysis of scales formed inside a) the sample A2, and b) the sample B2

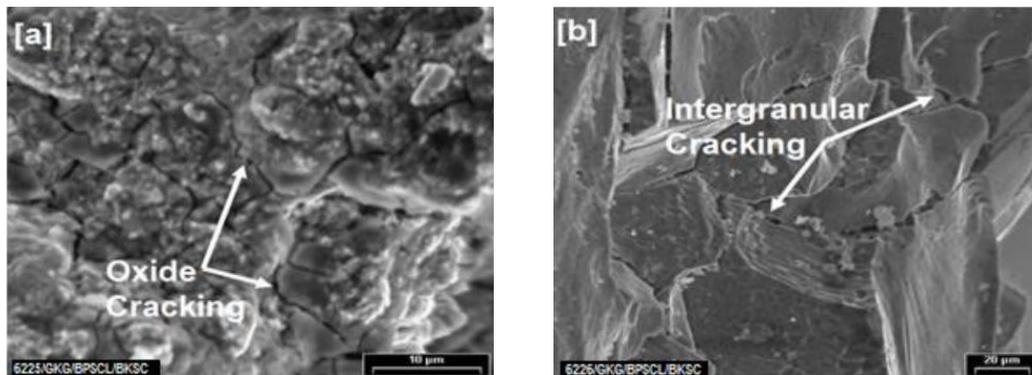
In certain regions, a cracked thick skin of oxide layer can be found (Fig. 12a). In case of Sample B2, inter-granular failure can be observed (arrows in Fig. 12b) at localized regions. This inter-granular cracking originated from voids adjacent to the grain boundary due to creep deformation (Fig. 8). Thus, thin lip fish mouth openings of fractured surfaces on both tubes A and B is the signature of mixed mode failure. In such case, creep deformation is accompanied by wall

thinning through necking. It reduces the strength of alloy, resulting in dimple rupture. If creep happens to be the only operating mechanism, then it turns into thick lip fish mouth failure as there would be no scope for material flow/deformation to reduce wall thickness.

Fig. 12. SEM fractographs of Cracks near damaged tubes; a) near sample A2 and b) near sample B2
