# Analysis on Damage to Rolling Bearings at Small Turning Angels

Ivan Okorn\* – Marko Nagode – Jernej Klemenc

University of Ljubljana, Faculty of Mechanical Engineering, Slovenia

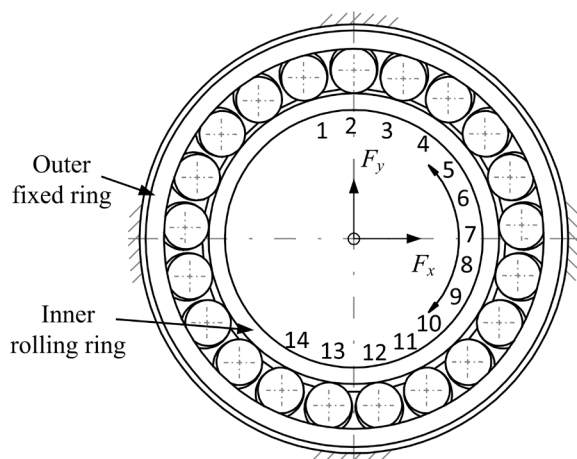
Fig. 2. Positions of rolling elements and damage

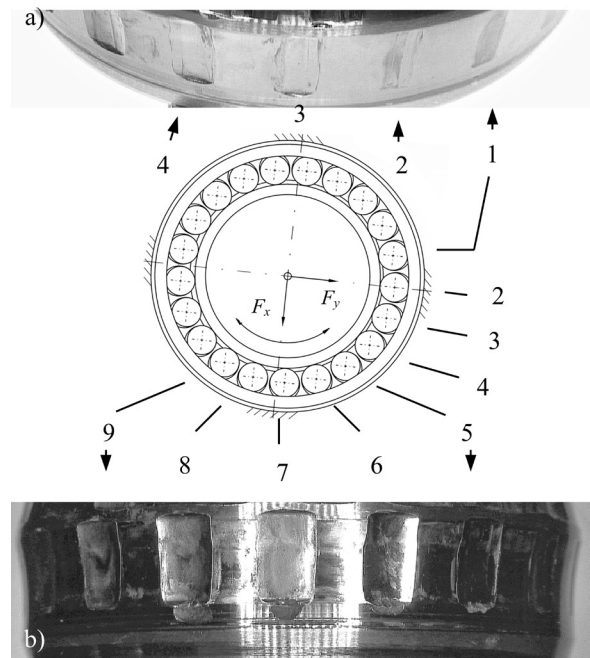
Depression depth increases from the second to seventh rolling element and then decreases. Depressions on the internal ring are shown in Fig. 8. Fig. 8a shows how damage depth increases under individual rolling elements. The location and extent of the damage is consistent with the distribution of load on the individual rolling elements. Deeper depressions formed under the elements that are loaded continuously.

**Fig. 8.** Defect at the surface of the raceway;  
a) damage depth under individual rolling elements 1 to 4,  
b) damage depth under rolling elements 5 to 9

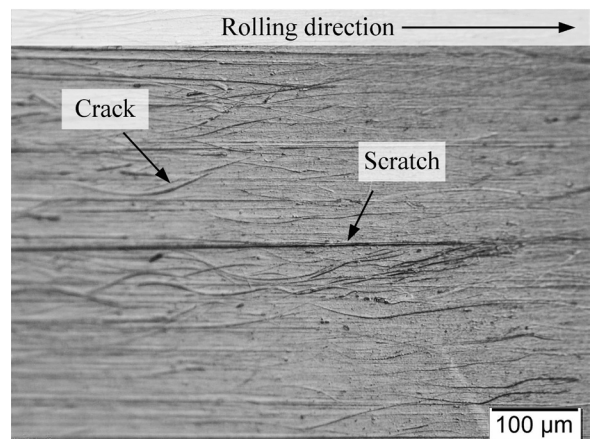
Only a trace of the rolling element can be seen on the internal raceway at the first rolling element, while the first traces of material removal can be seen at the third one. The damage at elements 3 to 7 is similar, with the extent of damage becoming larger. Damage 1 is shown in Fig. 9. When the surface was examined with an optical microscope, cracks were detected in the direction of the roll. Electron microscopy confirmed the fatigue cracks.

**Fig. 9.** Damage 1; cracks on the surface

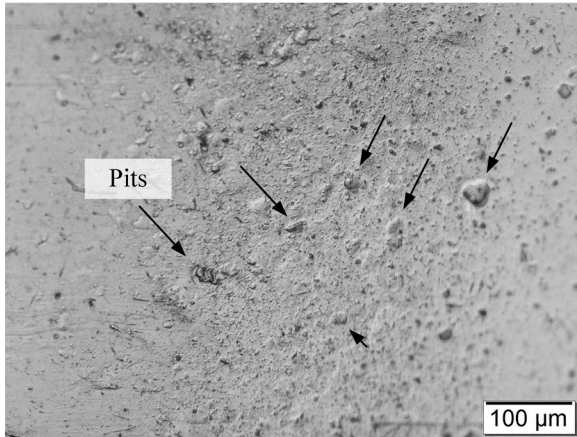
In the case of damage 3, the progression of the surface fatigue is visible, with a typical surface full of small pits (Fig. 10). Progression of cracks can be seen in some parts of damage 3 (Fig. 11). There are no oxidation products that would indicate fretting.

**Fig. 10.** Damage 3; pitting of the surface

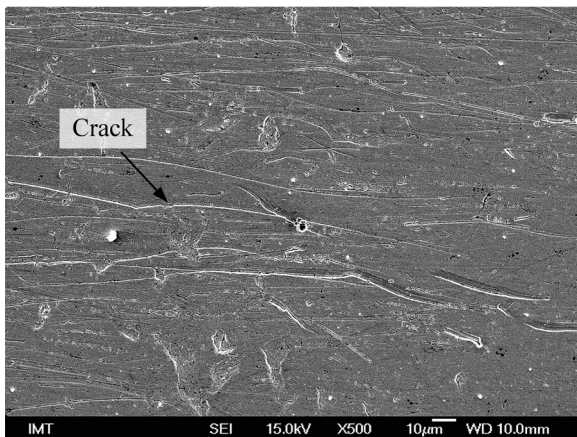
**Fig. 11.** Damage 3; progression of cracks

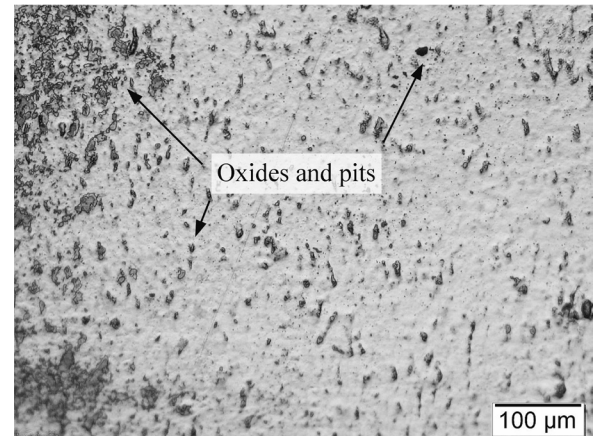
Damage 5 is deeper and wider than damage 3. The surface of the damage is shown in Fig. 8b. Pronounced removal of material with pitting can be seen in Fig. 12. Tribocorrosion and fretting wear occur on locations of pitting due to the uncovering of the metal surface. The wear mechanism is similar in damage 7, with the extent of damage being larger. Tribocorrosion is confirmed by the presence of red-brown surface areas. The presence of oxides was confirmed by electronic microscopy (Fig. 13). Oxides are harder than the surface material, so they act as abrasive particles between the roller and the raceway. The intensity of wear, therefore, increases further.

**Fig. 12.** Surface of damage 5

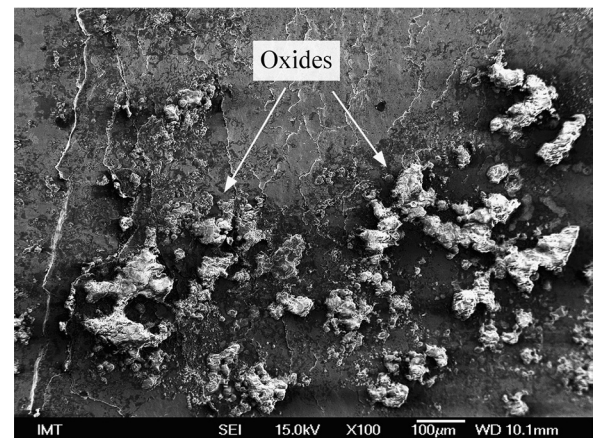
**Fig. 13.** Oxides on the surface of the damage

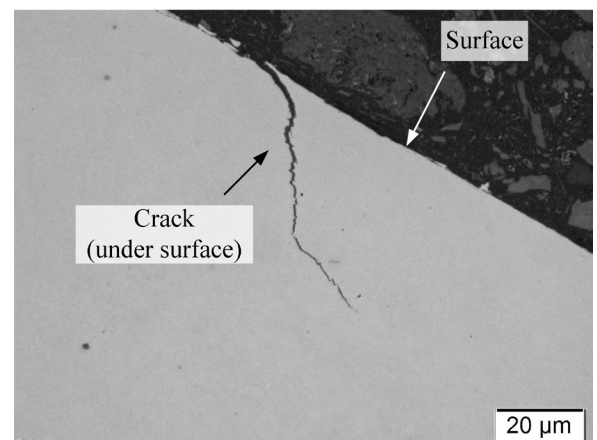
under the surface confirm the mechanism of fatigue. Widening of one of the cracks can be seen in Fig. 14.

**Fig. 14.** Propagation of cracks under the surface

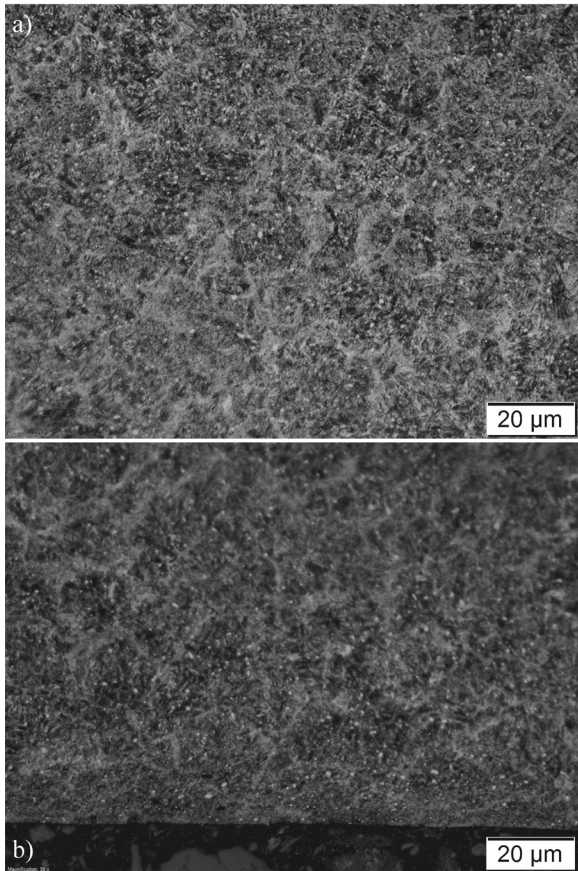
Microstructures in the core and under the damaged area in the cross section of metallographically prepared samples were compared. It can be seen from Fig. 15

that the microstructure is the same. This proves that the load of the contact area did not exceed the yield point, and there was no macro plastic deformation of the material.

**Fig. 15.** a) Core microstructure, b) microstructure under the surface of the damage

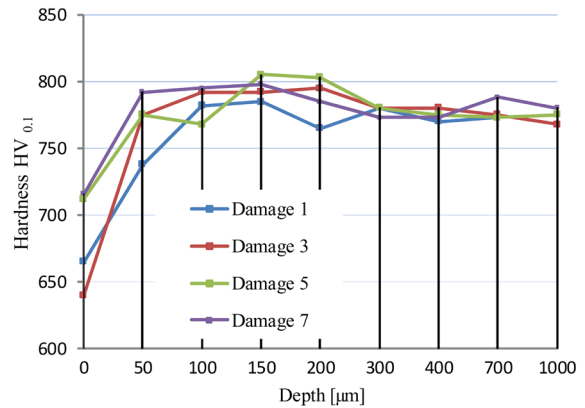
Distribution of microhardness of the material under the damage is shown in Fig. 16 for all four instances of damage that are the subject of this discussion. It can be seen from the profile that the surface does not become harder, which would be typical for the overload and makro plastic deformation of the surface of the bearing steel. A drop of hardness in the surface layer (50 µm micrometers to 100 µm thick) can be seen in all four instances of damage. A larger drop of hardness and the thickness of the layer with the reduced hardness are present at the early instances of damage (1 and 3). This indicates that a contact temperature increased ( $> 200\text{ }^{\circ}\text{C}$ ), which could lead to tempering of the material surface. The higher surface hardness at instances of damage 5 and 7 may be caused by the secondary hardening of the surface after the peeling.

**Fig. 16.** Microhardness under instances of damage
