FAILURE ANALYSIS OF A TRACTOR FRONT AXLE

Ibrahim Yavuz

Faculty of Technology, Afyon Kocatepe University, Afyon, Turkey

doi:10.17222/mit.2022.711

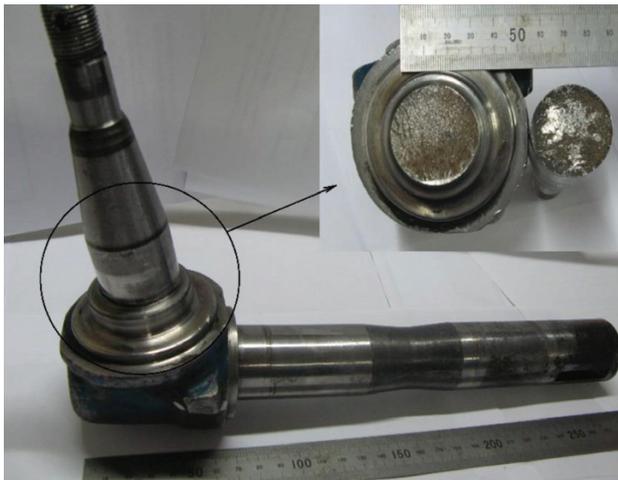
Figure 2: Tractor front axle and a broken surface analysis

This study investigated an early failure of an (operating) tractor front axle with similar methods of inspection. Stress analyses were also performed using the finite element method. **Figure 2** shows the tractor front axle and the broken surface analysis.

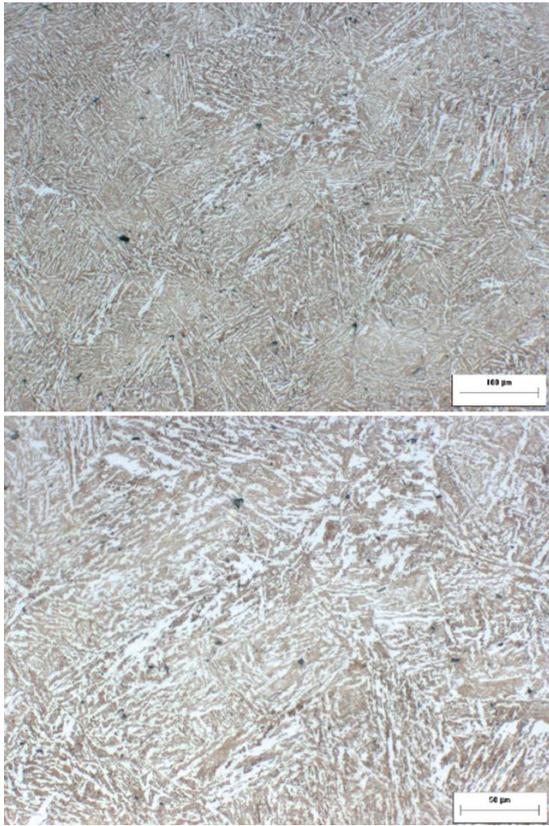
Figure 3: Optical-microscope photographs: a) 50 µm magnification image and b) 100 µm magnification image

The martensitic and ferritic structures stand out in the microstructure examinations (**Figure 3**). This is one of the steel alloys suitable for tempered steel hardening. As can be seen from the rigidity analysis, the axle was subjected to surface hardening. Therefore, the outer surface is hard, and the inner parts are ductile.

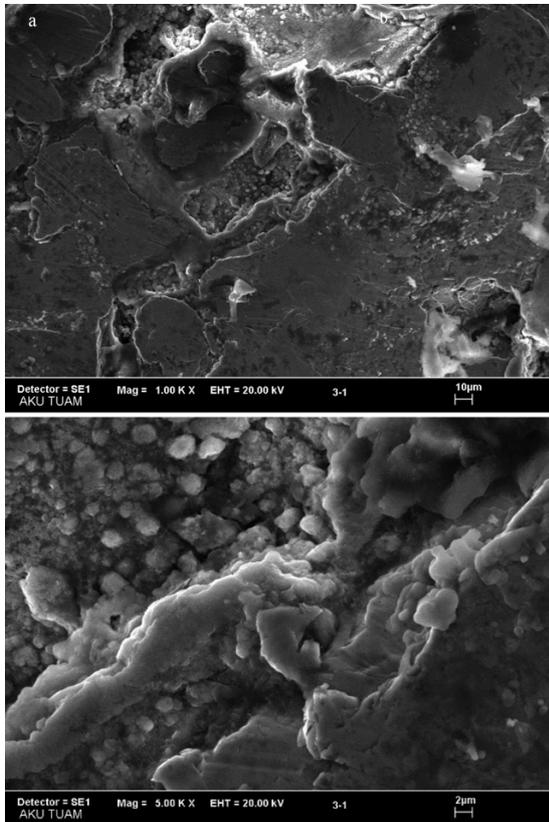
In **Figure 4a**, signs of a brittle fracture of the structure are observed. The fracture surface gradually obtained micro-scale pit characteristics as shown in **Figure 4b**. The reason for this is the martensitic structure.

Figure 4: SEM images of the fracture surface: a) 1000x and b) 5000x

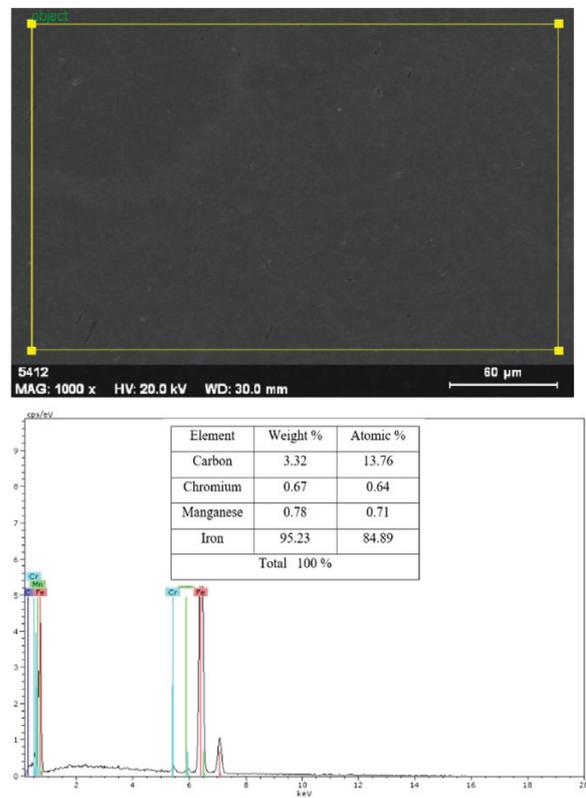
Figure 5: Tractor-axle EDX analysis

Figure 5. In the EDX analysis results, Cr and Mn stand out. Cr makes alloy steels more durable and more rigid than the standard carbon steel. Mn increases the hardenability of steel. The most crucial feature of Mn is that it makes a MnS compound with sulphur and prevents the formation of a FeS compound. FeS causes hot brittleness.

The semi-quantitative chemical analysis with EDX, added to SEM, was performed to qualitatively identify the damaged tractor axle shaft alloy and confirm the presence of any other components. No components that could cause damage were detected with the EDX analysis.

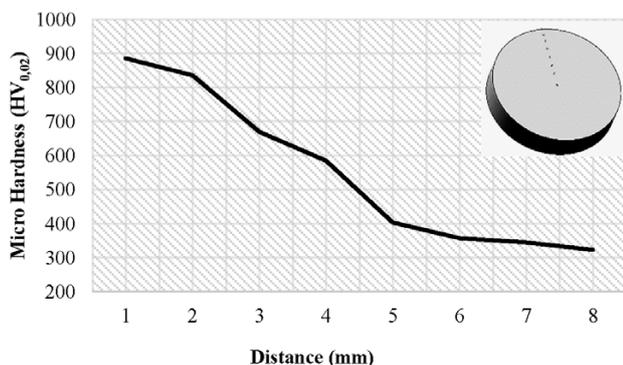
Figure 6 shows that the hardening takes place on the outermost part and the axis reaches the proper hardness towards the centre. It is noteworthy that the hardness is highest on the outer surface, with a value of 900 HV, decreasing towards the centre of the axis and reaching a core hardness of 323 HV. In the literature review conducted, it was determined that the outer surface hardness is around 700 HV and the inner surface hardness is around 250 HV at the end of hardening.²¹

The outer surface becomes too hard, making the material brittle. Inside, the material is softer but relatively rigid when compared to the rest of the material. This makes the material extremely brittle. Brittleness, on the other hand, causes fractures due to impacts on the material.

Figure 6: Micro-hardness analysis results

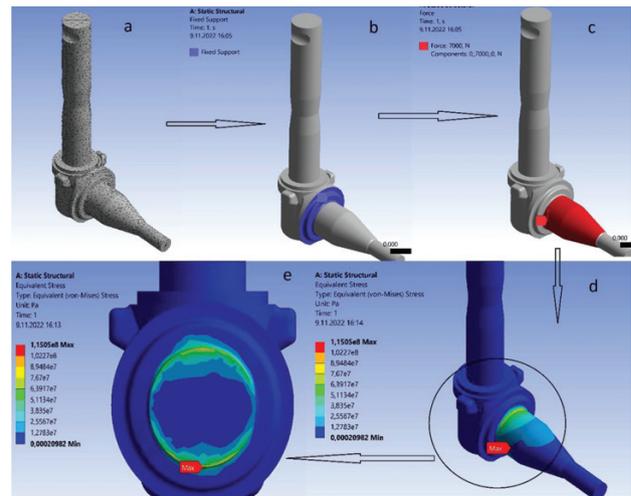
Figure 7: Von-Mises stress distribution for the tractor front axle damaged by fracture

Figure 7 shows the distribution of the von-Mises stress values for the tractor front axle for the damaged design condition. As shown in **Figures 7c** and **7d**, it was determined that the maximum von-Mises stress at the critical fracture zone of the tractor front axle end for the original design condition and damaged design condition is $\sigma = 115$ MPa. However, the variable character of the applied stress and possible effect of the forces from road-surface irregularities can decrease the fatigue limit.

Consequently, the tractor front axle end should have an infinite life at this loading and the original design condition. However, from the above observations, the fact that the fracture-damaged area and the high-stress concentration region of the axle shaft end occur in the same parts as the damaged crack origin proves that it contributed to the failure (**Figure 8**). The fracture region acts as a stress enhancer and may be an additional factor in the present situation. A fatigue fracture almost always

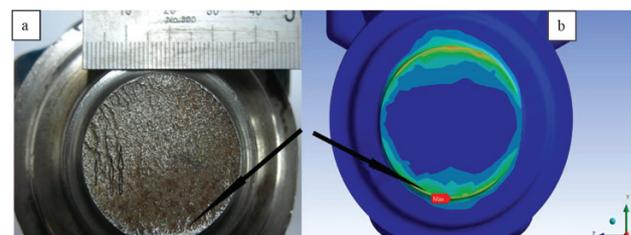
Figure 8: Comparison of the damaged area and stress concentration

occurs in parts such as notches, cracks or other stress concentrations. In the analysis, it was seen that the maximum stresses occur in the critical section of the transition region. It should be considered that this condition causes a high-stress concentration and may lead to the initiation of fatigue cracking during operation.

In brittle fractures, a macroscopic division is observed. It does not matter if the materials are metallic or non-metallic as long as they are brittle. Separation is defined as the breaking of a body on a single surface.²² As the cleavage will show slight variations at the plane levels of multiple fractures, the surface will show fine crevices called the fatigue pattern that gives the fractures their characteristic aspects with a macroscopic cleavage, as illustrated with the example in **Figure 8**. The propagation exhibits a greater roughness as the crack progresses towards the final split point.
