AN AES INVESTIGATION OF BRUSHED AISI 304 STAINLESS STEEL AFTER CORROSION TESTING

Matjaž Torkar, Djordje Mandrino, Martin Lamut

Institute of Metals and Technology, Lepi pot 11, 1000 Ljubljana, Slovenia
matjaz.torkar@imt.si

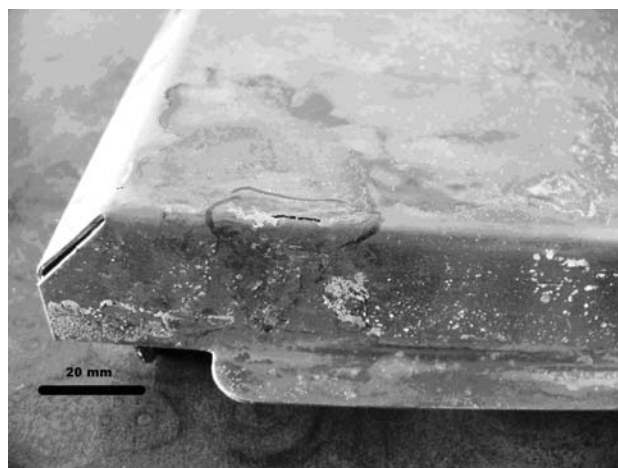
The rusty spots in **Figure 1** represent the remains of dried rust and were easily removed from the non-brushed surface. Most of the surface below the rusty spots was without any corrosion damage. The possible sources of rust were cut edges, holes for screws and deformed regions where the sheet was bent. It is also important not to neglect the remnants of other material that was in contact with the sheet, like for instance, fragments of the brush. It seems that a liquid, contaminated with rust, was spread over the sheet, and after drying the rust spots remained on the non-corroded steel surface.

Figure 1: Remains of rust and NaCl on the surface of AISI 304 stainless steel after a corrosion test in wet salt chamber. The longitudinal pit is present on the bent edge

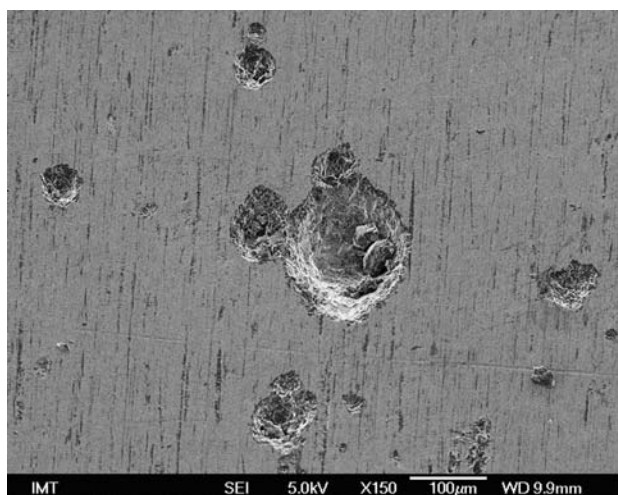
SEM microscopy of the brushed surface revealed individual corrosion pits and groups of corrosion pits (**Figure 2**). The longitudinal traces of brushing are evident on one side of the sheet, while the opposite side

Figure 2: Corrosion pits on the brushed surface after the corrosion test. SEM

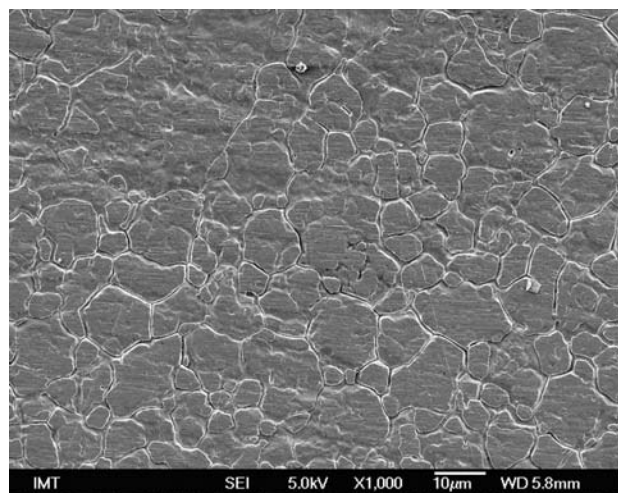
Figure 3: Untreated surface after the corrosion test. SEM

of the sheet and the non-brushed surface revealed equiaxed grains with clearly defined grain boundaries (**Figure 3**). Only the brushed surface and the bent edge of the sheet were damaged by corrosion, and on the curved edge longitudinal pits were observed (**Figure 4**). In corrosion-damaged regions we observed either the aggregation of shallow pits or individual deep pits (**Figures 2 and 5**).

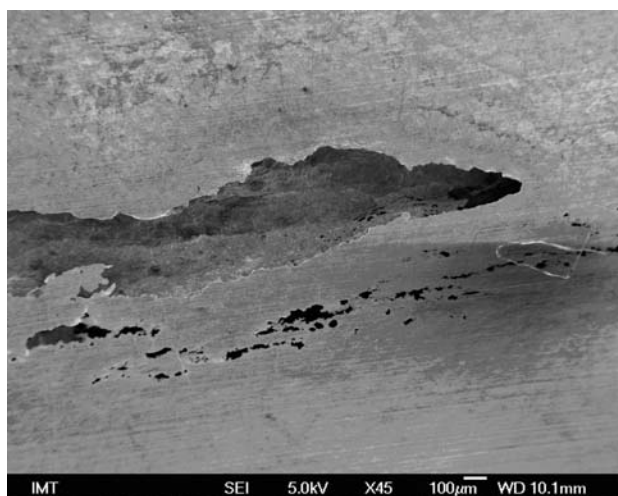
Figure 4: Longitudinal corrosion pit on the bent edge. SEM

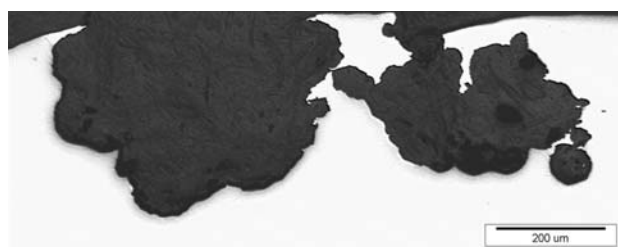
Figure 5: Micrograph of cross-section of the corrosion pit on the bent edge. Local corrosion advanced deep into the material of the case wall

Because of the wet environment and the presence of chloride ions in the salt chamber, the local pitting corrosion process started and advanced to the middle of the sheet, as revealed by the optical microscopy in the cross-section (**Figure 5**). The corrosion process was also accelerated by the presence of deformation-induced martensite. To transform the martensite into austenite, it is necessary to anneal the stainless steel after cold deformation.

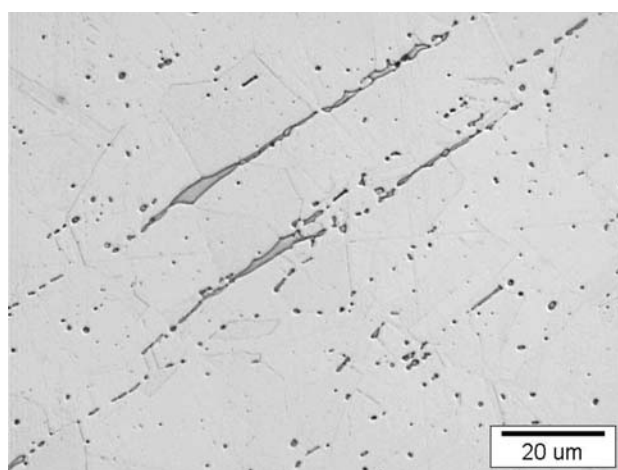
The metallography revealed martensite in the deformed regions in the austenitic matrix. Also, elongated delta ferrite (**Figure 6**) was present in the matrix. Both phases were a possible source of the corrosion, when in contact with the corrosion medium.

Figure 6: Microstructure of austenitic stainless steel AISI 304 with elongated delta ferrite. In deformed regions the deformation-induced martensite was also present. Etched with aqua regia.

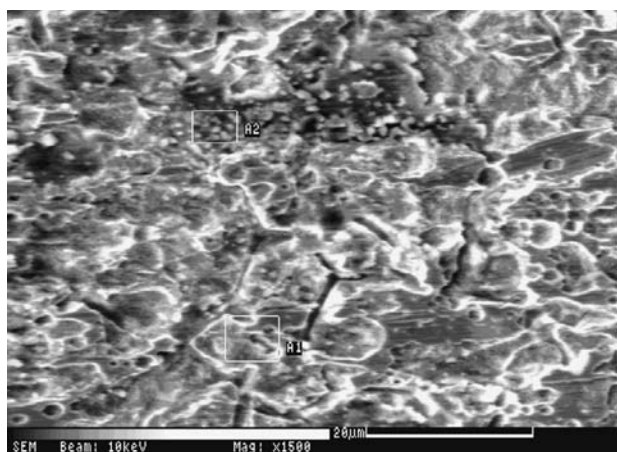
Figure 7: Surface damaged by corrosion (SEM). A1 and A2 mark the areas analysed with AES. Before the analyses the surface was ion etched for 45 minutes.

The AES analysis of the corroded steel surface (**Figures 7 and 9**) after the wet salt chamber test revealed that in the corrosion pits either sodium and chlorine or only chlorine were present (**Figure 8 and 10**). The binding energy of the analyzed element sodium corresponded to NaCl (**Figure 8**). The source of the NaCl was the wet salt chamber. No traces of sodium or chlorine were detected on the non-corroded surface (**Figure 10, P2**). But in typical use a possible source of chloride ions is from the environment (sprayed brine, the salt in food, cleaners).

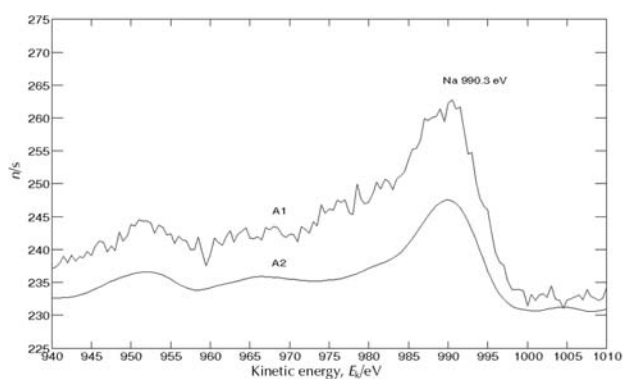
Figure 8: AES spectrum on the corroded places A1 and A2 marked in **Figure 7**. Presented peak for Na KLL at 990.3 eV in non-differentiated spectrum of AES corresponds to Na in NaCl⁹

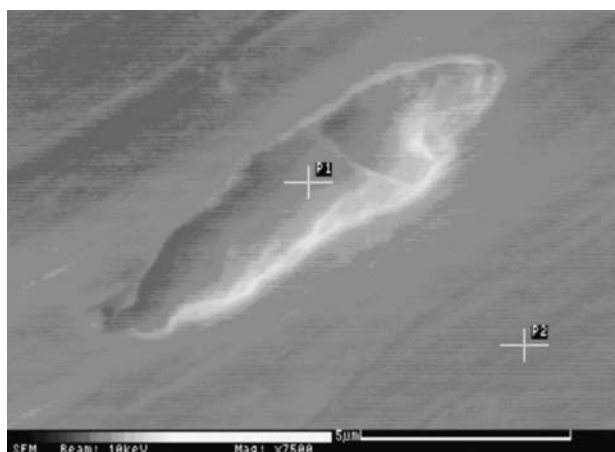
Figure 9: Surface with corrosion pit. At the points P1 and P2 the AES analyses were performed. The presence of Cl was detected only in the pit. SEM

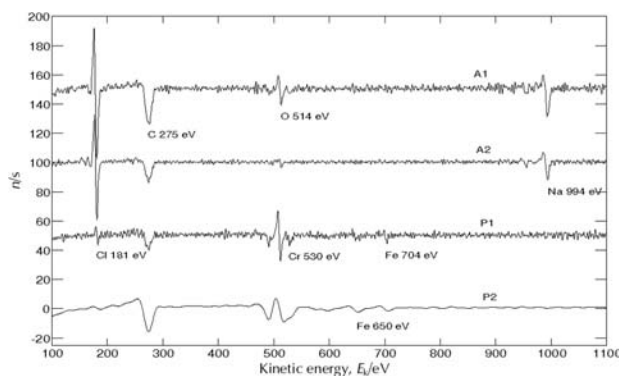
Figure 10: AES spectrum in the areas A1 and A2 (**Figure 7**), and at the points P1 and P2 (**Figure 9**) Only in the corroded areas A1 and A2 was the presence of Na and Cl detected. In the pit P1 only Cl was detected. Out of the pit no Na or Cl was detected.
