## Mehanizem obrabe kotalnega dleta

### Roller cone wear mechanism

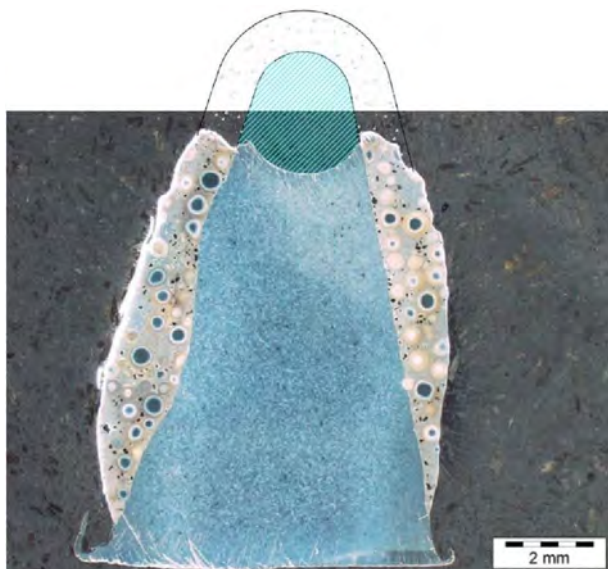
**Slika 2.** Makroskopski prerez zoba kotalnega dleta z rekonstrukcijo prvotne geometrije

**Figure 2.** Macroscopic cross-sectional view through the teeth of the drill bit, with the reconstruction of the original geometry

ter da je evidenten nastanek erozijskih kanalov na vrhovih zob. Zobje zunanje vrste so bili obrabljeni na straneh, ki niso bile zaščitene s karbidno oblogo. Na vseh zobeh kotalnega dleta je bilo opaziti erozijske kanale. Rezultati pregleda dleta so prikazani v tabeli 3.

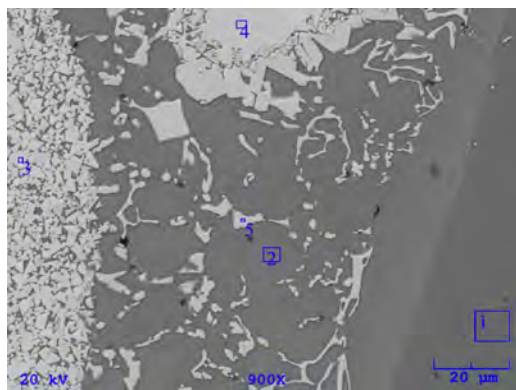
**Slika 3.** SEM prikaz zoba, od karbidne obloge, cone mešanja do jekla telesa zoba (od levo proti desni): 1 – telo zoba, 2 – matrica karbidne obloge, 3 – karbidni material, 4 – karbidni material, 5 – karbidni material**Figure 3.** SEM image of bit tooth, from carbide coating, mixing zone till steel tooth base (from left to right): 1 – tooth body, 2 – carbide coating matrices, 3 – carbide material, 4 – carbide material, 5 – carbide material

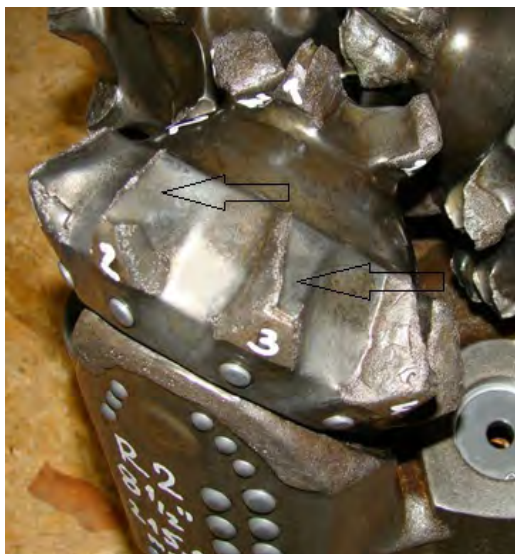
When the penetration rate started to rapidly decrease, the drill bit was extracted from the well. A visual inspection of the fatigue of the bit, which led to the poorer operation of the bit, was carried out. It was found that the wear on the bit occurred in the form of the loss of tooth materials in places where the teeth were not protected by a carbide coating. Such characteristic wear of the bit is shown in Figure 7.

Figure 7 illustrates the loss of steel material due to the erosion action of the mud, which contained a large proportion of silicate particles (Table 2). The wear was reflected in the reduction of the dimensions of the body of the tooth and the formation of erosion channels at the tip of the tooth. The formation of erosion channels at the top of the tooth can be attributed to the decay of the carbide coating during the drilling process, which allowed the flushing of mud with silicate particles (Table 2) to erode into the newly opened surfaces, as shown in Figure 8.

**Slika 7.** Karakteristične poškodbe kotalnega dleta

**Figure 7.** Characteristic wear of roller drill bit

Na sliki 7 lahko opazimo izrabo materiala zaradi erozijskega delovanja navrtanine, ki je vsebovala velik delež silikatnih delcev (tabela 2). Poškodbe se odražajo v zmanjšanju gabaritov telesa zob in v tvorbi erozijskih kanalov na vrhu zob. Tvorbo erozijskih kanalov na vrhu zob lahko pripišemo razpadu karbidne obloge v toku vrtnja, ki je omogočila, da je lahko izplaka z vsebnostjo silikatnih (tabela 2) delcev erozijsko delovala na novo odkrite površine, kot je prikazano na sliki 8.

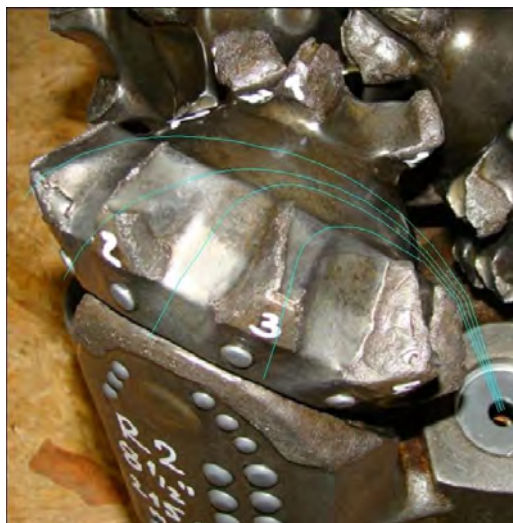
**Slika 8.** Poenostavljena slika strujenja izplake preko kotal dleta

**Figure 8.** Simplified sketch of mud flow through the roller of drill bit

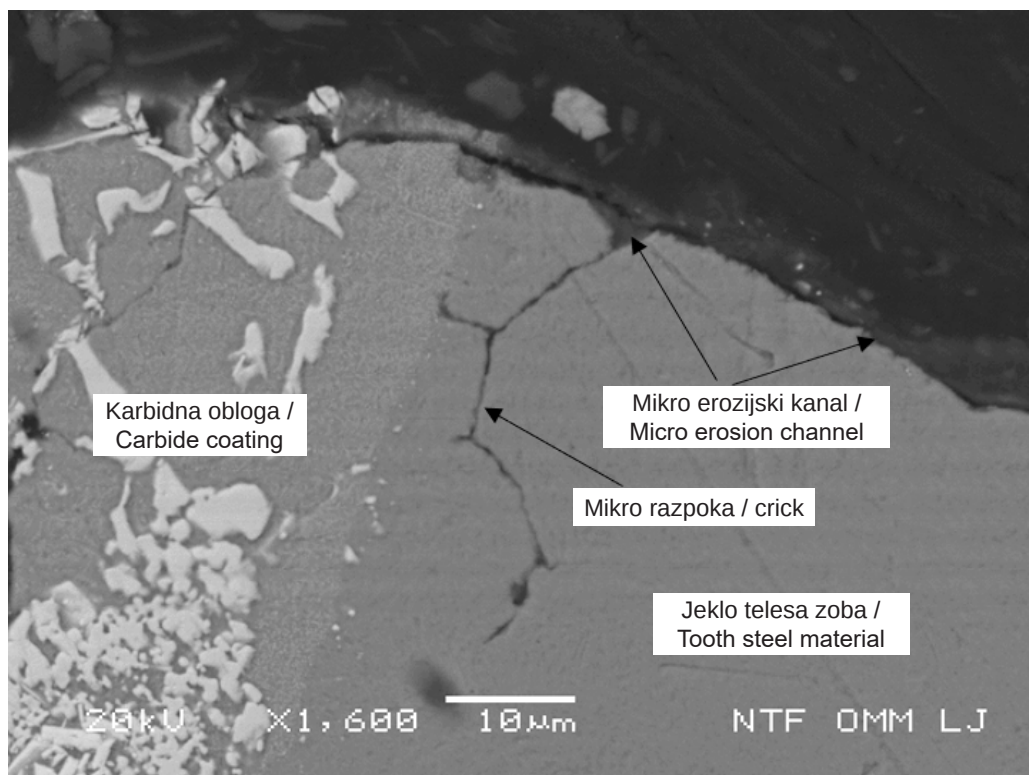
Zaradi precejšnje razlike v trdnostnih in toplotno razteznostnih lastnostih med karbidnim materialom, ki predstavlja oblogo (zaščito) telesa zoba in jeklenim materialom telesa zoba, je tokom izvajanja vrtnih del, zaradi različnih razteznih oziroma elastičnih materialnih karakteristik, prišlo do tvorjenja razpok med materialoma, kot prikazuje slika

of the tooth body and also due to various expansions or elastic material characteristics, cracks formed between the materials as shown at the Figure 9. A consequence of this is the split of the carbide coating from the tooth body. The result of this split between materials was the formation of a new steel surface through which mud containing a large amount of silicate abrasive components flowed. The abrasive components, which eroded the newly opened surfaces at the tips of the teeth, were caused by the formation of erosion channels and consequently the loss of the steel tooth material. The display of the formation of micro cracks resulting from the different elastic properties of the materials is shown in Figure 9. The picture shows the edge of the erosion channel at the top of the tooth. On the left side of the image, we can see a lining of carbide coating and, on the right side, the steel material of the tooth and the formation of a micro crack can be

seen. At the top of the tooth, micro erosion channels are visible. The carbide coating at the top of the tooth, which is more resistant to erosion, but fragile, gradually disintegrates due to the effects of pressure (weight on bit) and shear conditions combined with heating and cooling during the drilling process. This process can be seen in the top left side of Figure 9.

This phenomenon was only observed at the top of the tooth, while on the side of tooth, the formation of micro cracks in the carbide coating was not detected on the investigated drill bit.

**Slika 9.** Tvorba mikro razpok kot posledica različnih elastičnih lastnosti materialov

**Figure 9.** The formation of micro cracks as a result of various elastic properties of materials

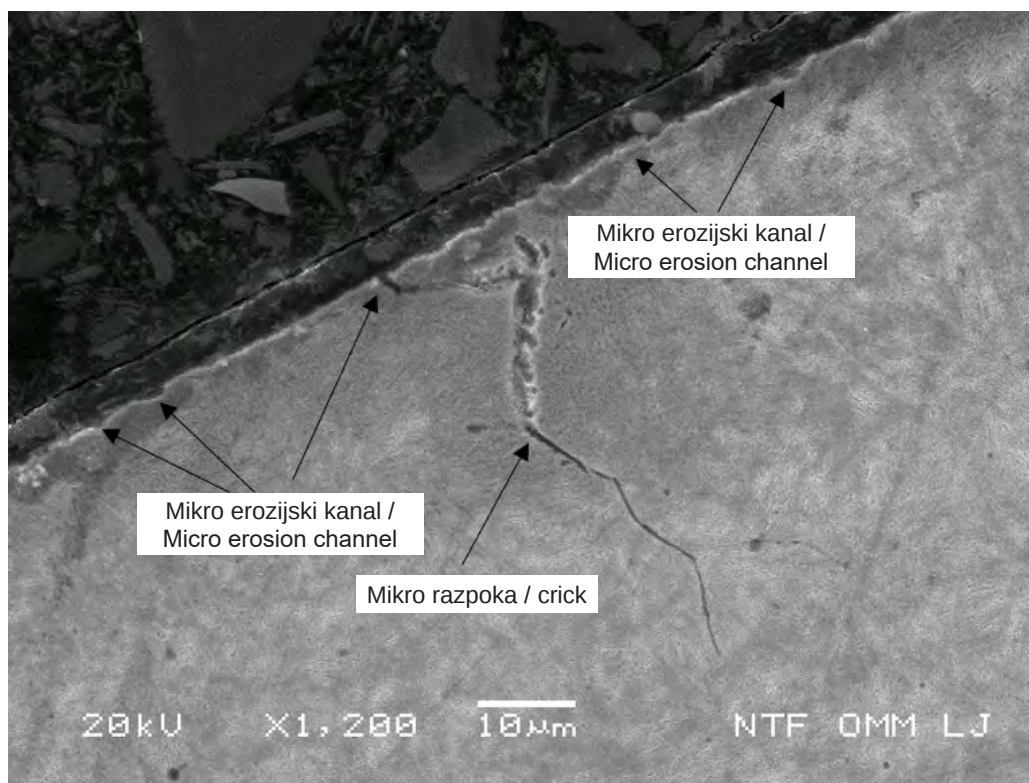
Similar phenomena can also be observed on the tooth body itself, which is not in the area of the carbide coating. Figure 10 shows the formation of micro cracks and erosion channels along the edge of the tooth.

**Slika 10.** Mikro razpoka in erozijski kanali

**Figure 10.** Micro cracks and erosion channels on the tooth body
