# Degradation of Plasticized Poly(1-chloroethylene) Waterproofing Membranes used as a Building Material

Gregor Kravanja,<sup>1,2\*</sup> Andrej Ivanič<sup>2</sup> and Samo Lubej<sup>2\*</sup>

## Abstract

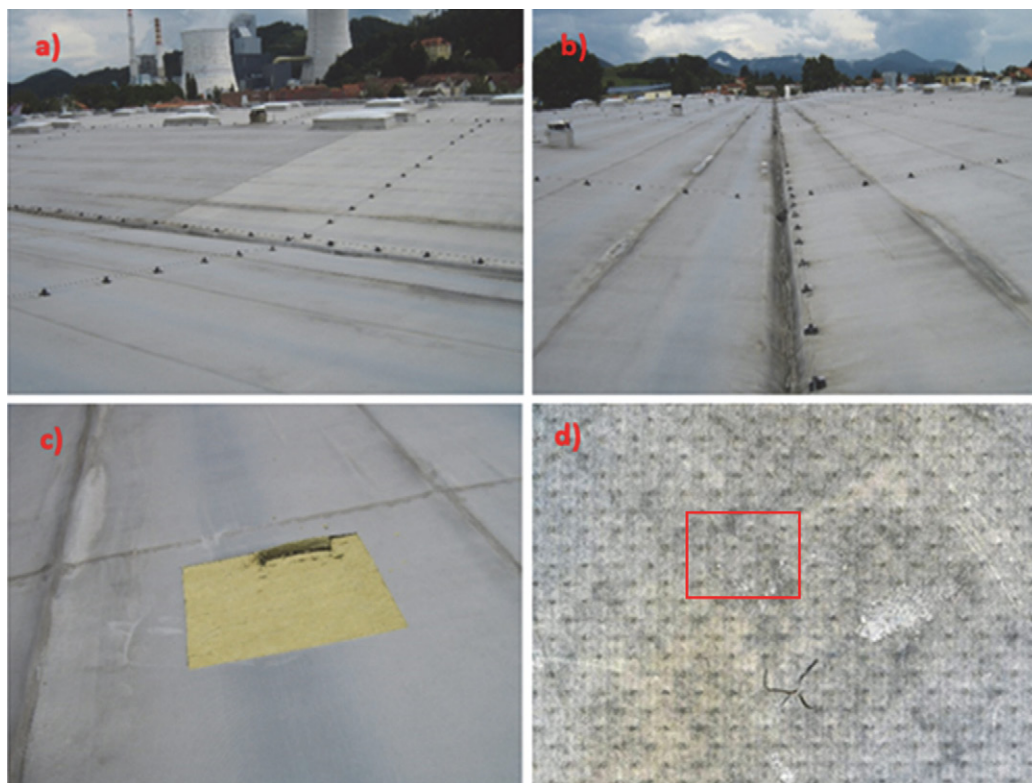
**Figure 1.** Plasticized PVC waterproofing membranes were taken from a flat industrial roof located in Slovenia, Central Europe (a, b) Extraction at sampling location 1 (c). Naturally aged and locally damaged plasticized PVC membrane (d).

SR, Soprema, Italy) were obtained from the unvented roof of an industrial building located in Slovenia, Central Europe, which is characterized by a Cfb climate zone (Figure 1 a,b,c). Membranes are made of 51% pure PVC, 46% additives and 3% reinforcing material. The roof construction consisted of several layers: on top, a 1.2 mm thick plasticized PVC membrane; below, a 200 mm thick layer of thermal insulation with a density of 150 kg/m<sup>3</sup>, followed by a 0.3 mm thick vapor barrier and trapezoidal sheet metal cladding anchored in steel roof beams (Appendix 1). An inspection revealed that the waterproofing membranes were damaged at several points where the photovoltaic modules were installed; the damage was visible as star-shaped cracks (Figure 1. d).

Samples exposed to natural outdoor weathering were taken from various sampling locations, as shown in Appendix 2. Location 1 is an area with many visible star-shaped cracks on the surface of membranes. Location 2 is an area where a strong colour variation of the membranes was observed. Location 3 is a softening roofing area where a significant deterioration in the strength of the insulation has been observed. Plasticized PVC membranes were taken from each of these roofing areas, immediately wrapped in polyethylene, and transported to the laboratory for further analysis.

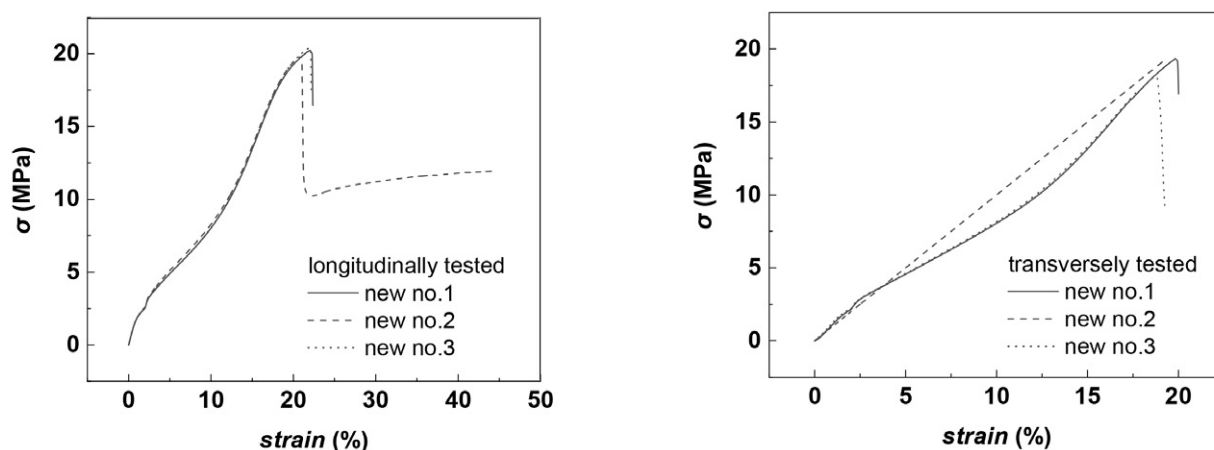
**Figure 2.** Tensile strength and elongation at break (load/strain curves) for new plasticized PVC membrane samples tested longitudinal (left) and transverse (right) directions at conditions:  $T = 393.15 \pm 2$  K, RH (relative humidity) =  $50 \pm 5$  %.

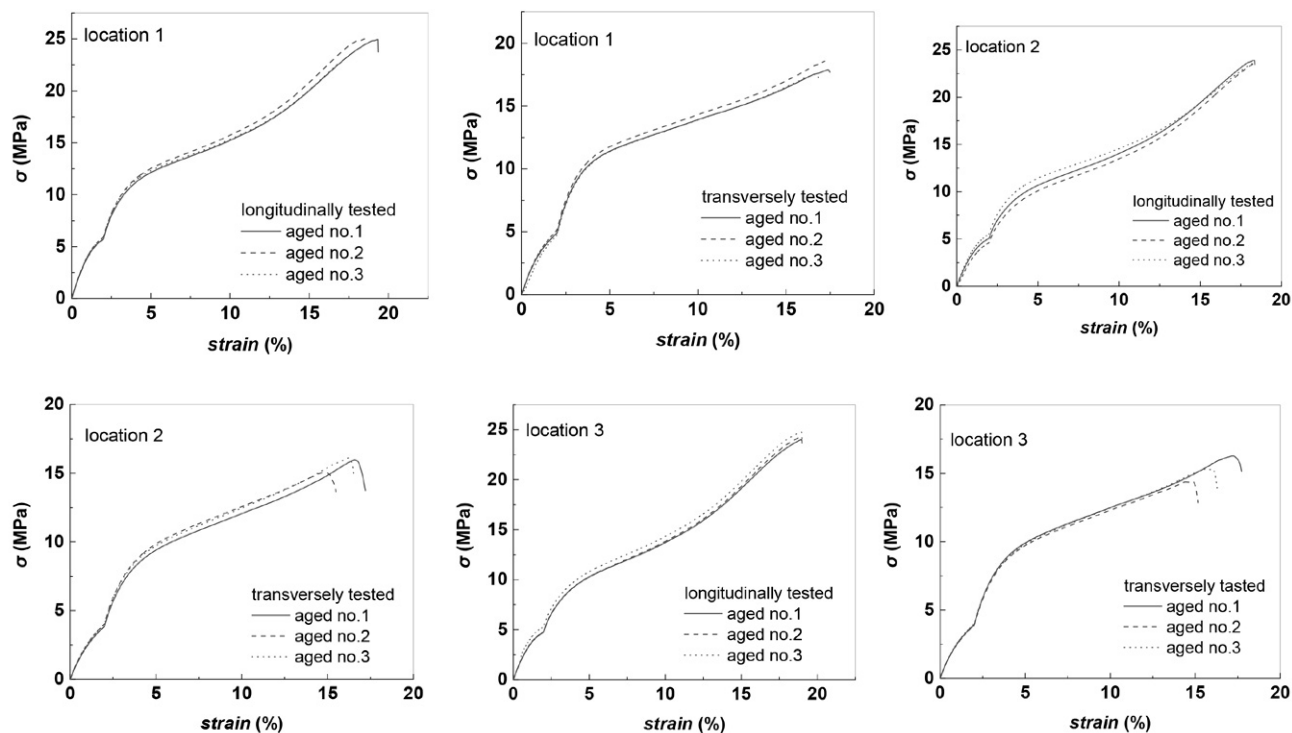
after 10 years of use and the values were compared with those of new samples (Figures 2 and 3). Three samples were tested from each sampling location. As can be seen in Figure 3, there is a small variation in tensile strength in the longitudinal direction of aged membranes. It appears that the polyester mesh is well encapsulated within the membrane matrix and has not degraded over time. In addition, there is a tendency for tensile strength to increase with age, as the membrane loses flexibility over time.<sup>9</sup> Similar observations were made in a study by Blanco et al.<sup>10</sup>, where both load and tensile strength in longitudinal and transversal

On the other hand, the strength of aged membranes decreases in the transverse directions compared to the strength of a new membrane. As shown in Table 1, aged membrane samples showed a shorter elongation at break than that of the new membrane. This indicates a loss of flexibility caused by natural aging under high humidity and thermal fluctuations. The deterioration in elastic properties is caused by the loss of plasticizers as a result of a long period of combined exposure to heat from solar

**Figure 3.** Tensile strength and elongation at break (load/strain curves) for aged, plasticized PVC membrane samples tested longitudinal (left) and transverse (right) directions at conditions:  $T = 393.15 \pm 2$  K, RH (relative humidity) =  $50 \pm 5$  %.

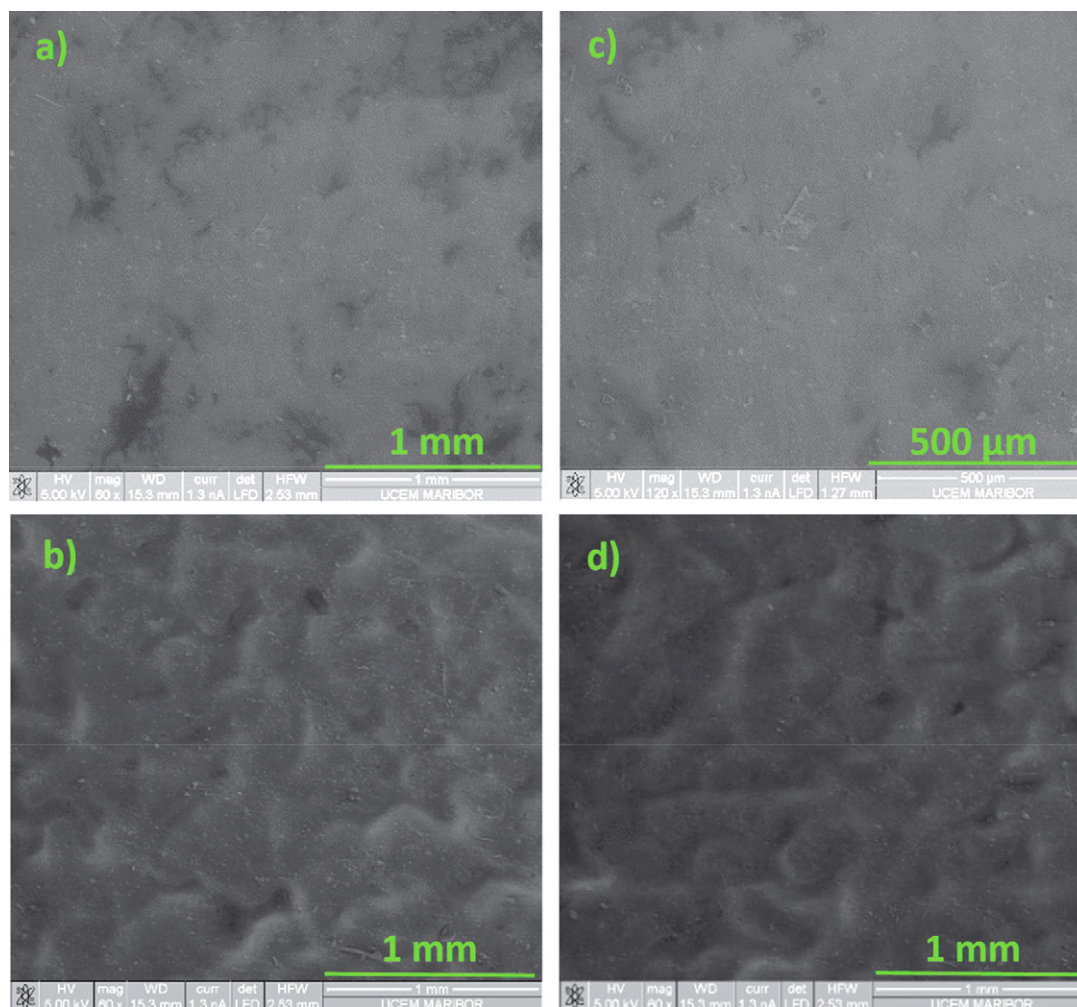
Microphotographs of new and aged membranes taken by SEM show significant differences between them. As shown in Figure 4, new membranes have a smooth surface, without cracks. Locally, only the grains of filler can be observed. In contrast, aged membranes that have been exposed to natural weathering show irritated surfaces with many cracks, agglomerates and craters as a result of plasticizer loss. The material becomes stiffer, which leads to

**Figure 4.** Microstructure of new membranes' upper layer (a, c) and lower layer (b, d).

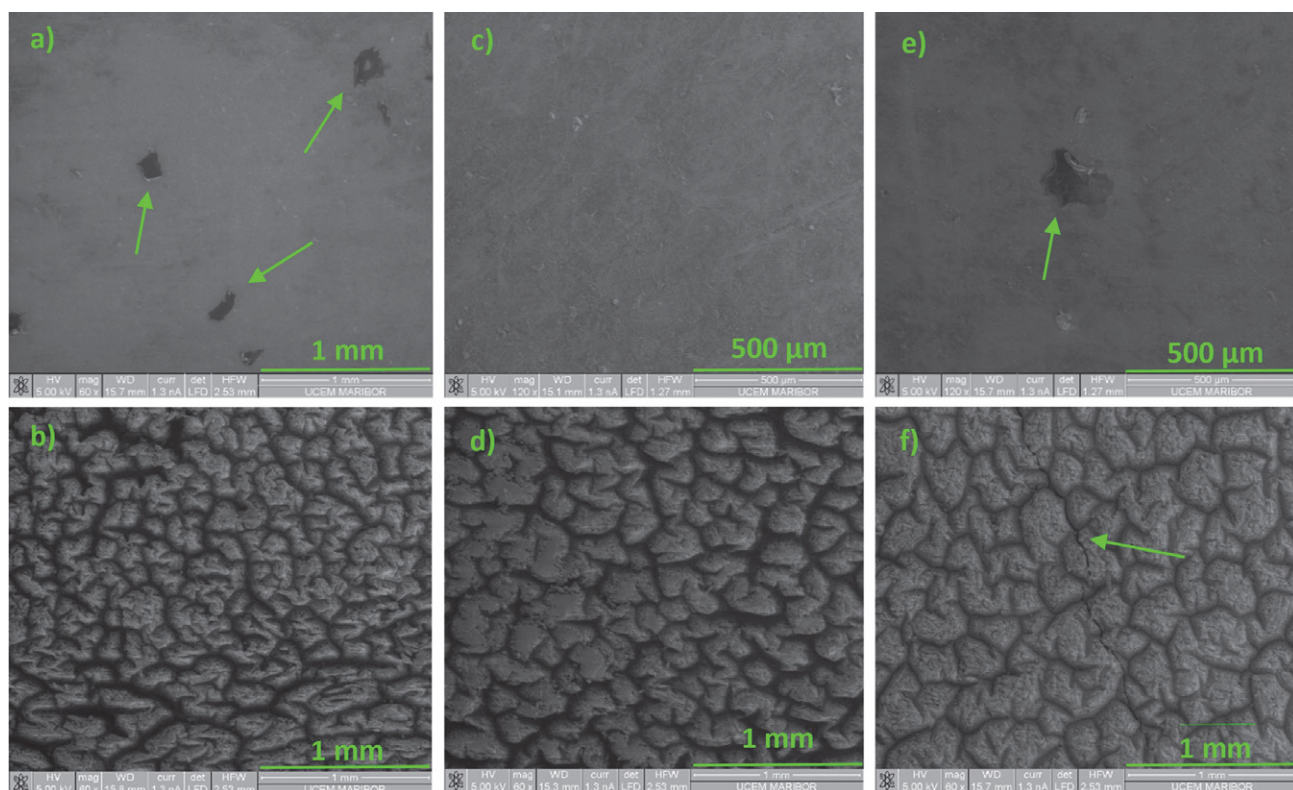
**Figure 5.** The microstructure of aged membranes extracted from different sampling locations: 1 (a, b), 2 (c, d), and 3 (e, f). The surface is more heterogeneous, with many craters, cracks, agglomerates, and voids.

contractions and the prevalence of voids (Figure 5). It is assumed that the rearrangement and aggregation of molecular chains are the main mechanisms of membrane degradation.<sup>19</sup> Pedrosa et al.<sup>20</sup> presented an interesting study using X-ray spectroscopy and SEM analysis of membranes exposed to different weathering conditions. They reported that aged membranes show numerous cracks and fractures and there is a significant decrease in chlorine content. Therefore, they suggested that dehydrochlorination may be the main mechanism of deterioration.

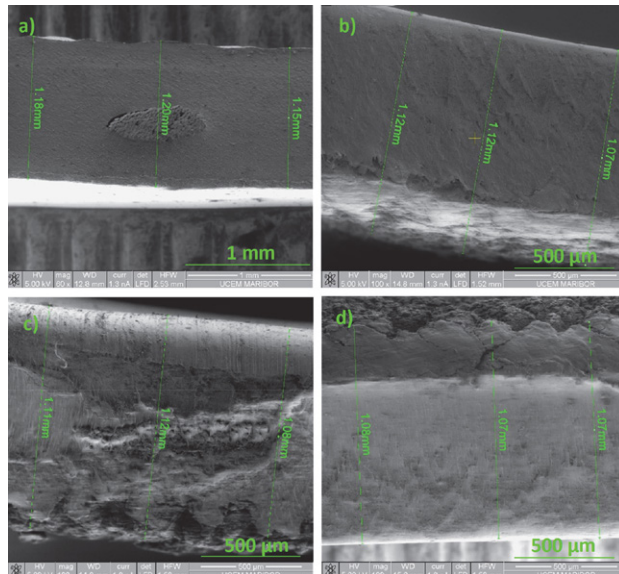
Cross-sectional microphotographs with thickness evaluations of the investigated plasticized PVC membranes are presented in Figure 6 and Table 6. It can be seen that the thickness of the aged membranes is decreased. As can be seen in Figure 6, there is also a visible difference in cross-sectional area between new and aged membranes.

**Figure 6.** Microphotographs in cross section with thickness evaluation for new membrane (a) and aged membranes (a, b, c).

For example, the average thickness values for location 3 decrease from 1.18 mm to 1.09 mm. Changes in material thickness might be because of the reduction of plasticizer content. To justify plasticizer loss in material, chemical changes were identified and quantified using ATR/FTIR analysis.

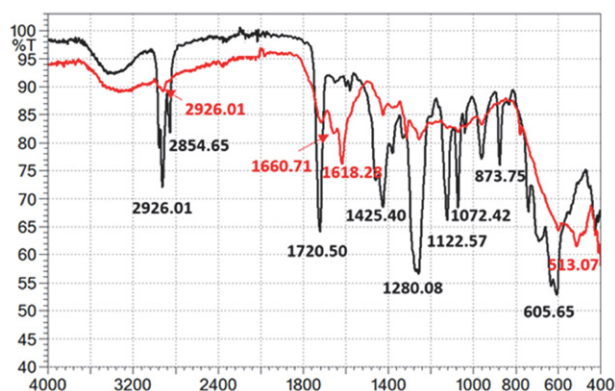
FTIR spectra were recorded to investigate the chemical changes in the aged membranes from location 3 (with the highest exposed to solar radiation, near-ultraviolet radiation, atmospheric oxidation and moisture. Both the front (directly exposed to weathering) and side (inverted next to the insulation material) surfaces of the membranes were examined (Table 7, Figure 7 and 8). In FTIR, the spectra appearance of several characteristic bands can be seen. In particular, the C=O stretching vibration of the ester function from plasticizer is detected at  $1720.50\text{ cm}^{-1}$ . O-H bending is detected at  $1425.40\text{ cm}^{-1}$  and symmetric and antisymmetric vibrations of the ester C-O-C group in the region  $1072.42 - 1280.08\text{ cm}^{-1}$ . At the front side of aged membrane new peaks appear at  $1660.71 - 1618.28\text{ cm}^{-1}$  that are associated with the stretching of the C=C bonds of the aromatic ring, indicating that chemical degradation appeared in the membrane molecules<sup>21</sup>. Compared to the front side of new membranes, the characteristic C-Cl stretching vibration at  $642.95 - 605.65\text{ cm}^{-1}$  is not visible. This suggests that UV aging could have caused a dehydrochlorination reaction. These data are consistent with changes in the

**Figure 7.** FTIR spectra at the front side of the new plasticized membranes (black line) and aged membranes (red line) operating in attenuated total reflection (ATR) mode.

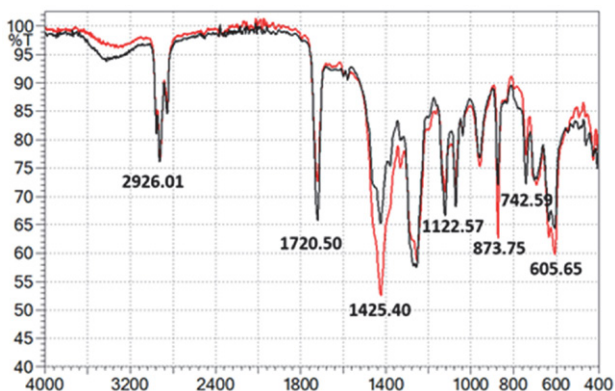
**Figure 8.** FTIR spectra at the back side of the plasticized membranes (black line) and aged membranes (red line) operating in attenuated total reflection (ATR) mode.

membrane morphology and elongation properties. On the back side of the membranes there is no visible difference in spectra between new and aged samples. The C-H stretching mode can be observed at  $2954.95 - 2852.72\text{ cm}^{-1}$  and the *trans* C-H wagging mode at  $873.75\text{ cm}^{-1}$ <sup>22</sup>.
