HOMOGENIZATION OF AN Al-Mg ALLOY AND ALLIGATORING FAILURE: ALLOY DUCTILITY AND FRACTURE

Endre Romhanji, Tamara Radetić, Miljana Popović

University of Belgrade, Faculty of Technology and Metallurgy, Department of Metallurgical Engineering,
Karnegijeva 4, POB 35-03, 11 120 Belgrade, Serbia
endre@tmf.bg.ac.rs

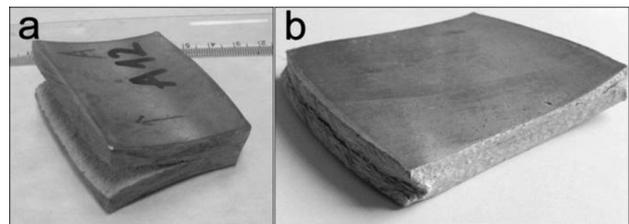
The effects of different homogenization treatments on the hot-rolling outcome are shown in **Table 2**. The hot rolling of the plates homogenized according to Regimes I and II failed due to the alligatoring. The critical passes corresponded to the partial reductions of ≈ 20 %. The alligator crack (**Figure 2a**) opened at the front side in all the cases.

Figure 2: a) Image of an alligatoring defect after hot rolling with the total reduction of 44 %, b) concave front profile of the plate that did not alligator (total reduction of 74 %)

The fronts of the plates developed a concave profile during the hot rolling, with the formation of a groove at the centerline as the deformation progressed (**Figure 2b**). The shape of the side profile varied with the position along a slab. Some lateral spreading was observed at high total reductions.

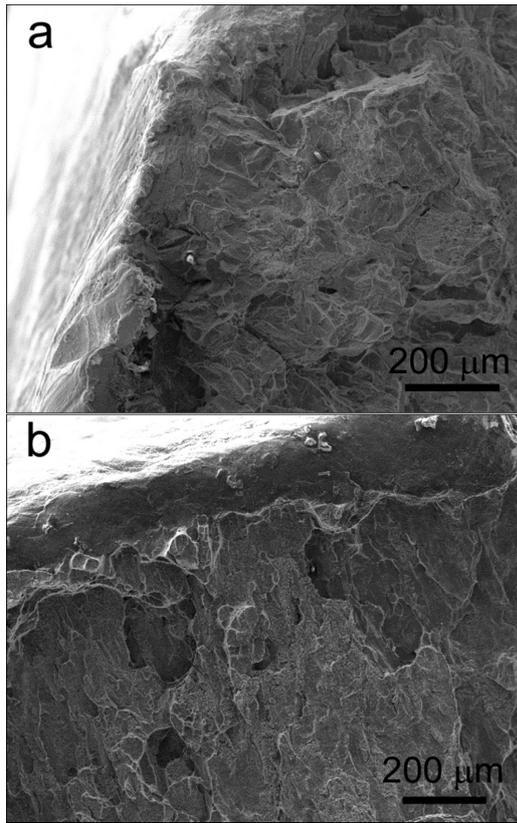
Figure 3: Secondary-electron SEM micrographs of the front edge of a plate: a) Regime I, b) Regime II

A SEM characterization of the plates homogenized according to Regime I showed that the fractured surface extended to the very end of the front edge (**Figure 3a**). A hem, with markings from the front side of the plate, was observed only at a few points.

On the plates homogenized according to Regime II, the hem with the front-side marks extended over the entire front edge, being 100–200 μm wide (**Figure 3b**). Adjacent to it was a region of shallow, elongated dimples that is characteristic for a shear fracture and void sheeting. Away from the edge, the predominant fracture mode was ductile intergranular fracture for all the alligatored plates (**Figure 4**).

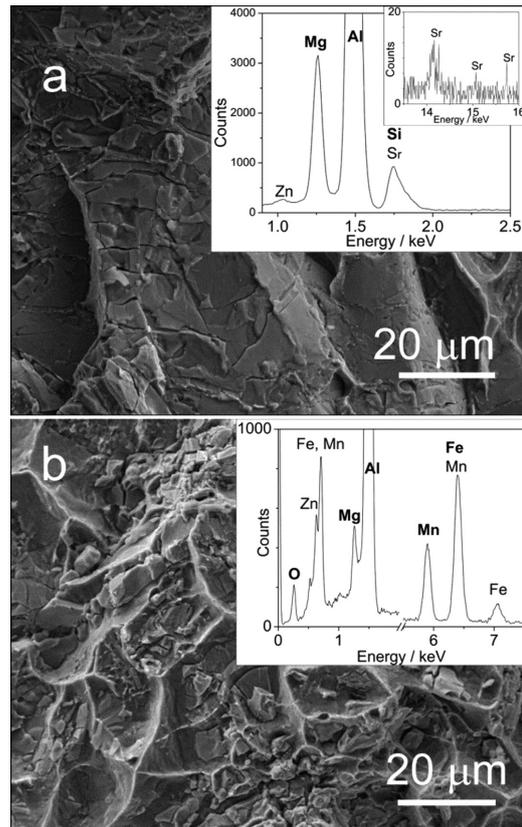
Figure 4: Secondary-electron SEM micrographs of ductile intergranular fractures and EDS of the broken constitutive particles: a) Regime I, b) Regime II

An intergranular fracture proceeded due to a coalescence of voids created by a break-up of constitutive particles. However, there was a distinction between the broken constituent particles filling the voids, depending on the homogenization regime. Most of the particles of the plates homogenized according to Regime I had a thin plate-like morphology (**Figure 4a**). The EDS analysis showed that those particles were a Mg-Si-Sr rich phase. On the plates homogenized according to Regime II, a mixture of a plate like Mg-Si-Sr and more irregularly shaped $\text{Al}_6(\text{Fe},\text{Mn})$ was observed (**Figure 4b**).

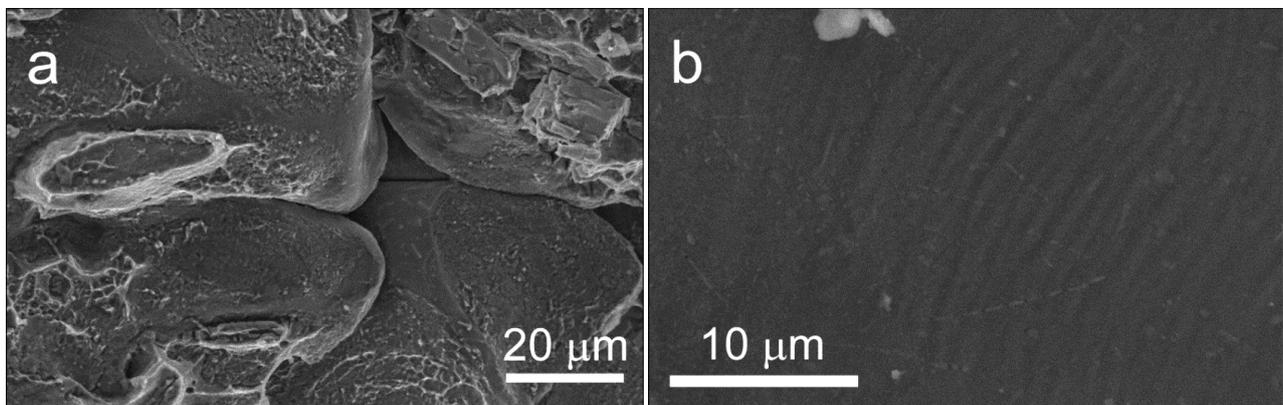
Figure 5: Secondary-electron SEM micrographs of a brittle intergranular fracture (Regime I): a) smooth grain surfaces, b) slip-line traces and shearing of dispersoids

Another difference was that a grain decohesion and a brittle intergranular fracture were observed only on the plates homogenized according to Regime I. Smooth grain surfaces of the brittle intergranular fracture par-

tially covered with fine dimples nucleated at grain-boundary dispersoids are shown in **Figure 5**.

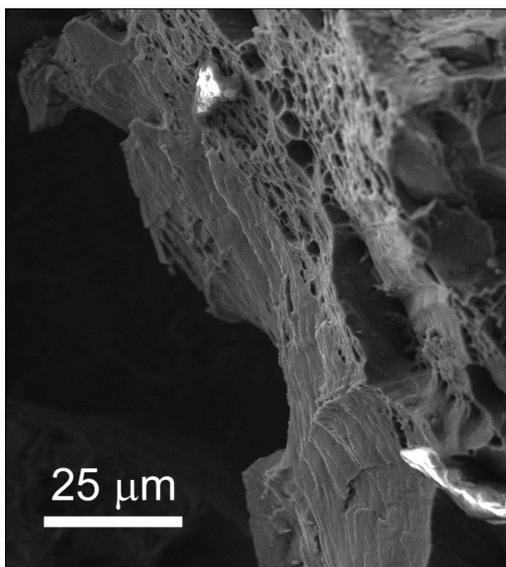
Figure 6: Secondary-electron SEM micrograph of a cleavage (Regime I)
Slika 6: SEM-posnetek s sekundarnimi elektroni cepilnega loma (Režim I)

A cleavage, with a typical river pattern (**Figure 6**), was observed on the plates homogenized according to both Regime I and II.
