Deterioration of the granodiorite façade – case example Maximarket, Ljubljana

ALENKA MAUKO¹, BREDI MIRTIC², ANA MLADENOVIC¹, BENT GRELK³

¹ Slovenian National Building and Civil Engineering Institute, Dimičeva 12,
SI-1000 Ljubljana, Slovenia; E-mail: alenka.mauko@zag.si

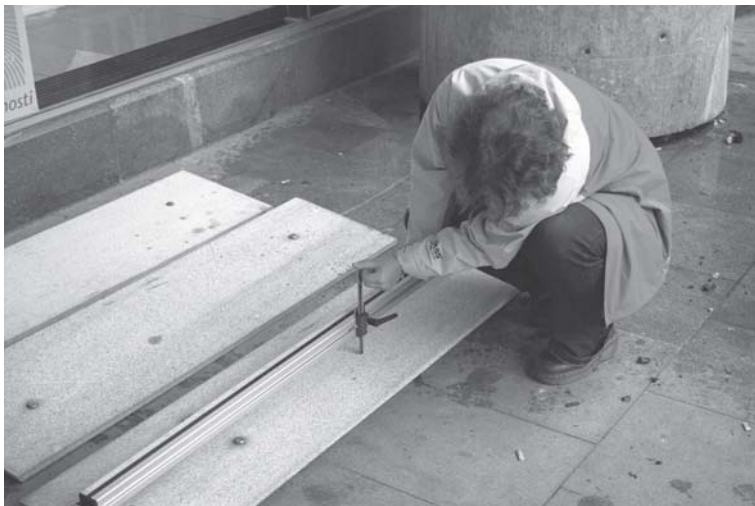
Figure 3. Bowing measurements of panels, which had been detached from the west façade

and the amount of observed bowing. Bowing was measured at the mid-point of the vertical mid-line due to the panel's small width (Fig. 3). The distance (L) between the supporting points depended upon the size of the panel.

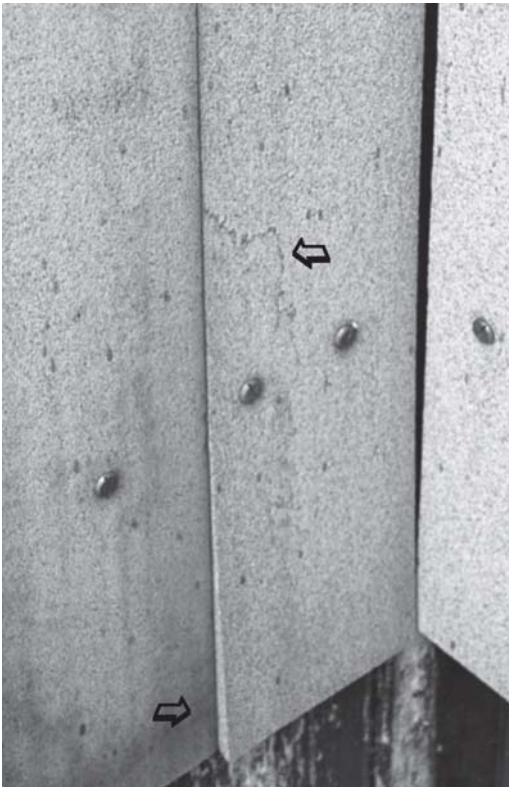
The largest amount of bowing ($B = 12.8 \text{ mm/m}$) was measured on the west façade on the bottom row of panels. In general, the panels on the west façade are more bowed than those on the east, although this assumption cannot be statistically proved due to the scarcity of measurement results. Lateral bowing was not observed. A visual inspection of the entire façade revealed that bowing is most pronounced on the south

**Figure 4.** Concave bowing of granodiorite panel on the west façade (left arrow) and crack in chlorite vein (right arrow)

Thin chlorite veins can be observed in the fresh rock (ZUPANČIČ, 1994). Blocks with chlorite veins are usually rejected in the extraction process due to their low mechanical resistance.

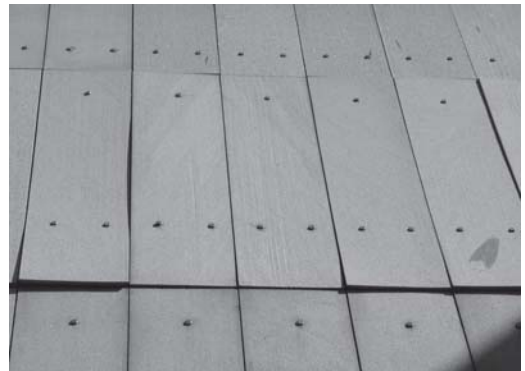
façade. Pronounced bowing was also observed on south facade of the neighbouring building, which was built in the beginning of 1980ies and is covered with the same granodiorite panels (Fig. 5).

**Figure 5.** Bowing on the south facade of neighbouring building

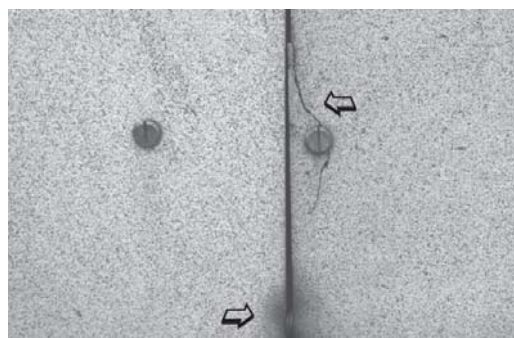
During the inspection, state of the supporting steel structure was also evaluated. It was concluded that steel framework was in poor shape, and that repair works are urgently needed. Rainwater had penetrated into and under the stone façade through the joints between the panels and through other

Figure 6: Corrosion stains (left arrow) formed due to oxidation of metal subframe and crack near the dowel (right arrow)

openings like cracks and breakouts, and had attacked the steel structure (BORTZ ET AL, 1988). As a result stains begin to appear on the edges of the panels, around the anchors and along cracks. Such corrosion stains (see Fig. 6, 7) are more obvious on the west façade, where variations in temperature and moisture are greater. The corrosion of the steel framework due to temperature and moisture variations was studied also by BILBIJA (1984).

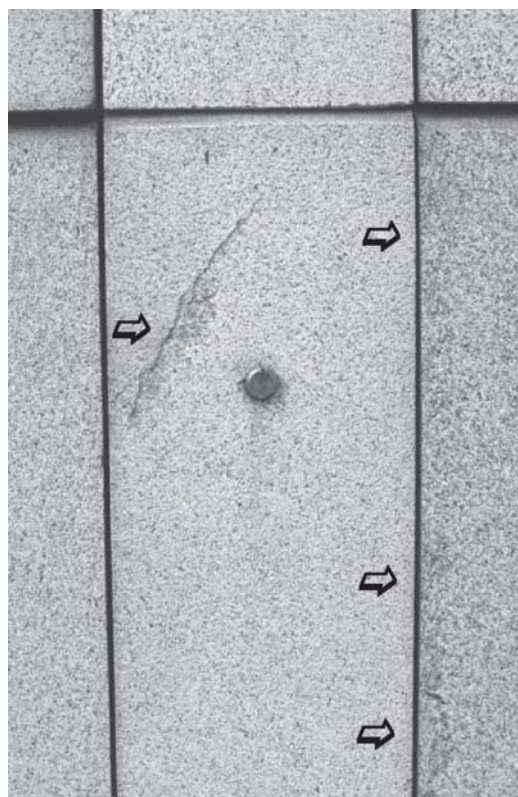
Figure 7. A crack formed on the boundary between the matrix and the lens of mafic minerals (left arrow) and corrosion stain on the edge of the panel (right arrows)

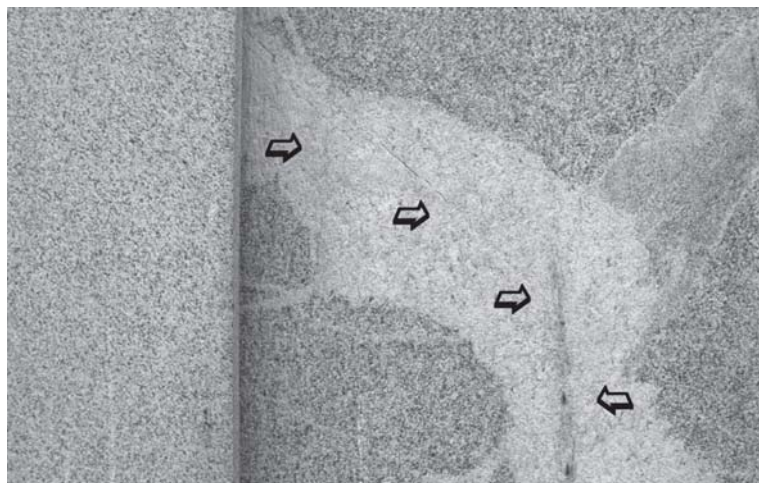
Many birds' nests were observed under the edge of the roof. Bird excrements accelerate the deterioration processes of the stone.

Organic acids from excrements cause the dissolution and other changes of the stone minerals in the presence of the rain water. Reactions of this type has previously been studied by (WINKLER, 1975; 1994).

Figure 8. Cracks in an aplite vein (left arrows) and a vertical stain formed by bird excrement (right arrow)

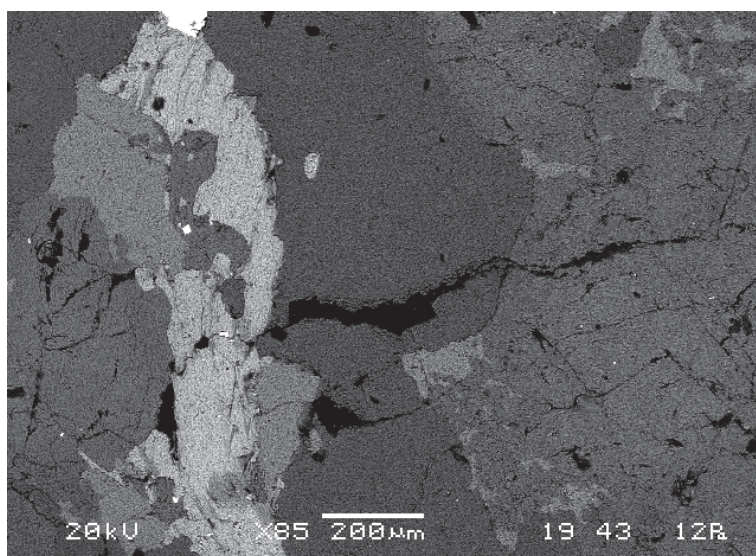
feldspars, was observed (MLADENVIĆ ET AL, 2003). Comparison of samples taken from one of the removed panel and from fresh rock shows higher frequency of transgranular and intragranular cracks in the case of deteriorated panel (Fig. 9). From the same

Figure 9. Formation of transgranular cracks in specimen taken from the exposed panel. SEM, BSE
