# MICROSTRUCTURAL CHANGES OF FINE-GRAINED CONCRETE EXPOSED TO A SULFATE ATTACK

**Martin Vyšvařil, Patrik Bayer, Markéta Rovnaníková**

Brno University of Technology, Faculty of Civil Engineering, Institute of Chemistry, Žitkova 17, 602 00 Brno, Czech Republic  
vysvaril.m@fce.vutbr.cz

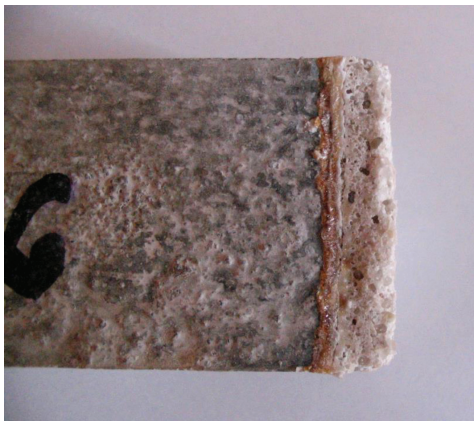
**Figure 1:** Lower part of SRP concrete sample after being in  $\text{H}_2\text{SO}_4$  0.5 % for 6 months

After being in 0.5 %  $\text{H}_2\text{SO}_4$  for six months, a visible degradation of the submerged part occurred on all the investigated samples and the creation of a rust layer on the periphery of each sample, just above the level of the acid, took place. **Figure 1** illustrates the effect of the 0.5 % sulfuric acid on the SRP-concrete sample. A detailed view of the immersed part of the sample is shown in **Figure 2**. There are well recognizable exposed aggregates and white precipitates of gypsum ( $\text{CaSO}_4 \cdot 2\text{H}_2\text{O}$ ) on the surface.
