# GRAVEL PLAINS IN URBAN AREAS: GRAVEL PITS AS AN ELEMENT OF DEGRADED LANDSCAPES

## PRODNA RAVNINA V MESTNEM PROSTORU: GRAMOZNICE KOT PRVINA DEGRADIRANE POKRAJINE

Mimi Urbanc, Mateja Breg

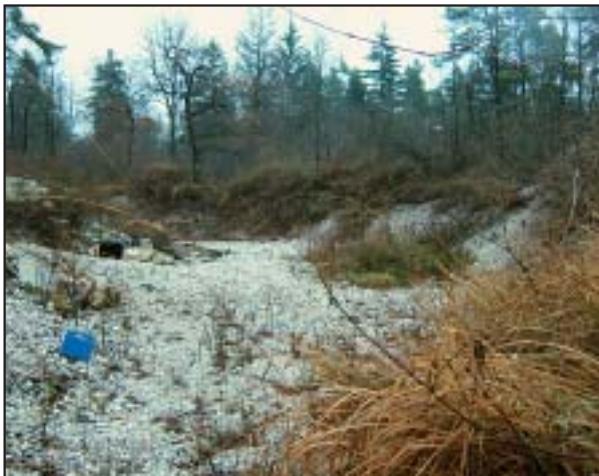
Many gravel pits on the Jarški prod area have attracted illegal dumping (photography: Mateja Breg).  
Številne gramoznice na Jarškem produ so postale priljubljeno odlagališče odpadkov (fotografija: Mateja Breg).
