Reconstruction of two road tunnels

Rekonstrukcija dveh cestnih predorov

JAKOB LIKAR^{1,*}, MELANIJA HUIS², ANDREJ LIKAR²

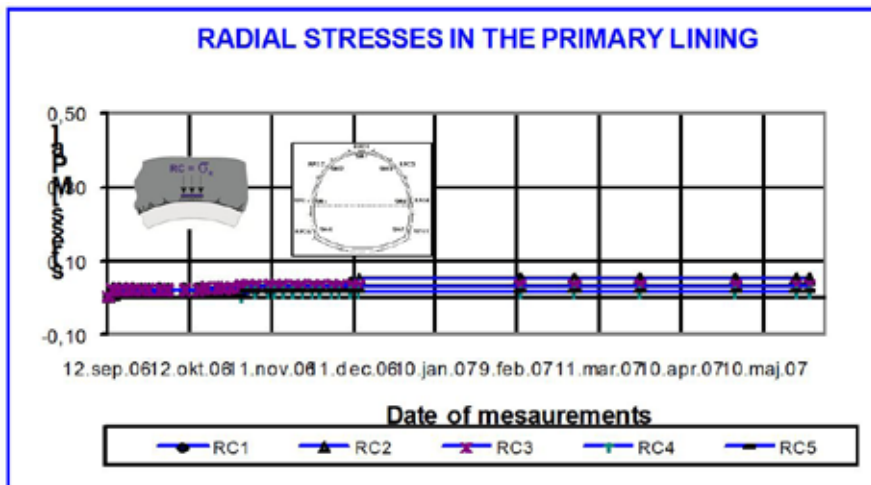
Figure 4. The results of measurements of radial stress on the contact between the primary lining and surrounding rock in the left tunnel tube.

struction of the left tunnel tube in the same geological geotechnical conditions did not show additional increases in circular (tangential) and radial stress (see Figures 3 and 4). In the future the swelling potential will not produce additional stresses on the inner lining, because the primary lining has enough loading capacity. The process which explain swelling pressure increasing in investigating ground shows that the closure of cracks depends of ground water isolation.

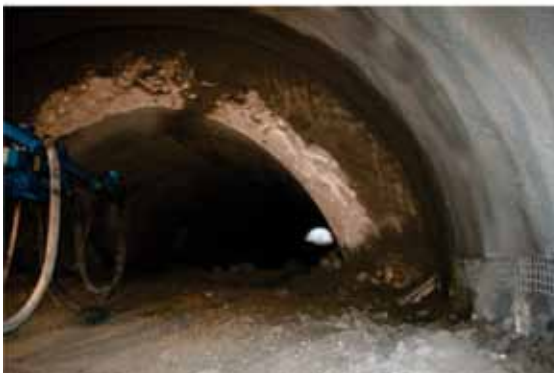
Figure 8. The final cross-section of right tunnel tube after reconstruction.

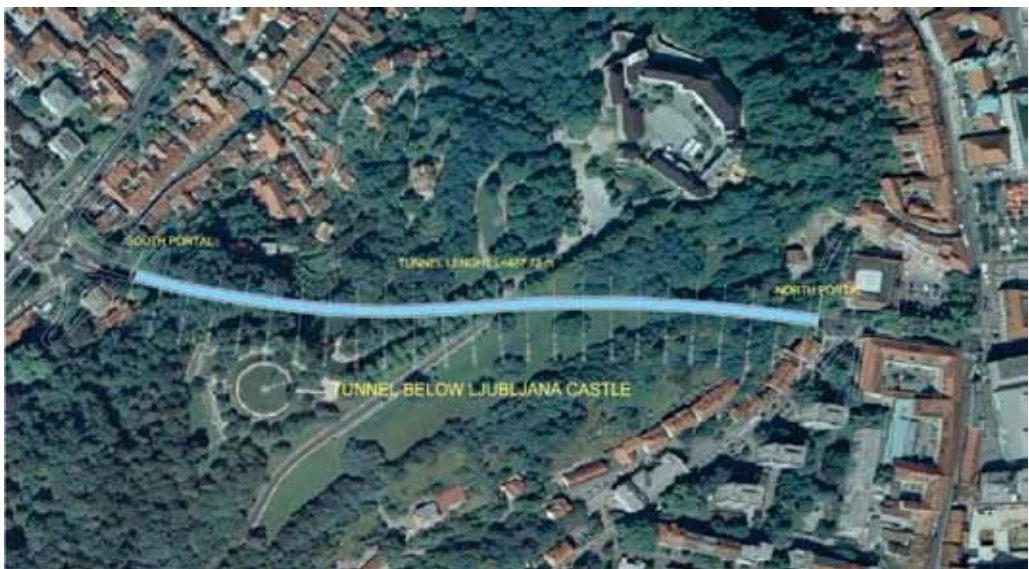
Figure 11. A synoptic situation the Tunnel below Ljubljana Castle.

Rout of the road in the tunnel running from the junction with Karlovška road at the south tunnel portal (chainage km. 0+000) to Kopitar road at the south tunnel portal (chainage km. 0+487.73). Surveyable tunnel situation is shown in Figure 11.
