## PHYSICAL AND SOCIAL ASPECTS OF LAND DEGRADATION IN MEDITERRANEAN HIGHLAND TERRACES: A GEODIVERSITY APPROACH

*Moshe INBAR*

*Ali ZGAIER*

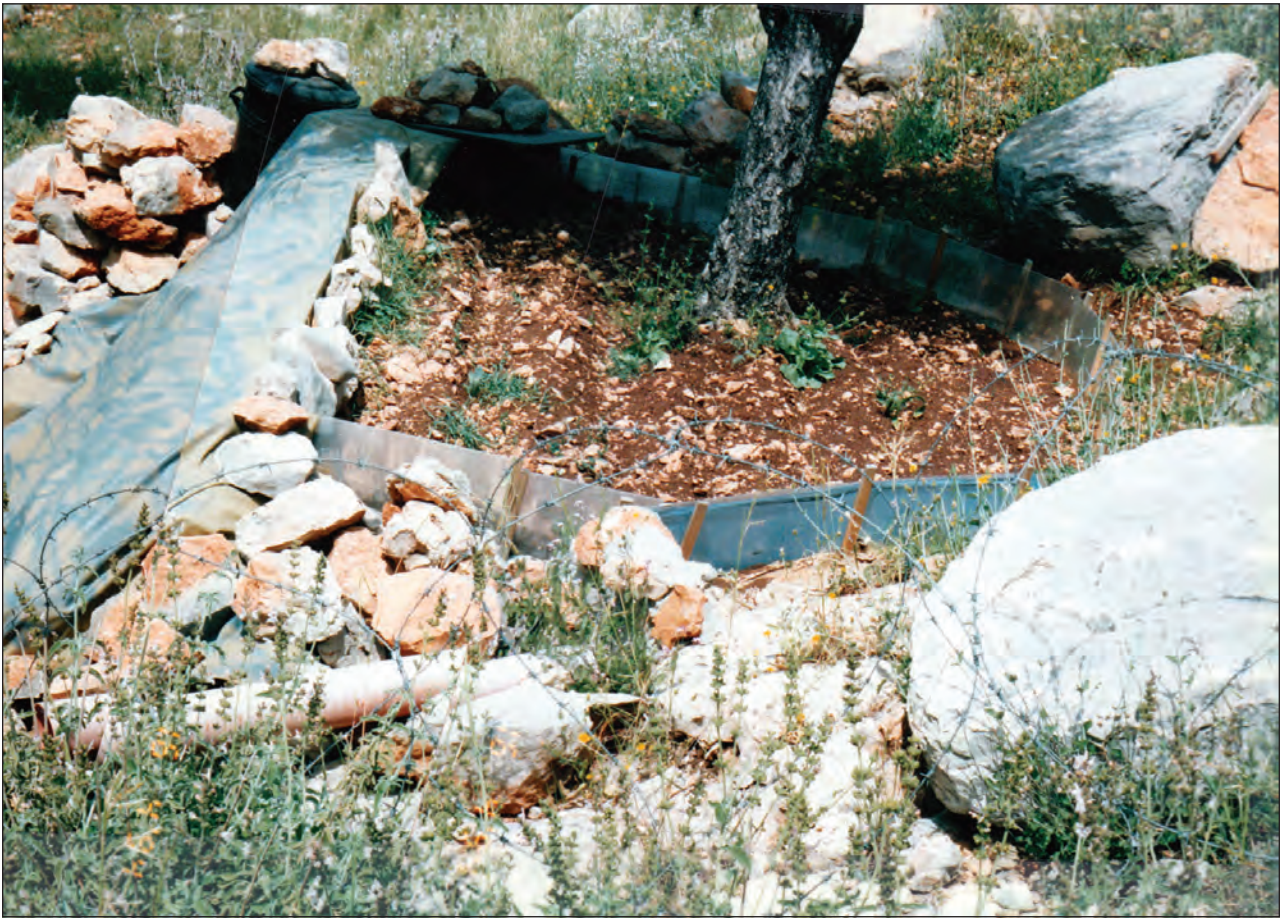
**Fig. 4: Experimental plot #1: plastic fences are the limits of the plot.**

Five experimental plots were installed on abandoned terraces and one control plot on a cultivated terrace, in order to measure runoff and sediment yield from terraces after rainstorms

The plot area for each terrace is between 2 m<sup>2</sup> and 36 m<sup>2</sup>. The plot is bordered by a plastic fence closed at a lower apex with a plastic tube delivering water and sediment through a pipe to closed containers (Figure 4). Rainfall was measured by rain gauge daily. Water and sediment are collected after each rain and the total amount or a sample is kept for sediment content and analysis at the laboratory.

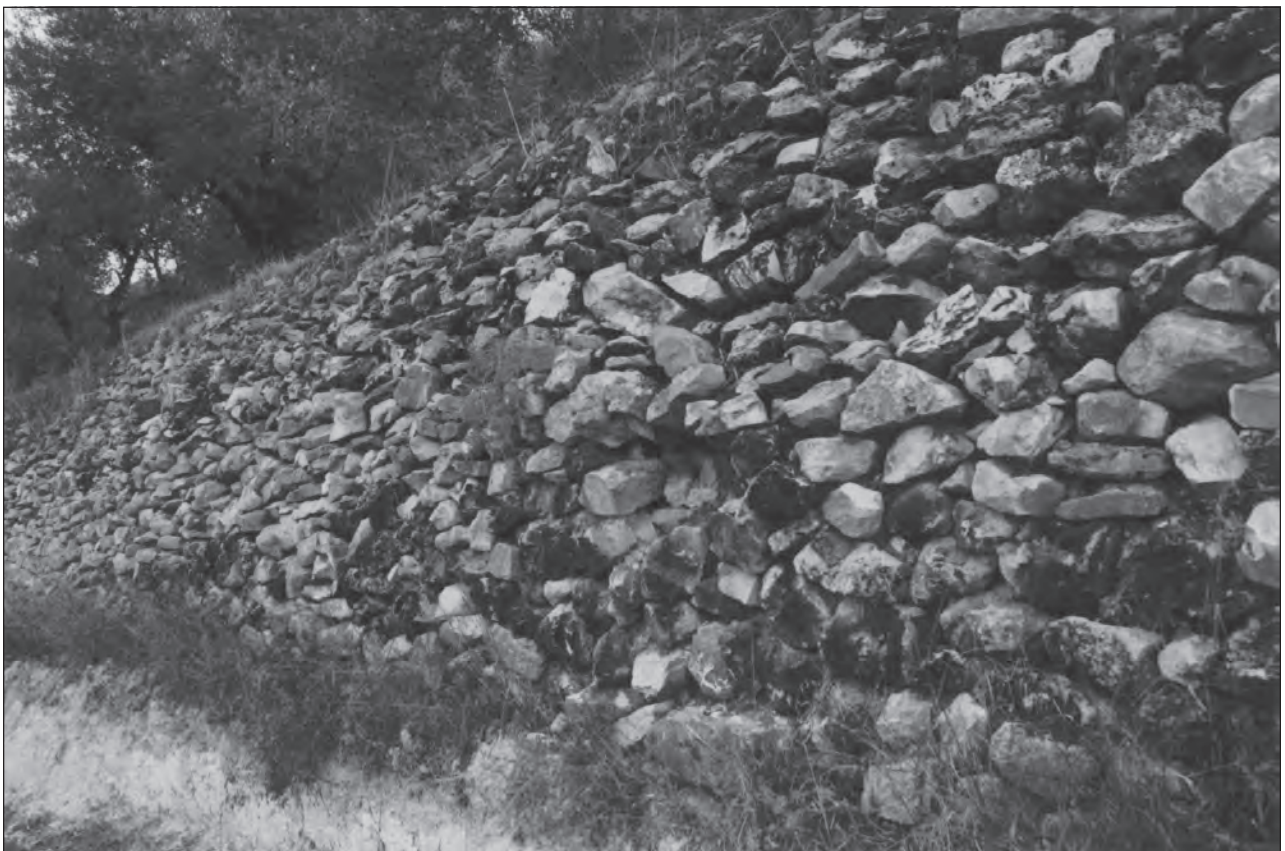
**Figure 7: Collapsed wall.**

Physiographic and morphometric characteristics of the terraces were measured: length, width, area, stoniness and slope terrace; length, height, stone dimensions and curvature of terrace wall. Wall swelling and bulge development is characteristic to many retaining walls before their failure, and they develop due to the lateral soil pressure and its shearing effect. The wall collapse determines the starting of accelerated soil erosion from the terraces (Figure 7).

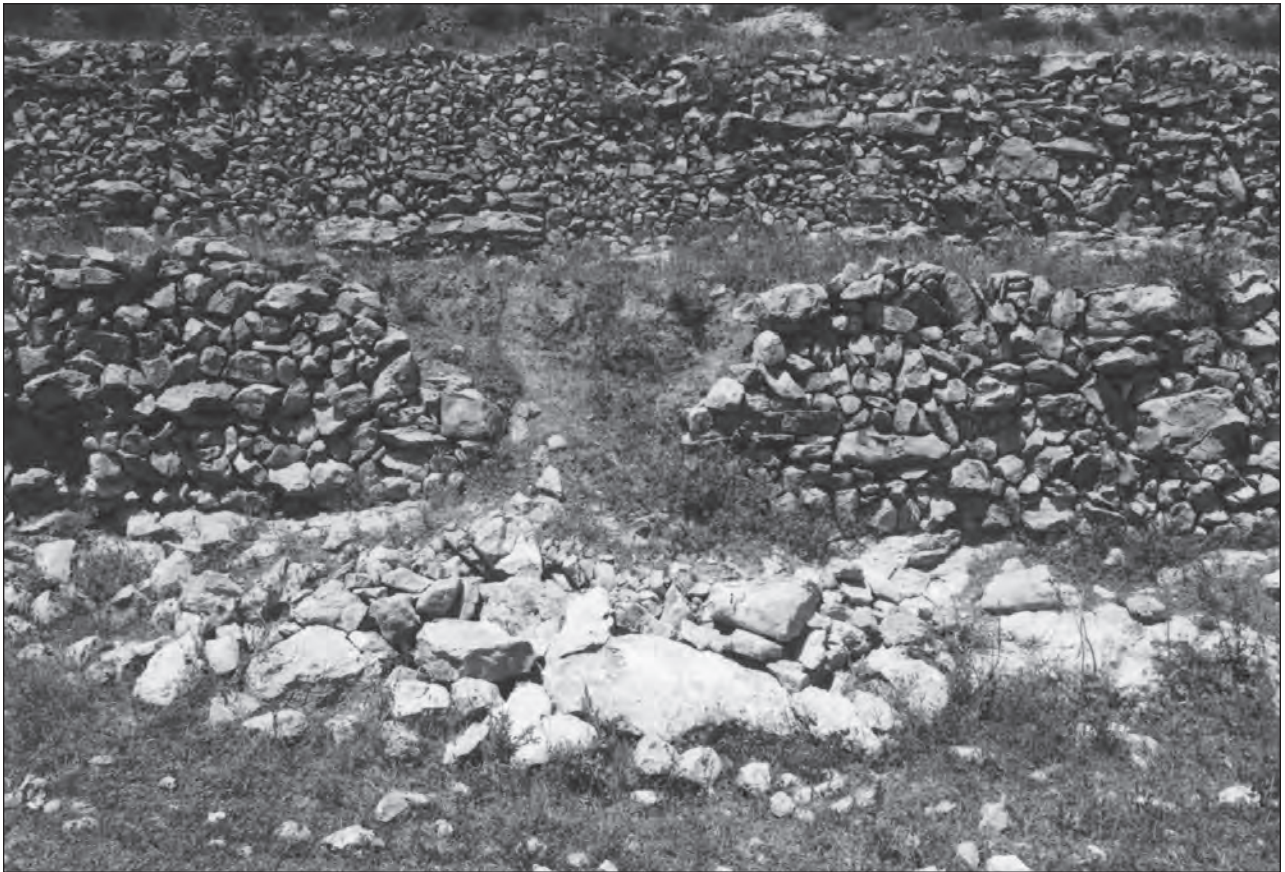
**Figure 10:** A collapsed wall landslide.

Landsliding is one of the most important mass-wasting processes that affect agricultural hillslope terraces retained by dry built stone walls in Mediterranean regions (Figure 10). The built stone retaining wall is the

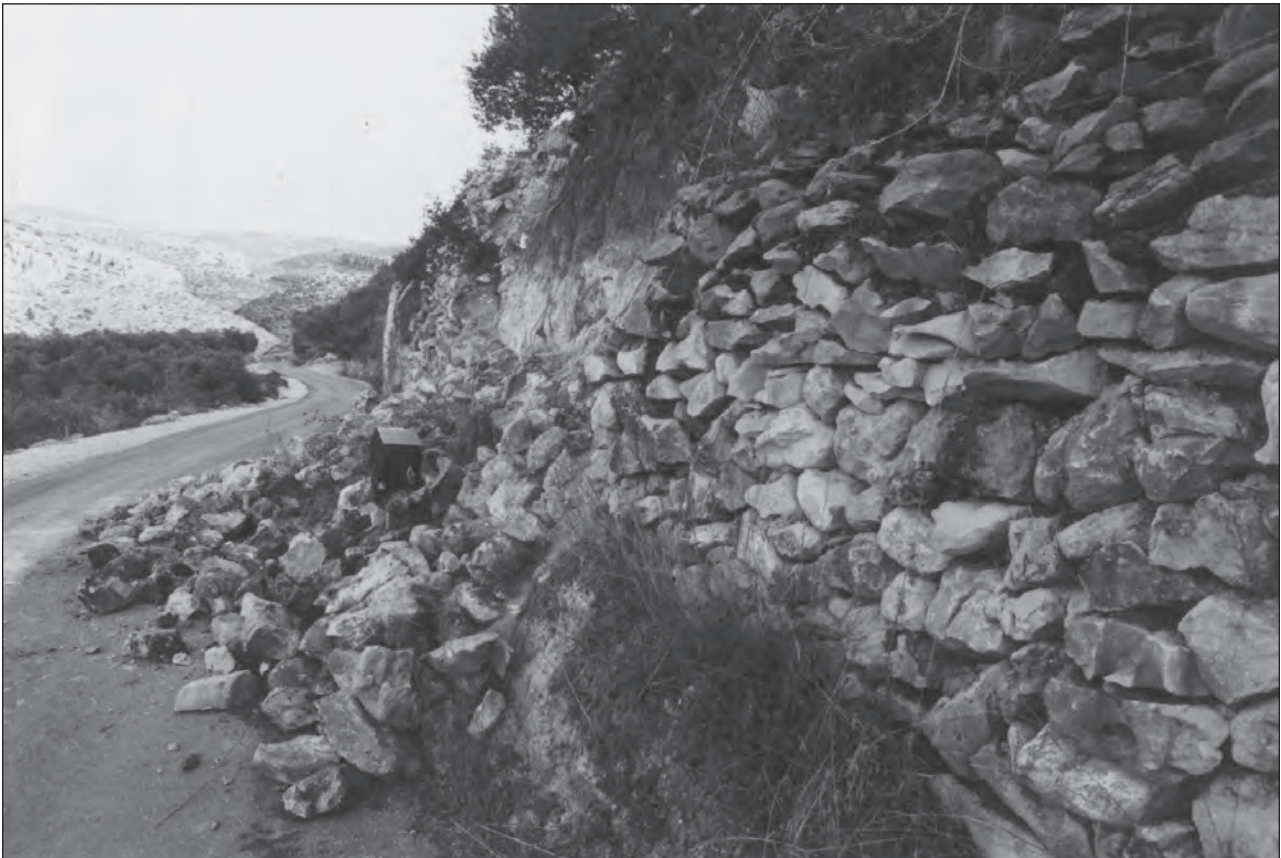
**Figure 13:** *Recent debris cone formed after a heavy rainfall storm.*
