ENERGY RENOVATION OF THE LETUŠ CULTURAL CENTRE

ENERGETSKA PRENOVA KULTURNEGA DOMA LETUŠ

Abstract

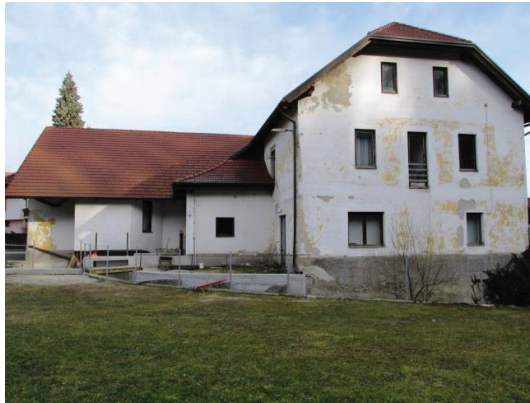
The building was built in an L-shape with external layout dimensions of 22.25 m × 25.30 m and a ridge height of 10.3 m (Figure 1). In the NW-SE direction of the ridge, the building contains the main room, which is a one-floor hall. In the direction of the NE-SW ridge in the second part of the building is a two-floor hall. The ground floor contains an office, meeting room, handy kitchen, wardrobe, utility cleaning room, an archive and a hallway that connects all of these areas. On the first floor of this building, there are a museum and cultural society rooms. On the ground floor, there is a large glass-enclosed hall, which is not heated. Figure 2 shows the building from the front to show the architectural diversity of the building.

Figure 2: Front side of the Letuš Cultural Centre

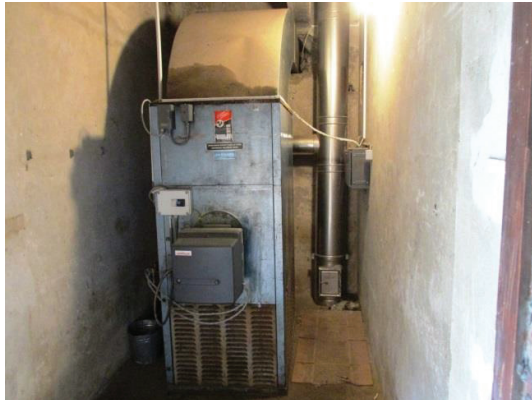
For heating the ground floor and the halls of the Letuš Cultural Centre, a heating system with an ELFO (Extra Light Fuel Oil) 85,000 kcal/h boiler is used (shown in Figure 3), and the heat transfer is conducted via an air-air heat exchanger. Blowing of the heated air is carried out with ducts (80 cm × 20 cm), which are routed into the hall and hallway. The water system is designed with a central air duct, which runs from the boiler room to the multipurpose hall. Air duct distribution pipes were originally not built for heating auxiliary rooms, but later an additional channel for heating of the meeting room was constructed. Control of the volume of blowing air is not carried out; in addition, steering hatches to make a selection of the heated rooms have not been installed. Hall temperature control is two-point, conducted by a room thermostat that is placed on the wall in the hall. The temperature mode of functioning is set. Other rooms have no temperature control. The ELFO system heats the hall and the ground floor. First floor rooms are not heated with this system; portable radiators are used for heating. The temperature is set manually with thermostats on eight different radiators.

Figure 3: Boiler room with ELFO boiler

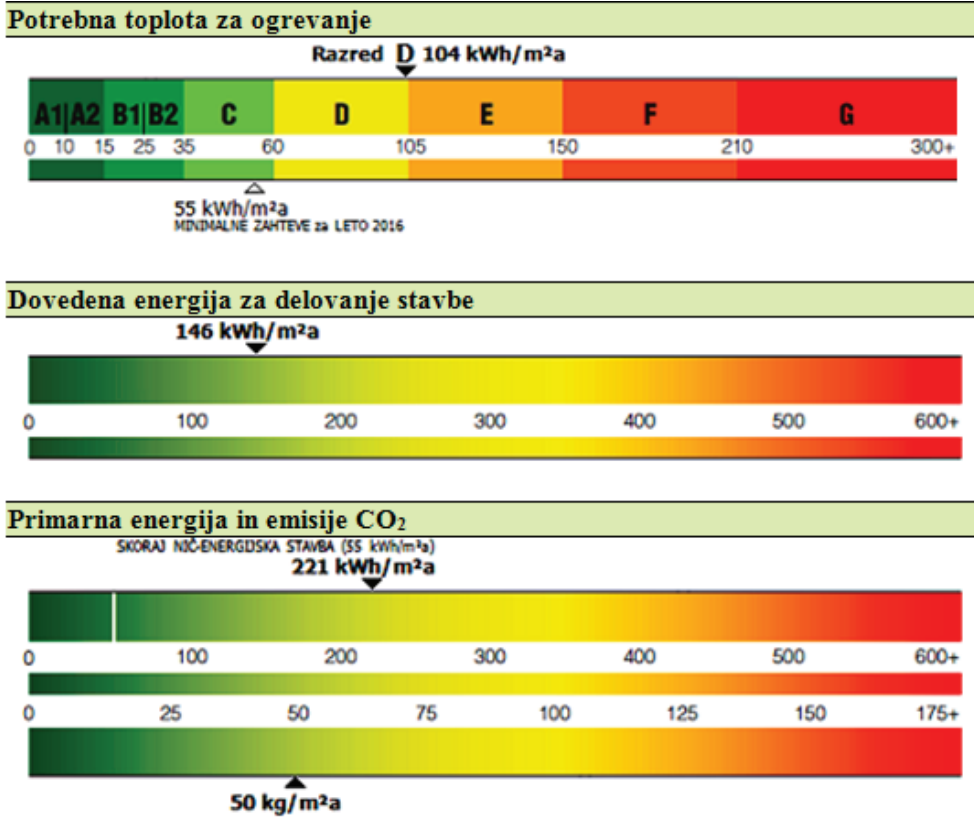
The balance of energy indicators for the building after the renovation is shown in Figure 6.

Figure 6: Primary energy and CO₂ emissions after implementation of the measures

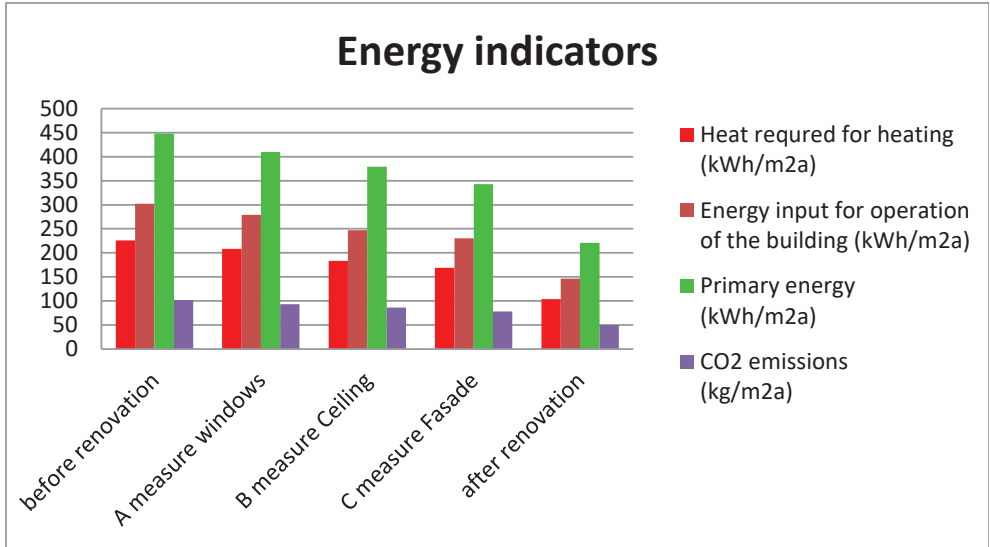
Figure 7 shows energy indicators before and after the renovation of the Letuš Cultural Centre. It was found that the consumption of the energy by the building was reduced by more than one half after the proposed measures were implemented. On closer examination, the smallest contribution to the reduction of used energy is contributed by Measure A: replacement of the external building materials. This is due to a very low “z” factor of windows and doors against the surface of the entire building envelope. The proposed Measure B represents a greater contribution to reducing energy consumption via the additional insulation of ceiling structures. The maximum reduction of the energy consumption can be achieved with Measure C: the renovation of the facade with the installation of thermal insulation materials.

Figure 7: Energy indicators
