WEAR MECHANISM FOR DEEP-WELLS DRILLING TOOLS

Jurij Šporin*, Željko Vukelić

University of Ljubljana, Faculty of Natural Sciences and Engineering, Department of Geotechnology, Mining and Environment, Aškerčeva 12, 1000 Ljubljana, Slovenia

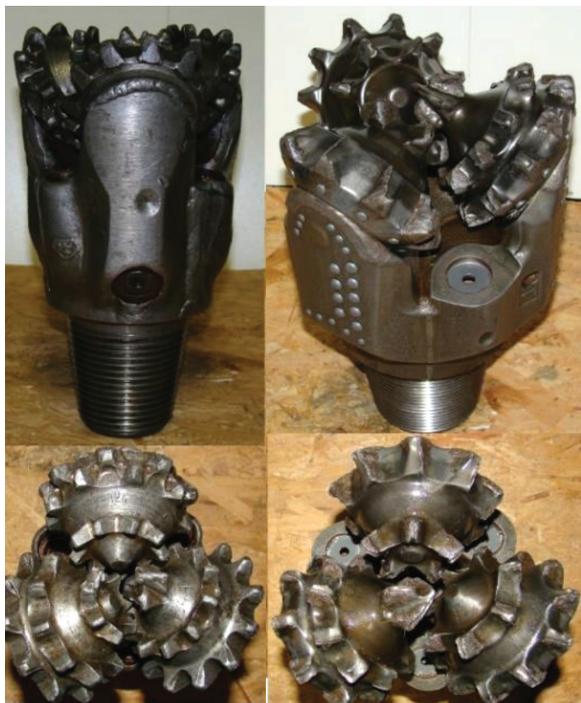
In the first case, a roller-cone drill bit with the IADC code 117 was used and in the second case a roller-cone drill bit with the IADC code 136. Both bits are shown in **Figure 2**. The IADC code is a system for classifying bits according to their properties and their applicability in various soil and rock materials. The IADC classification is created by the International Association of Drilling Contractors (IADC).

Figure 2: Roller-cone bit IADC 136 (left), IADC 117 (right) – side and top view

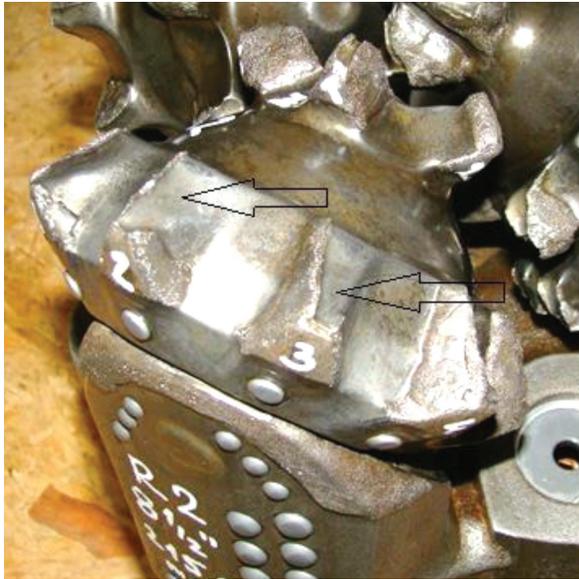
Examination of bit 117, which had been drilled over a longer interval and loaded according to the manufacturer's instructions, showed that damage in the form of wear of the bit-tooth material had occurred wherever the bit was not protected by a carbide coating. The material wear is due to the erosive effect of the drill cuttings, which contain a high proportion of silicate particles. The damage is reflected in the reduction in the dimensions of

Figure 6: Overview of the characteristic wear of the teeth of a roller-cone drill bit 117

the tooth body and the formation of erosion channels on the top of the tooth (**Figure 6**).

The failure of the carbide coating on the top of the teeth of the roller-cone drill bit 117 is due to the difference in strength and thermal expansion properties between the carbide material that forms the lining (protection) of the tooth body and the steel material of the tooth body. The carbide coating material is welded to the steel base of the teeth of the bit. During the drilling process, the teeth of the bit that come into contact with the rock to be crushed are strongly heated and then cooled by the flushing medium that flows around the teeth as they rotate around the roller axis. The different expansion or elasticity properties of the material, as actually observed during the tests in the low-temperature dilatometer, lead to the formation and progression of cracks between the two materials.

The latter led to a failure of the carbide coating. The failure of the carbide coating led to a new open surface of the steel tooth material, over which the flushing medium, which contained a large amount of siliceous abrasive components, flowed. The abrasive components eroded the newly opened surfaces at the tooth tips and caused erosion channels and thus the loss of the steel tooth material.
