# Detecting Groan Sources in Drum Brakes of Commercial Vehicles by TVA-FMEA: A Case Study

*In this article, the strategy followed by an automobile company for detecting the root causes of groan complaints related to rear drum brakes in commercial vehicles is presented using data collected from the sold troubled vehicles and from new vehicles from the production line, as well as the drum-brake test rig at the laboratory. Drum brake groan is often very intense and can cause large numbers of customer complaints. During a groan noise event, vehicle structure and suspension components are excited by the brake system and result in a violent event that can be heard and felt during brake application. This paper condenses experimental studies on a low frequency drum brake groan problem that has caused high warranty costs. First, the environmental conditions causing the groan were identified and the groan was reproduced. Vehicle tests were performed both at the factory and in traffic. To conclude the planned study, TVA (Total Value Analysis) and FMEA (Failure Mode and Effects Analysis) methods were used effectively. A strategy to determine the root causes was planned and implemented systema

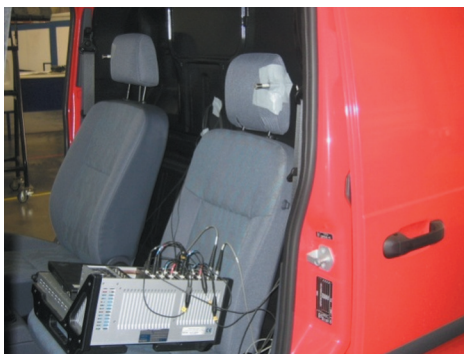
Fig. 10. Microphone positioning in cabin onto driver head guard

The sound pressure level in-cab has been measured by mounting microphones in the ears of drivers and passengers. The location of the microphones was as shown in Fig. 10. Microphones were placed as close as possible to the ears of the passenger and driver. The type of microphones used in the measurements is the Brüel & Kjaer 4189-A-021.

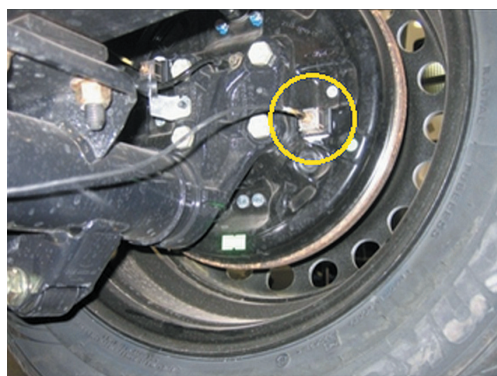
Fig. 11. Accelerometers mounted on the backing plate

When the vehicle was tested, all the windows were closed and the drivers and passengers were in a quiet environment. A Brüel & Kjaer microphone with type 2671 pre-amplifier was tested and calibrated up to values 93.8 dB - 1000 Hz. The NVH test of the vehicles were carried out in three stages: (1)

collecting data with accelerometers and microphones located at the outside of the backing plate, (2) taking measurements from both the leading and trailing brake shoes and (3) measurement of the leading shoe of a faulty drum brake unit. To begin with, double accelerometers were placed onto the backing plates of the left and right rear drum brakes as shown in Fig. 11. The accelerometers used were 4 mA – 100 mV/g and type 7254A-100 and 2258-100. In addition, optical readers were used to compare the collected data with the vehicle speed. Data collected for the cabin sound level and data for the backing plate acceleration were transferred to an FFT analyser for processing. Data were analysed using Head Acoustics Artemis and SQ Lab-III via computer software. The vehicle used was a van type vehicle with 90 HP and steering on the right affected by brake groan. In the test, only selected vehicles with similar properties were compared. Therefore, trouble-free vehicles to be tested had the same properties as the troubled vehicle.
