CHARACTERIZATION OF LIME MORTAR AND PLASTERS OF FORTRESS CONCEPCION DE LA VEGA

**Esteban Prieto-Vicioso^{1*}, Virginia Flores-Sasso², Sagrario Martínez-Ramírez³,
Letzai Ruiz-Valero², Gloria Pérez⁴**

doi:10.17222/mit.2022.525

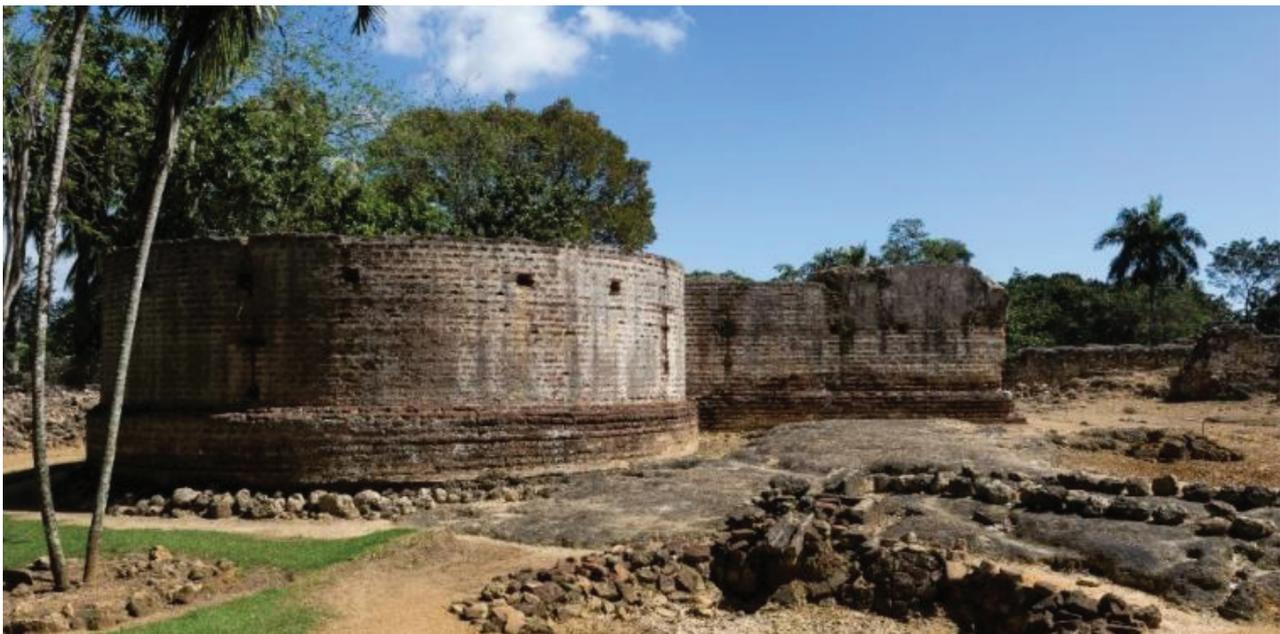
Figure 1: Current state of the tower

The fortress of the Concepción was a rectangular enclosure of approximately 44 m × 21 m, with brick walls of approximately 1.67 m in width (2 varas castellanas) and two cylindrical towers with walls of 1.75 m in width placed diagonally opposite each other (**Figure 1**).

The existing tower has an outer diameter of 8.95 m, an inner diameter of 5.35 m and more than 4-m high, built-in brick masonry with 6 flared loopholes. The fortress had in its interior a tower of two levels that served as the residence of the warden and other dependencies. Today only one of the towers, parts of the outer wall and

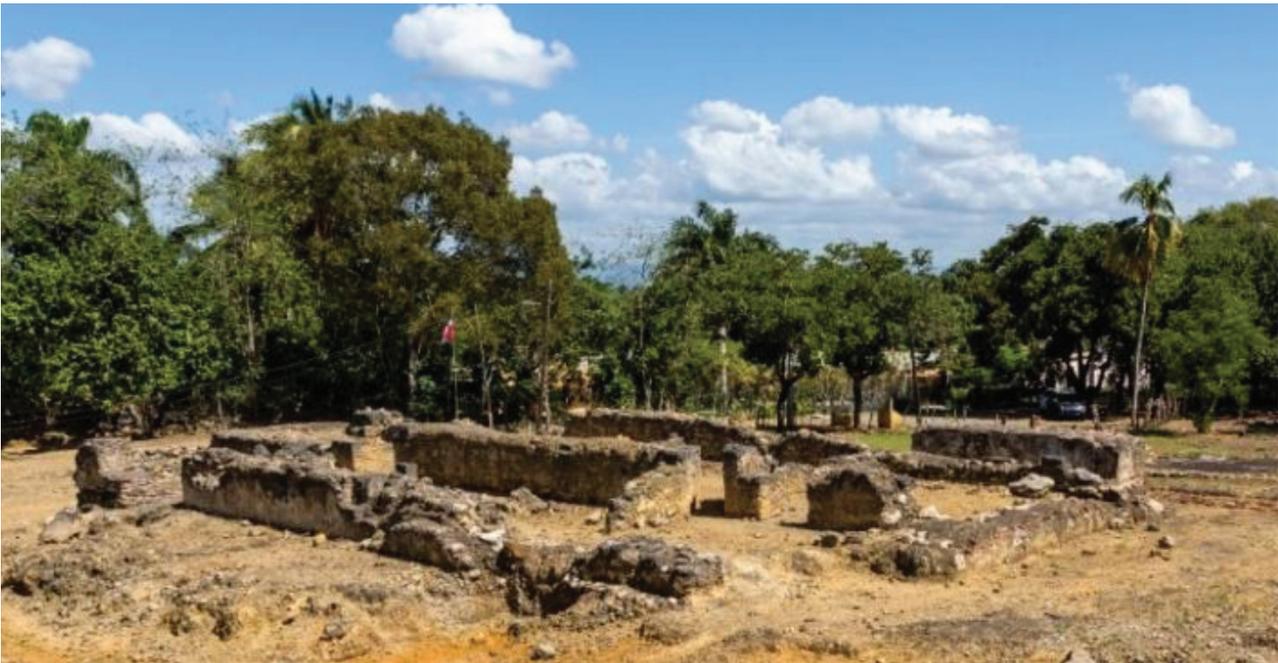
Figure 2: Current state of the fortress

parts of the walls of Torre del Homenaje remain (**Figure 2**).

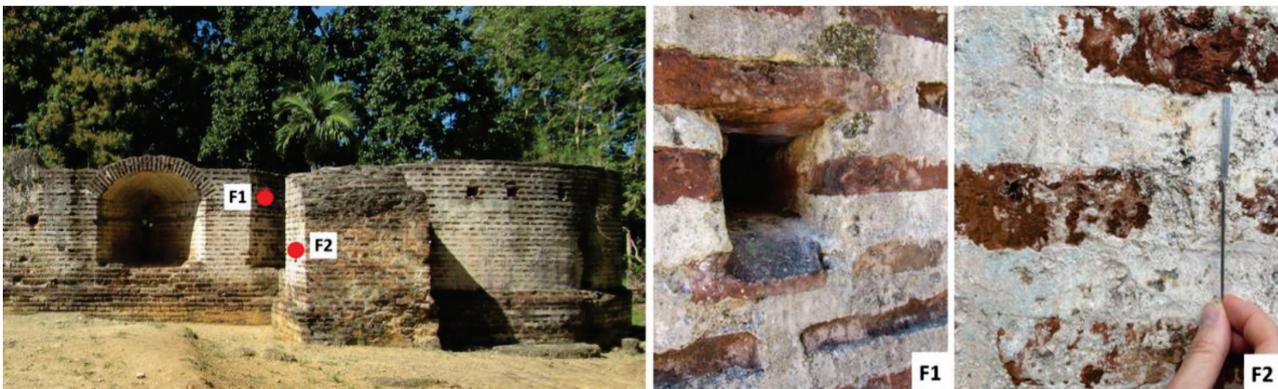
Figure 3: Location of the samples

The analysis was performed on two samples that were taken from the ruins of the fortress tower of Concepción de La Vega: F1 is a mortar sample and F2 is a plaster sample (**Figure 3**). The techniques used were:

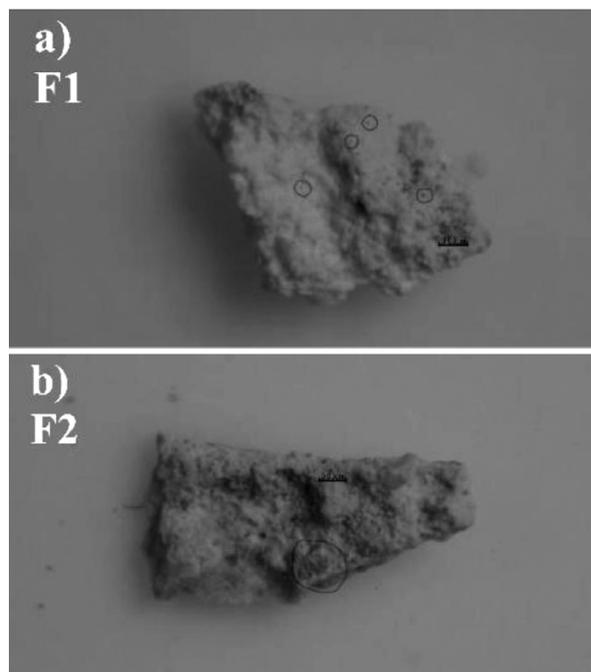
Figure 4: General view of the samples: a) mortar (F1), b) plaster (F2)

Figure 4 shows a general view of the samples. In the case of mortar F1 (**Figure 4a**) small black points indicate the presence of the aggregate with a very low size.

Plaster F2 (**Figure 4b**) shows red particles that can indicate the presence of iron oxide.

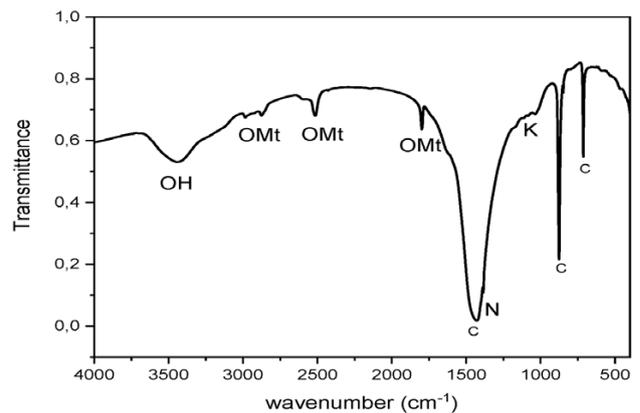
Figure 5: FTIR of the mortar (F1): C – calcite, K – kaolinite, OH – OH from water molecules, N – nitrates, OMT – organic matter

Figures 5 and **6** show the FTIR of mortar F1 and plaster F2, respectively. The mortar sample shows the following main characteristics: vibration bands of the CO_3^{2-} group present in calcite, a strong band at 1431 cm^{-1} from stretching vibrations, as well as two narrow bands from bending vibrations²¹ at 870 cm^{-1} and 712 cm^{-1} . Additionally, small bands from kaolinite at (1030, 1077 and 1117) cm^{-1} were identified.²² Signals due to the presence of organic matter probably coming from contamination were also observed, as well as a small signal at 1387 cm^{-1} due to the presence of nitrates.

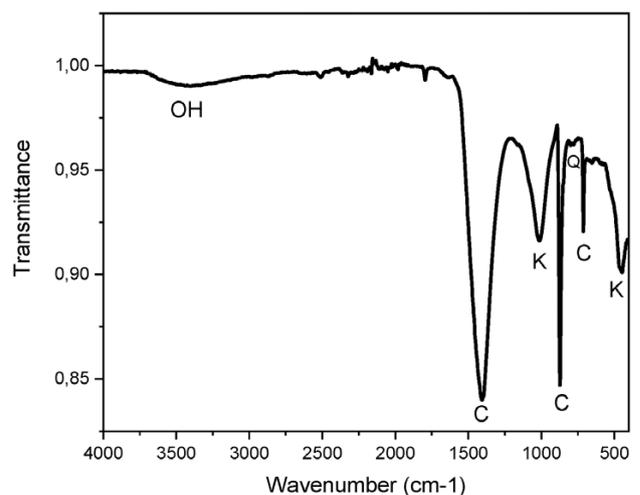
Figure 6: FTIR of the plaster (F2): C – calcite, K – kaolinite, OH – OH from water molecules, Q – quartz

The plaster sample also shows calcite and kaolinite; however, for this sample the bands from kaolinite have a higher intensity than for the mortar.

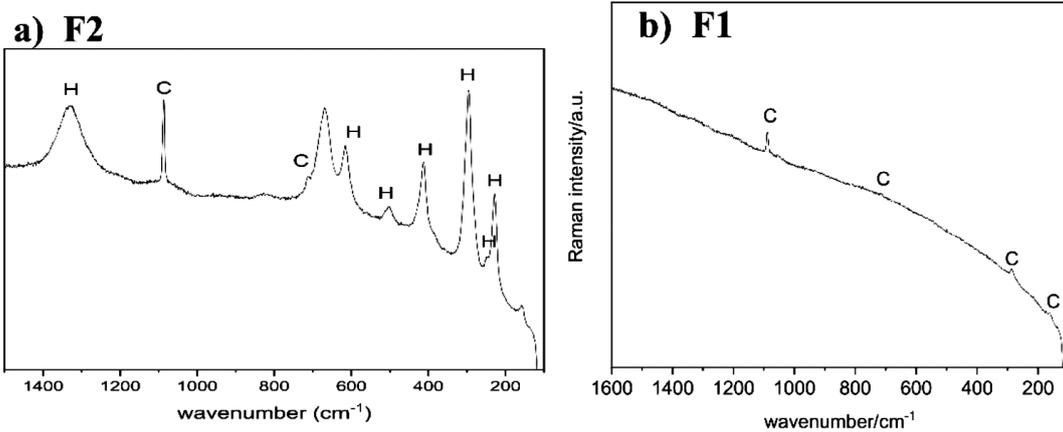
Figure 7: Micro-Raman spectra of the samples: a) plaster (F2), b) mortar (F1) (C – calcite, H – hematite)

The Raman spectrum of the plaster (F2) is shown in **Figure 7a**, where the main bands can be attributed to iron oxide in the form of hematite ($\alpha\text{-Fe}_2\text{O}_3$) and there is

a sharp band at 1085 cm⁻¹ indicating CO₃²⁻ present in calcite (CaCO₃). The spectrum also shows a signal at 668 cm⁻¹ whose origin is uncertain. Bikias et al. and other authors associate it with the Al-O-Si bond in kaolinite,²³ while Aguayo et al. and some other authors assign it to magnetite, an iron oxide present in igneous and metamorphic rocks.²⁴

In the case of mortar (F1), only signals indicating calcite are identified (Figure 7b).

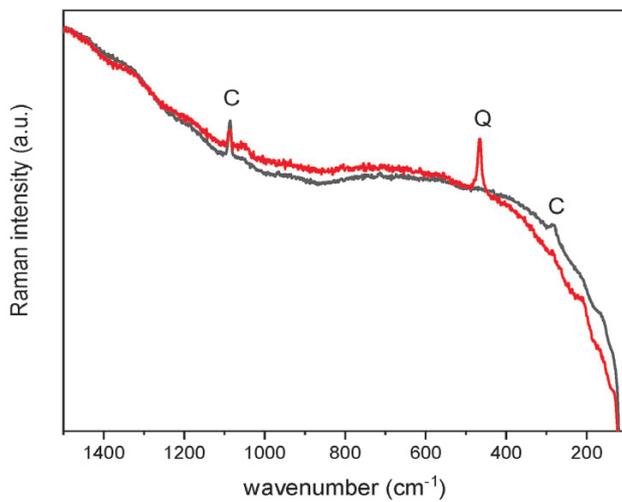
Figure 8: Micro-Raman spectra of the aggregates present in the mortar sample (F1) (C – calcite, Q – quartz)

Figure 8 shows the Micro-Raman spectra of two different aggregates of the mortar (F1), showing that both calcite and quartz were used.

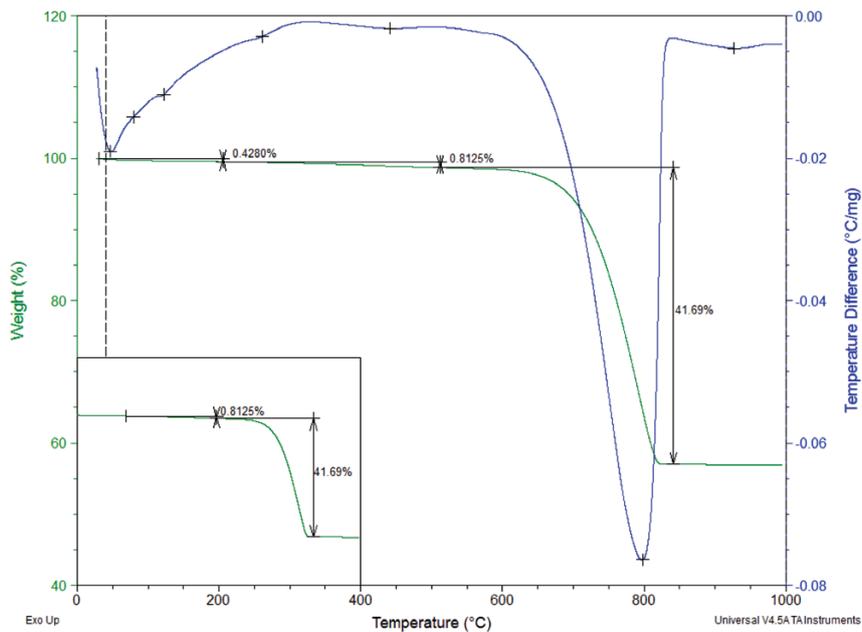
Figure 9: DTA-TG analysis of the mortar (F1)

In order to determine the amount of calcite present in the mortar (F1), a DTA-TG was performed and the results are presented in Figure 9 and Table 1. The mortar

sample (F1) shows seven endothermic peaks. In ranges of 70–130 °C and 110–180 °C, the weight loss due to water of the crystallization of calcium sulfate hemihydrate and dihydrate, respectively, takes place.²⁵ The peaks are very small so they are probably due to atmospheric pollution. The two peaks in the interval of 200–500 °C are attributed to the goethite transformation into hematite and dehydroxylation of kaolinite, respectively. The main endothermic peak at 797 °C with a mass loss of 41.69 % is attributed to the decarbonation of calcium carbonate. Finally, the endothermic peak at 929 °C, without any weight loss, is possibly due to the crystallization of the new high-temperature phases such as clay minerals.²⁶ The weight loss in the interval of 600–800 °C is 41.96 % of CO₂, which corresponds to 95.4 % of CaCO₃. These data indicate that the main compound in the mortar is calcium carbonate with small amounts of goethite and kaolinite, which are probably impurities from the calcite.
