Experimental and Numerical Studies of Jaw Crusher Supporting Structure Fatigue Failure

Eugeniusz Rusiński – Przemysław Moczko* – Damian Pietrusiak – Grzegorz Przybyłek
 Wrocław University of Technology, Poland

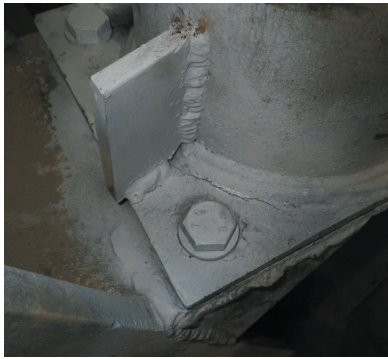
structure were observed. A view of the cracks in the side vertical bracing is shown as an example in Fig. 3.

The growth rate of fatigue cracks was high. The maximum length of cracks was found to be 160 mm. The significant level of damage meant that immediate action would have to be taken in order to prevent

Fig. 3. Fatigue crack in the side bracing

According to the FEM calculations on the existing structure, the fatigue resistance of critical joints (see Fig. 11) does not fulfil ISO-5049 standards [8]. This was confirmed by the presence of the many cracks observed in these areas (an example of such cracking is shown in Fig. 3).

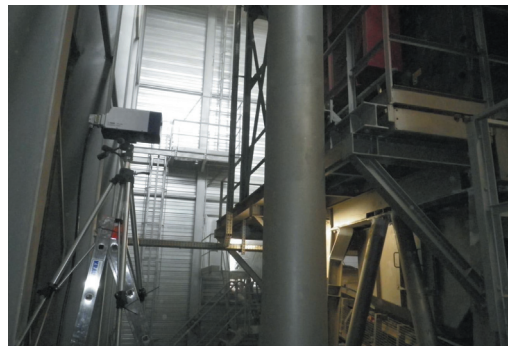
Fig. 5. Scanning head of the POLYTEC PSV-400 vibrometer

The testing equipment used during the tests is shown in Figs. 5 and 6.

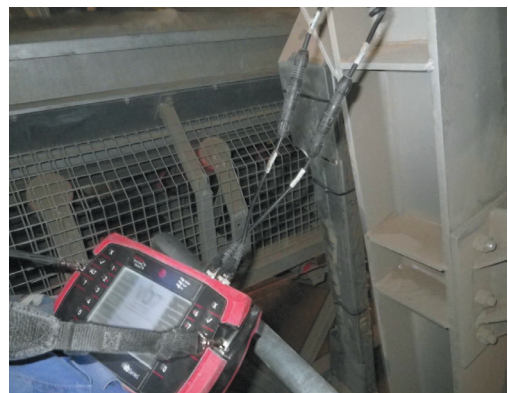
Fig. 6. COMTEST vb7 vibrometer

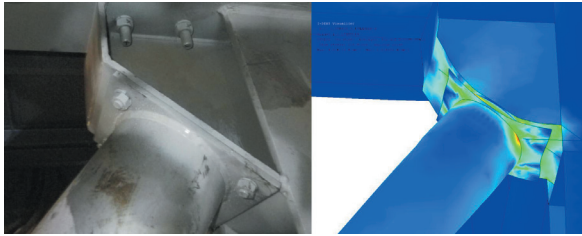
- 1) resonance vibrations in the transverse direction caused by not enough stiffness in the structure in this direction,
- 2) weak design of the joints, which have low resistance to loads due to operating conditions with movement in both horizontal directions (an example of such a design is shown in Fig. 12). The design of the joints would be sufficiently strong in the case of a static load, however the geometry of the gusset plates does not assure proper load transfer in the case of a dynamic load. Lateral forces acting on the faceplate and the bolted connection cause high effort in those elements. Moreover, the joints do not assure smooth stiffness changes. Therefore, strong bending and pulsations are present and cracks occur as a result of rapid fatigue.

Fig. 12. Example of the weak design of the joints

Due to the condition of the existing joints, which exhibit multiple cracks and thus multiple repairs, it was decided to cut out all weak joints and incorporate new redesigned ones. Special care was paid to the joint's design to assure proper fatigue resistance.
