A STUDY OF PARTICULATE AND GASE-OUS EMISSIONS OF A DAMAGED TUBU-LAR COMBUSTION CHAMBER IN A PELLET STOVE

Zdravko Praunseis³¹

This study presents the influence of damaged tubular combustion chamber on smoke fine-particle emissions at small scale pellet burners. This research aims to reduce the particulate matter emissions of small scale pellet boilers and contribute to cleaner air.

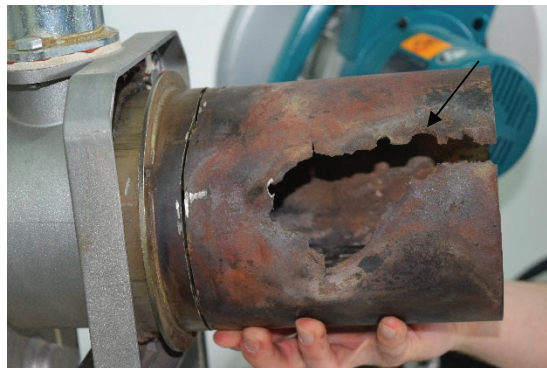
The damage of the steel tube (tubular combustion chamber) and the grille occurred after one year of the burner operation time, as shown in Figure 4 and Figure 5.

Figure 4: Hole as a damage of the steel tube (tubular combustion chamber)

The damage appeared at the burner tube as holes, as can be seen from Figure 4. The total measured amount of damaged tube surface was 22.75 cm².

The tubular combustion chamber should be made from high-temperature Cr-Mo resistance steel, which contains a prescribed amount of Cr (at least 9%) and Mo (about 1%) due to the high flame temperature, which can exceed 600 °C. The improper selection of base material (HSLA steel) leads to the damage of the steel tube due to the high operating temperatures during the combustion of pellets (Figure 4). The highest flame temperature of 643 °C (Figure 2, point M17, see arrow) was measured at the surface of the HSLA steel tube end (Figure 3 and Figure 4, see arrow) with an

infrared camera, as shown in Figure 2 and Table 1. Thus, the tubular combustion chamber must be made from a high-temperature Cr-Mo steel, containing a prescribed amount of Cr and Mo.

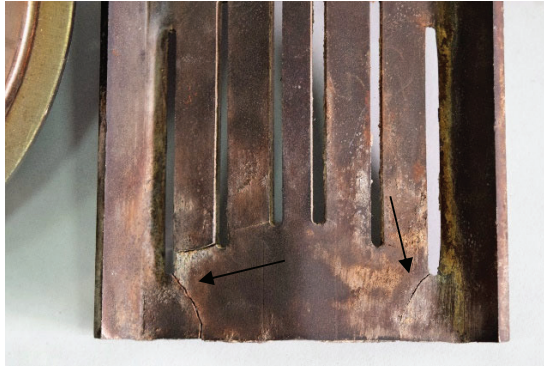
Figure 5: Hot cracks as a damage of the steel grille

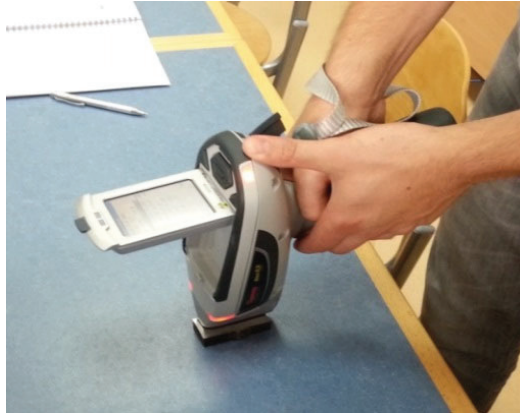
Measurements were carried out manually (Figure 6) with the target points on the steel tube (Figure 7). Each measurement was repeated three times, and later the average value was calculated. Each measurement was done for one minute.

Figure 6: Manual measurement of chemical analyses of steel tube (tubular combustion chamber) with X-ray fluorescence spectrometry (XRF) using an X-ray fluorescence spectrometer

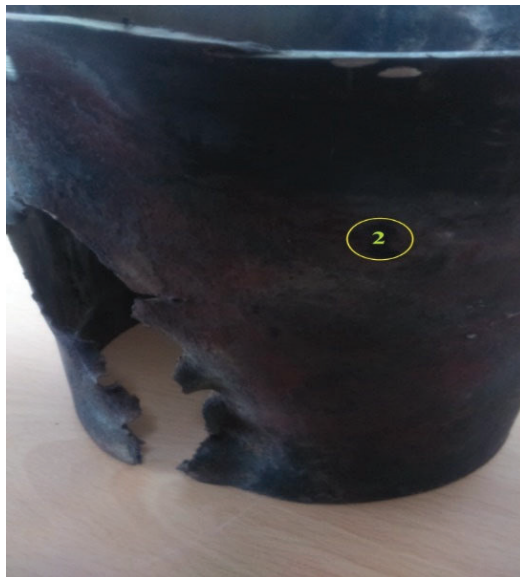
Figure 7: Target point (number 2) for manual measurement of chemical analyses of real steel tube (tubular combustion chamber)

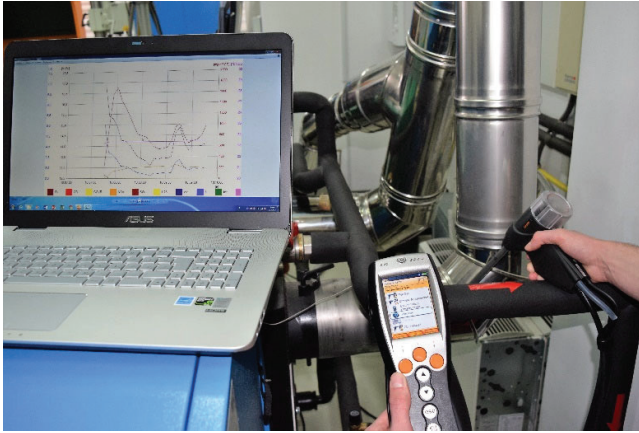
Fine particle measurements were made in the chimney tube at a distance of 20 cm from the boiler using a fine particle analyser (Figure 8), which measures fine particles, O₂ concentration and CO emissions in real-time for 15 minutes.

Figure 8: Fine particle measurement with the Testo 380 fine particle analyser

Because of this, holes with diameters of 11 mm were drilled into the new steel tube (Figure 10 and Figure 11) made of X11CrMo9 high-temperature-resistant steel to simulate the damage of the tube (tubular combustion chamber) measured with a fine particle analyser (Figure 8).

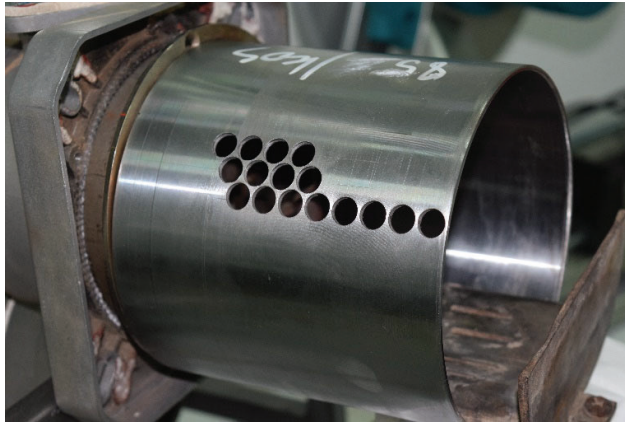
Figure 10: Cr-Mo steel tube with damaged surface (16 holes)
