# THE DEGREE OF DETERIORATION OF THE TUNNELS OF THE PRAGUE METRO BASED ON A MONITORING ASSESSMENT

IVAN VANÍČEK and MARTIN VANÍČEK

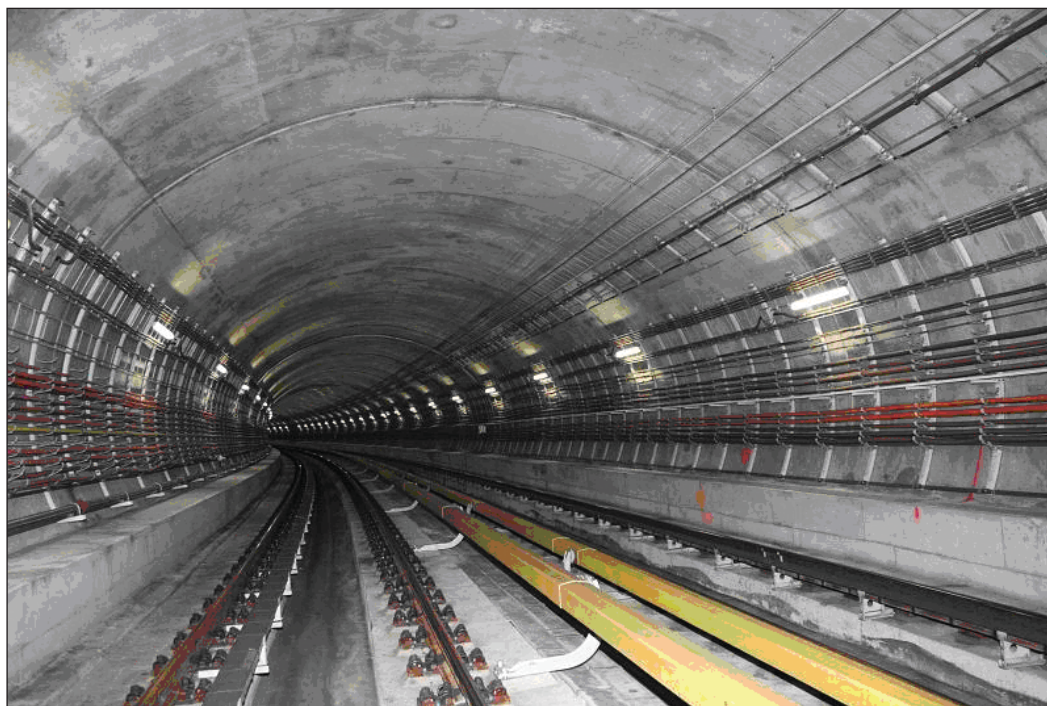
**Figure 3.** Double-track metro tunnel on line C.

extension of line C as far as Ládví Station: two additional stations and a length of 3.981 km. The highlights of this section are the first double-track driven Metro tunnel (Figure 3) and Prague's first single-nave driven Kobylišy Station, which is also the deepest station on line C, being situated 31.5 m below ground.

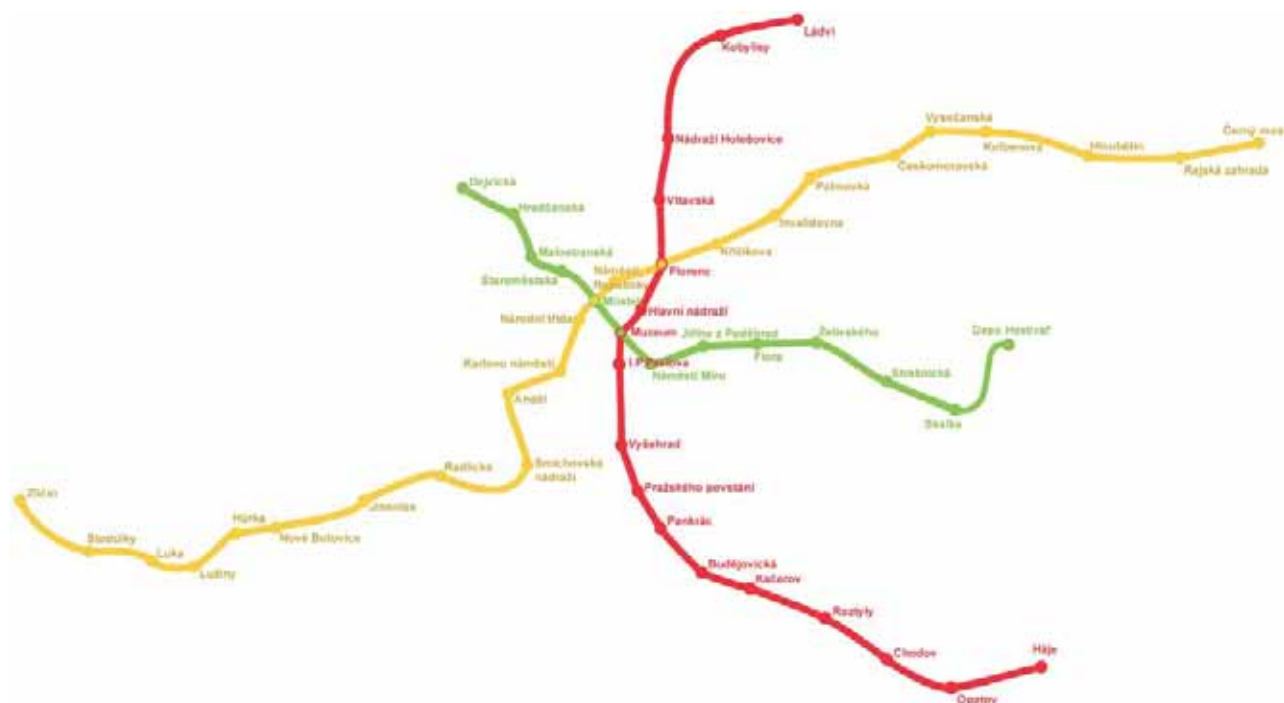
Figure 4. Present system of the Prague Metro's lines.

The Prague Metro system presently (Jan 2008) operates 3 lines (A, B, C) with 54 stations and a total length of 54.7 km (see Figure 4 on next page). Line A has 13 stations and is 11.0 km long; line B is the longest, with 24 stations and a length of 25.7 km; and line C has 17 stations and is 18.0 km in length.

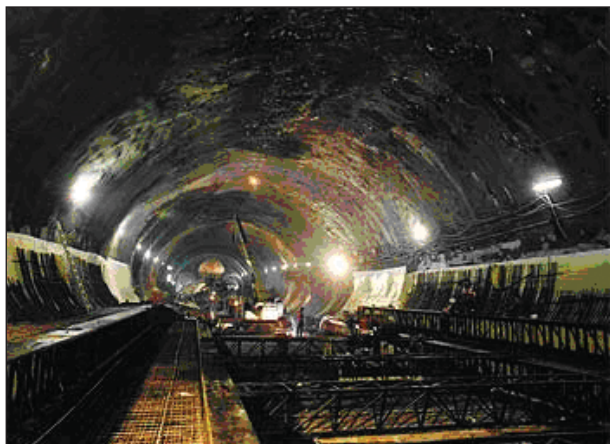
Figure 8. The building of the Kobylisy station.

This method was first used in the 1980s and is typical for a two-shell lining – the primary lining is made from shotcrete and the secondary lining is made from monolithic reinforced concrete, with a sealing in between (see Figure 8).

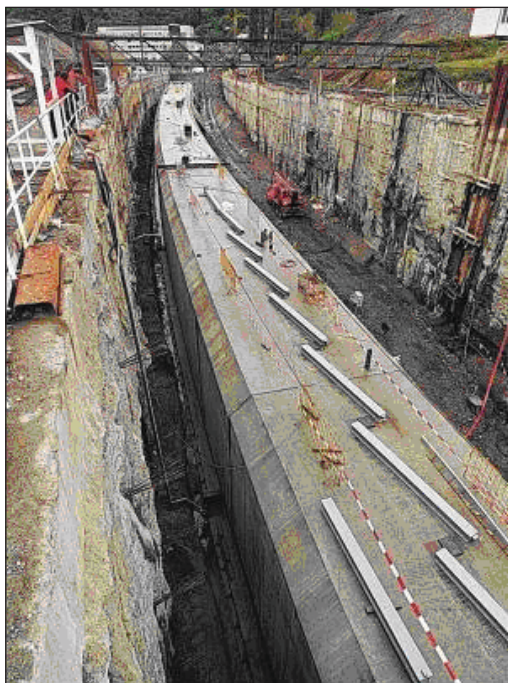
Figure 9. Immersed tunnel – the concrete tube still in the dry dock.

The basic principle of this technique consists of constructing individual tubes in a dry dock, which was dug in the Troja bank at the location of future tunnels (see Figure 9) [7]. When the concrete structure of the tube was completed, the internal balance tanks and the

steel bulkheads at both ends were installed. A suspension system was connected to the tubes in the form of anchoring elements cast into the tubes. After the installation of the tunnel outfit the dry dock was then flooded, allowing the shifting of an individual tube into its final position in a trench dug in the river bed. Two tow steel cables anchored on the opposite bank drew the tubes

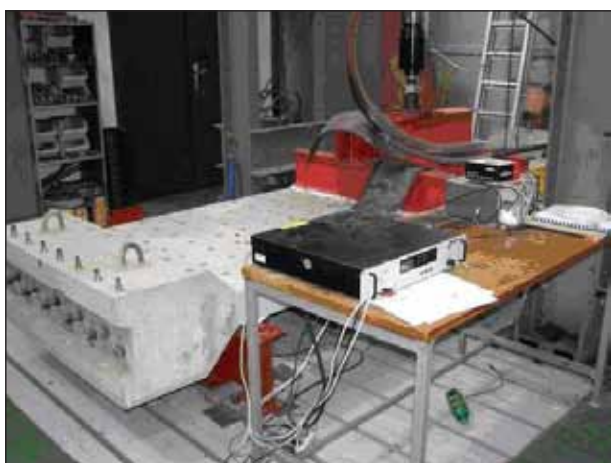
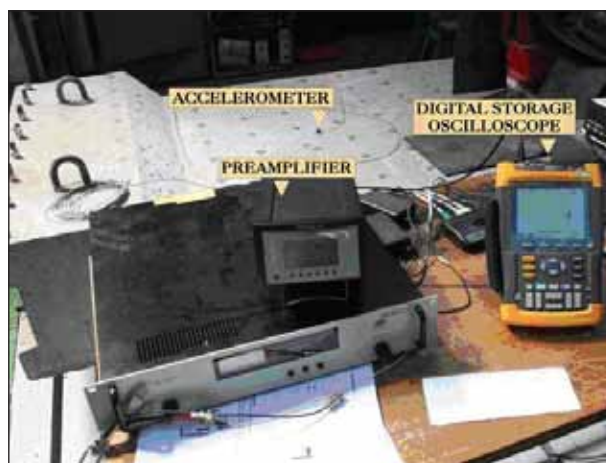
**Figure 15.** The experimental arrangement (a) and the measuring line (b).

In parallel with the monitoring in the Prague Metro's tunnel we also started to study the dynamic response accelerograms of a reinforced concrete slab in laboratory fatigue tests (see Figure 15).

We measured the acceleration of a single point movement at one-third of the span of the specimen's supports. Our main concern was the development of changes with time in the course of deformations, as there is no doubt that the specimen must gradually lose its elasticity with the increasing number of loading cycles it has undergone. As the laboratory test is currently only half way through, there is not yet enough data to process and determine the overall degree of deterioration of the slab. However, there are results from accelerometers that indicate some ageing of the tested member, and the results from the frequency spectra analysis indicate some fatigue development. At the time of writing there is no visible macroscopic failure whatsoever on the specimen.
