# Analysis on Damage to Rolling Bearings at Small Turning Angels

Ivan Okorn\* – Marko Nagode – Jernej Klemenc

University of Ljubljana, Faculty of Mechanical Engineering, Slovenia

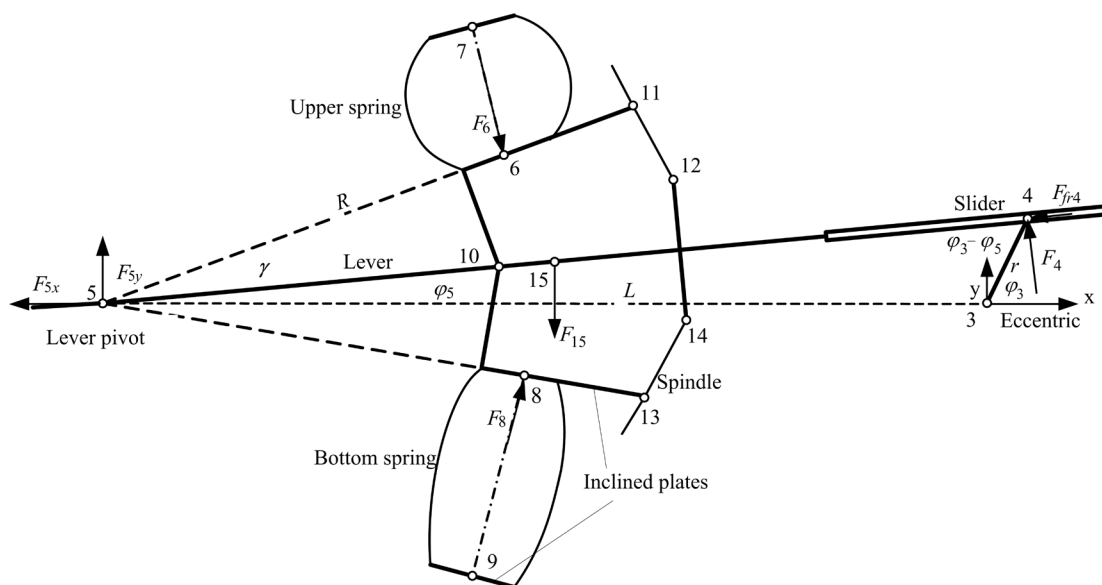
Fig. 1. Loading of air springs

Fig. 1 schematically shows the loading of the spring. The eccentric mechanism with a rotation point 3 pushes the lever via a slider. The lever oscillates around its rotating point 5, thereby loading one spring and releasing the other one via inclined plates. Four springs are tested simultaneously. They are loaded with two eccentric mechanisms that are phase shifted by an angle of  $90^\circ$ . The spring that is being released returns the energy to the system, while the spring that is being compressed, uses the energy from the system. An electric motor drives the test rig; it provides the missing energy to compress the spring and energy to cover friction losses. The energy situation in the test rig was analysed in paper [8].

Bearings in the rotation point are loaded radially by the resultant of forces  $F_{5x}$  and  $F_{5y}$ . The forces change during the oscillation of the lever. They depend on working forces of the springs, weight and inertia of the lever. Reaction forces on the lever are shown in Fig. 1. Forces that act from the lever to the bearings are of equal size and in the opposite direction. The size of  $F_{5x}$  component (but not its direction) changes due to the inclination of the spring. Rolling elements on one side of the bearing are always in contact with the raceways, in spite of increasing play during operation. Neglecting the lever weight, the bearing is symmetrically loaded with respect to the  $x$ -axis, and it is loaded only with the  $F_{5x}$  component in its neutral (horizontal) position. When the locations of damage were checked, damage in the rings was symmetrical with respect to the  $x$ -axis.

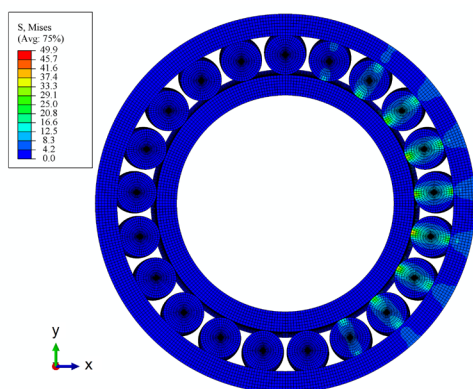
Fig. 3. Von Mises stresses in MPa at  $F_x = 10$  kN and  $F_y = 0$  kN

The distributions of contact pressure and von Mises stress have been calculated in two characteristic lever positions by using the FEM. In order to reduce the number of finite elements, only half of the width of the bearing was used in the calculation. The force was entered in the middle of the entire width of the bearing. The movement of rings was limited along the  $z$ -axis. Fig. 3 shows the stress in the bearing elements in a neutral position of the lever, while Fig. 4 shows the stress at the maximum turn of the lever.

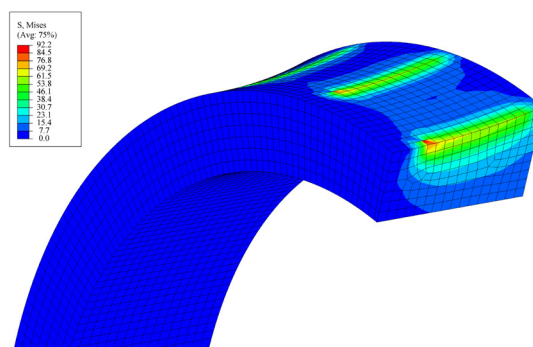
Fig. 5. Distribution of stresses by depth at position 5 in MPa at  $F_x = 14$  kN and  $F_y = 10$  kN

Fig. 5 shows a distribution of Von Mises stresses along the depth of the inner ring. We selected the location with the highest stresses (position 5).

The purpose of the FEM analysis was to determine the load distribution on the bearing ring and to determine the maximum pressure and stress. By comparing the actual stress and the yield strength of the 100Cr6 bearing steel (ISO 683-17 notation), the

probability of plastic deformation at the macro level was determined. The yield strength of the 100Cr6 steel is about 1300 MPa. The actual highest stress is thus about 14 times smaller than the yield stress of the bearing steel. On the basis of the FEM analysis it was concluded that the plastic deformation of raceways at the macro level was not possible.

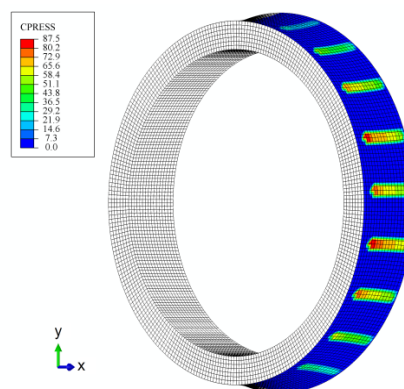
Fig. 6. Contact pressure distribution in MPa at  $F_x = 10$  kN and  $F_y = 0$  kN

The pressure distribution on the surface of the internal ring raceway is shown in Figs. 6 and 7.

The pressure distribution on the other raceway is symmetrical with respect to a plane passing through the middle of the bearing.
