## Mehanizem obrabe kotalnega dleta

### Roller cone wear mechanism

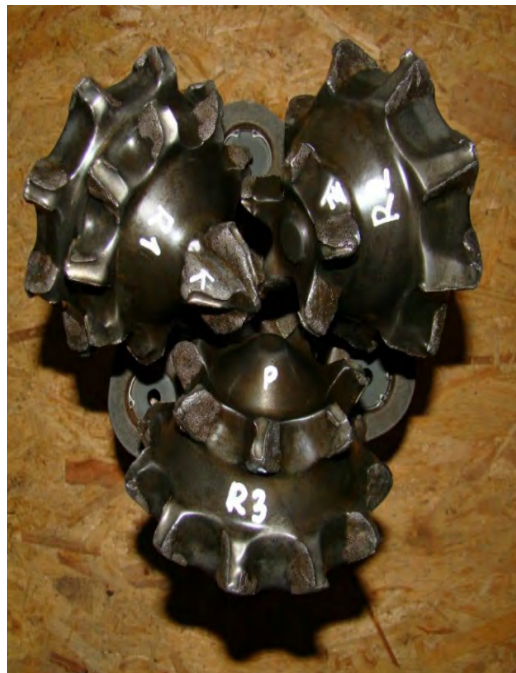
**Sika 1.** Kotalno dleto Smith ST117

**Figure 1.** Roller cone drill bit Smith ST117

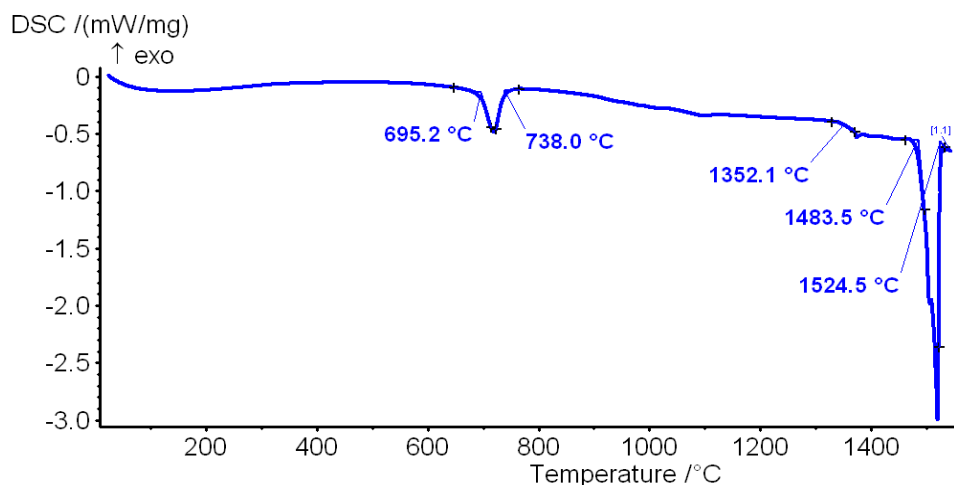
The results of simultaneous thermal analysis (STA) (Figure 4) of the steel sample from the body of the roller show that an eutectoid transformation in solid state starts at a temperature of 695.2 °C, which is characterized by an endothermic peak. When this was completed (738 °C), the metal base was transformed into an austenite structure. At a temperature of 1352.1 °C, the low temperature eutectics began to melt into the investigated steel and then, at 1483.5 °C, into the primary

**Slika 4.** Segrevalna DSC krivulja jekla kotala in telesa zoba

**Figure. 4.** DSC heating curve of the steel of the roller and body of the bit tooth

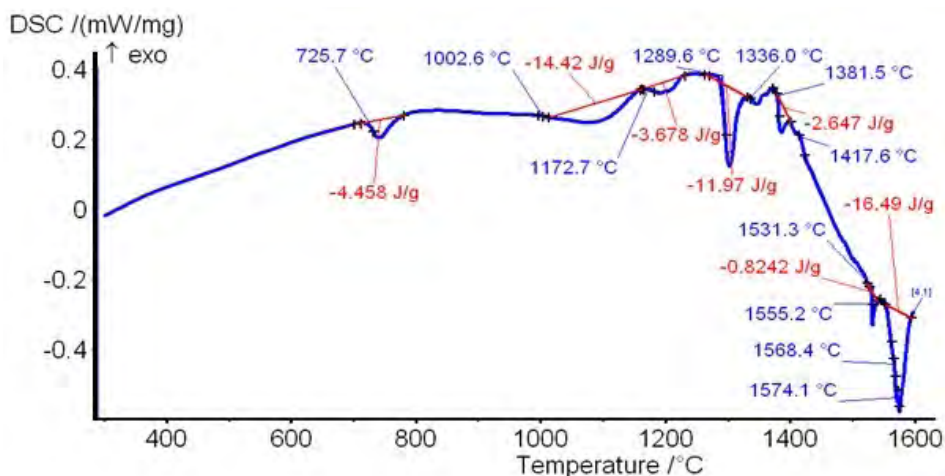
**Slika 5.** Segrevalna DSC krivulja jekla karbidne obloge zoba

**Figure 5.** DSC heating curve of carbide coating of the bit tooth

Figure 5 shows the heating curve of the investigated carbide coating sample, which, on the surface, still contained a mixing zone between the steel of the tooth body and the carbide coating. At a temperature of 725.7 °C, an eutectoid transformation began, which is undoubtedly related to the part of the demisting zone between the steel and the carbide coating. Otherwise, this is not typical for carbide coatings. At 1002.6 °C, the dissolution of the elements from the mixing zone began in the cobalt matrices of the carbide coating. The first melting was registered at 1289.6 °C and was terminated at a temperature of more than 1600 °C.

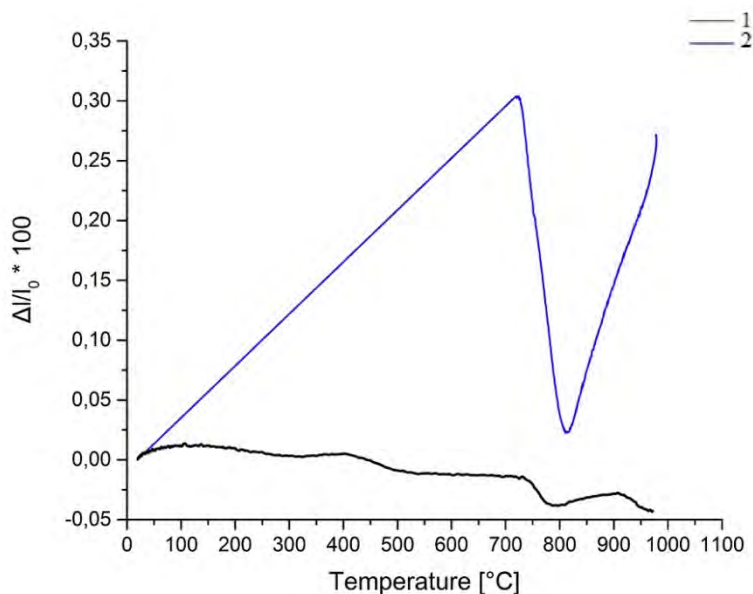
The dilatometric heating curve of the roller steel and the dilatometric heating curve of the carbide coating is shown in Figure 6. From the measurements, it can be seen that the steel extends linearly to the temperatures of eutectoid transformation during heating. The inclination of the curve corresponds to the linear thermal expansion coefficient of the steel for cold

work tool steel. On the contrary, the curve of the investigated sample of carbide coating, which contains a thin layer of the mixing zone, shows a relatively flat curve. Therefore, the temperature expansion coefficient of the carbide coating is considerably lower. If we look at the difference in the zone of working temperatures that can reach a local temperature even at 500°C, despite intense cooling, the absolute difference is 0.15 %. This is important because it results in a strong increase in internal stresses, particularly in the mixing zone, which is the preferred site for the initiation and propagation of cracks. The dilatometric curve of the carbide coating shows a deviation in the field of eutectoid transformation, which is related to the eutectoid transformation of the thin layer of the mixing zone on the carbide coating, except that the reference temperatures are slightly higher. The cause of higher temperatures is the chemical composition of the mixing zone.

**Slika 6.** Dilatometrijska analiza jekla kotala (telesa zoba) in karbidne prevleke 1 – karbidna obloga, 2 – jeklo telesa zoba

**Figure 6.** Dilatometric analysis of the steel of the roller and carbide coatings 1 – carbide coating, 2 – tooth steel material
