Deterioration of the granodiorite façade – case example Maximarket, Ljubljana

ALENKA MAUKO¹, BREDI MIRTIC², ANA MLADENOVIC¹, BENT GRELK³

¹ Slovenian National Building and Civil Engineering Institute, Dimičeva 12,
SI-1000 Ljubljana, Slovenia; E-mail: alenka.mauko@zag.si

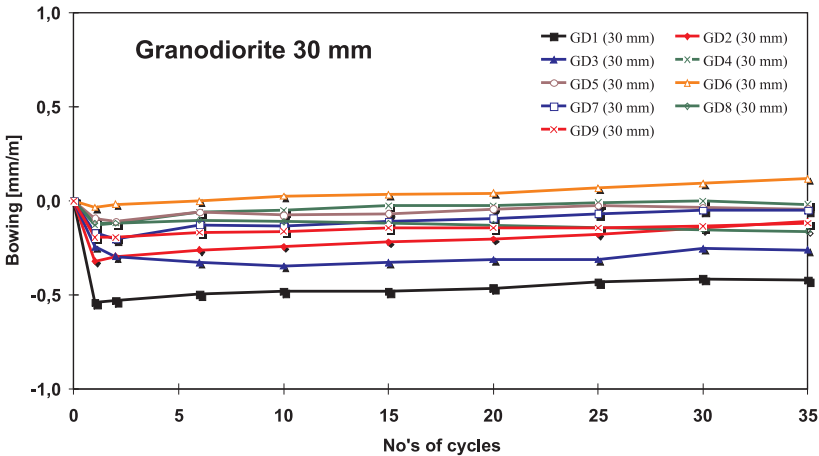
Laboratory determination of bowing potential was conducted on two sets of granodiorite panels of different thickness and on one set of specimens taken from removed panel. Almost no bowing was observed on 30 mm (Fig. 10) or 10 mm (Fig. 11) thick panels although slight difference in curvature of average bowing curve was observed between two sets of specimens (Fig. 12). Clear bowing tendency was observed on specimens taken from removed panel (Fig. 12). After 15 cycles of heating and cooling a bowing of approximate 2 mm/m was determined.

Figure 10. Bowing of 30 mm thick panels during 35 cycles

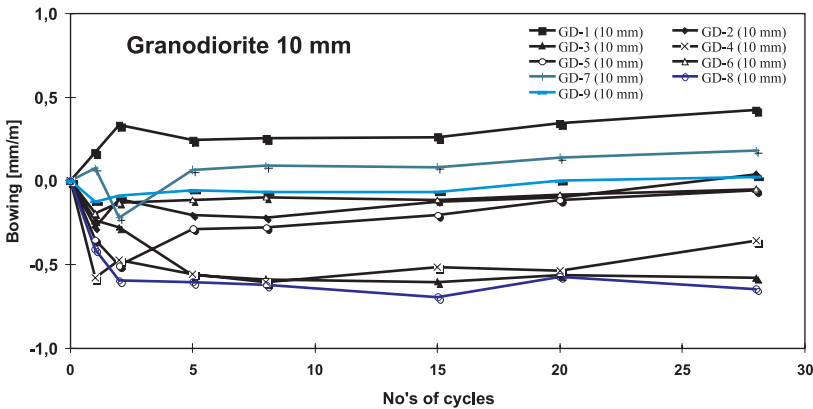
Figure 11. Bowing of 10 mm thick panels after 28 cycles of heating and cooling of partly immersed specimens from 20 to 80 °C

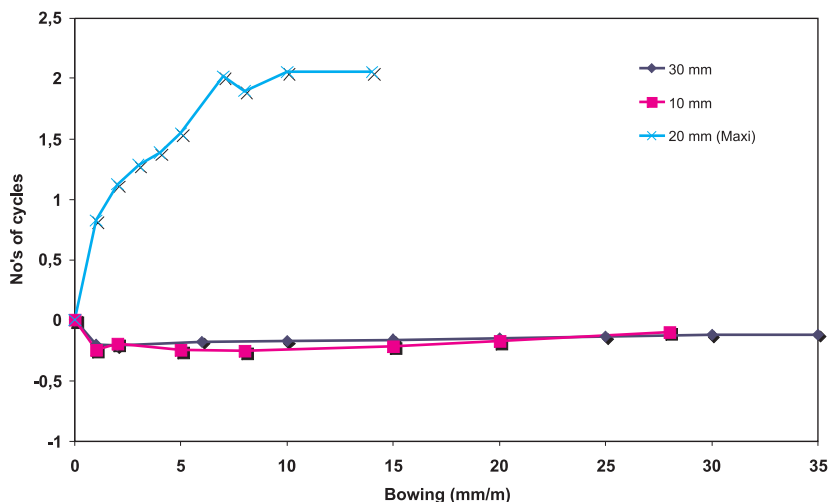
Figure 12. Comparison of average values of three sample sets
