STUDY ON THE ACCELERATED CORROSION BEHAVIOR OF A GALVANIZED X80 PIPELINE STEEL WELDED JOINT DURING A CYCLIC SALT SPRAY TEST

The corrosion behavior of galvanized X80 pipeline steel welded joints in a marine atmospheric environment was studied using the cyclic salt spray accelerated corrosion test. The corrosion weight loss, corrosion morphology and corrosion products of samples under different cycles were characterized by means of appearance inspection, SEM and EDS. The results show that with the rupture of the galvanized layer, cracks first appear when the weld metal is exposed for eight days. With the infiltration of the corrosive liquid, pitting pits first appear in the weld metal. In the early stage of corrosion in the heat-affected zone, the fracture degree of the zinc layer is more serious than that in the other two areas. The corrosion products of the zinc layer accumulate irregularly and more pits appear, resulting in early cracks and pitting pits in the later stage. Compared with the first two regions, the base metal shows better corrosion resistance.

Keywords: galvanized alloy steel, X80 pipeline steel, corrosion of welded joints, cyclic salt spray test

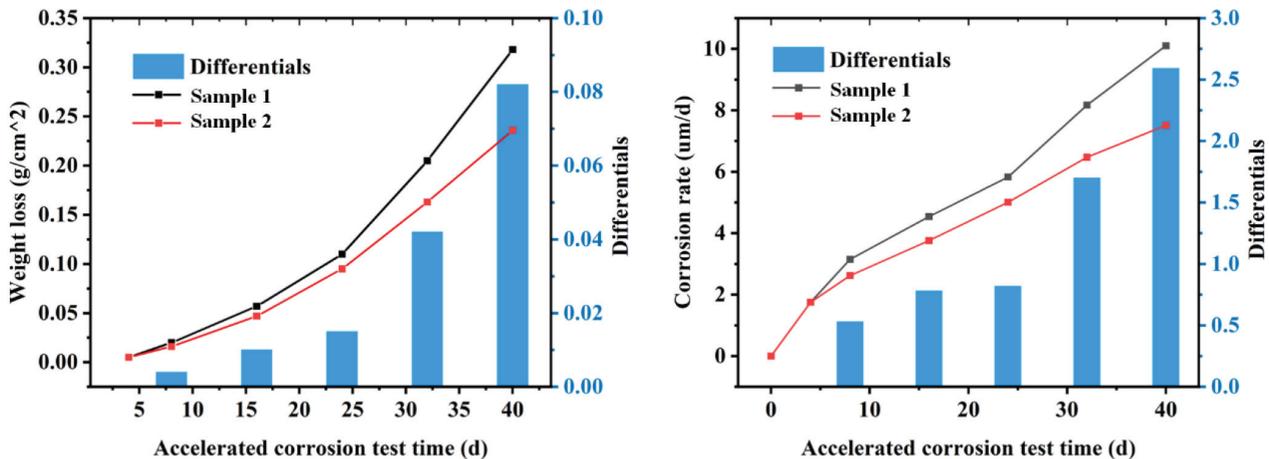
Figure 1: Corrosion weight loss curve and corrosion rate curve of galvanized X80 pipeline steel welded joints

The data for the corrosion weight loss and corrosion rate of the samples exposed to an accelerated corrosion environment for different times are shown in **Table 2**, and the curve of the corrosion exposure time is shown in **Figure 1**. It can be seen from the corrosion weight loss and corrosion rate curves of the X80 pipeline steel exposed to an accelerated corrosion environment for different times that the accelerated corrosion exposure of X80 pipeline steel can be roughly divided into four stages. In the first stage (4–16 d), the trend of corrosion weight loss and corrosion rate increased slowly, indicating that the zinc layer had a good protective effect on the substrate at the initial stage of corrosion. In the second stage (16–24 d), the trend of corrosion weight loss and corrosion rate increased more slowly and the difference between the two groups was lower than that in the first stage. At this time, the zinc layer was locally corroded,

and the corrosion products produced due to the exposed substrate were combined with the corrosion products of the galvanized layer, increasing the protection of the substrate. In the third stage (24–40 d), with the extension of the exposure time, the zinc layer on the surface of the substrate was completely corroded, and the surface rust layer began to loosen or even fall off. The unprotected substrate surface was affected by corrosive media such

as Cl^- and H^+ , resulting in a rapid increase in the corrosion weight loss and corrosion rate.

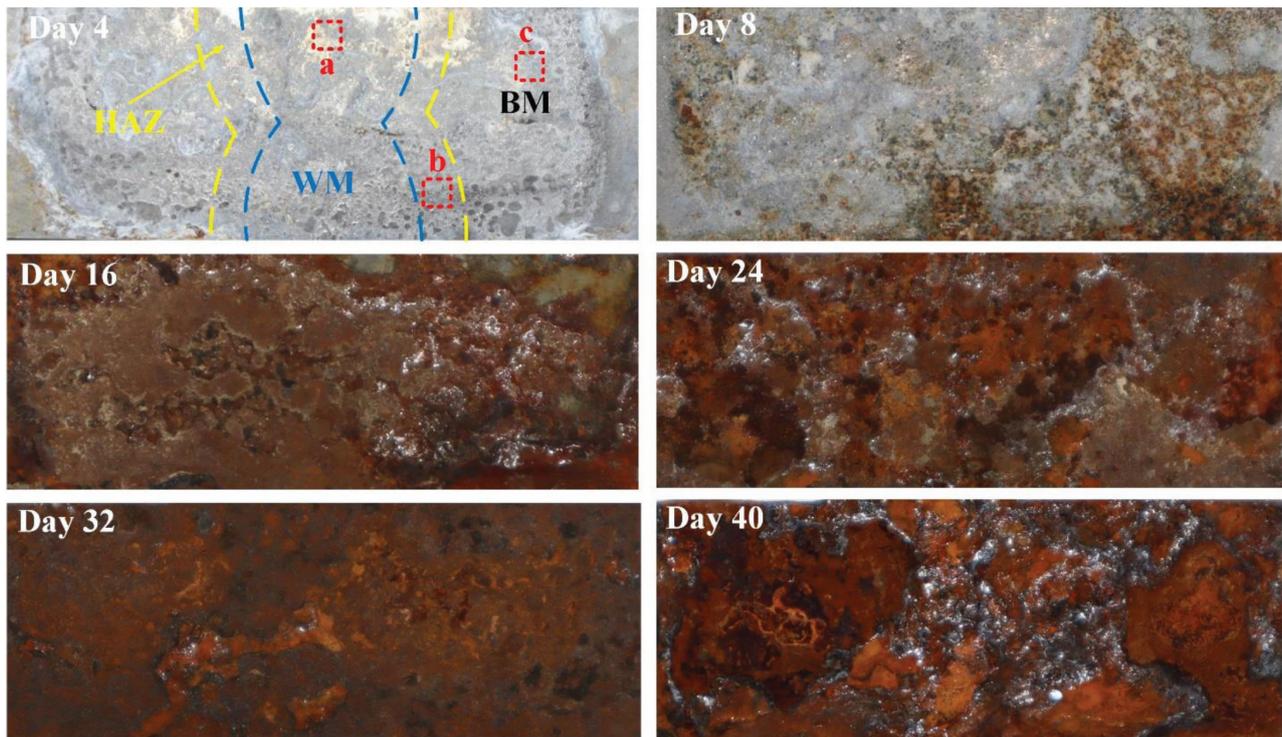
Figure 2: Macroscopic diagram and the measuring point of a galvanized X80 pipeline steel welded joint

Figure 2 shows the macroscopic morphology of galvanized X80 pipeline steel exposed to an accelerated corrosion environment for different periods. By observing

and comparing, it can be seen that when exposed for 4 d, the surface of the sample was evenly covered with gray-white corrosion products dominated by the galvanized layer, while other areas retained the original color and luster. When exposed for 8 d, the corrosion products of the coating expanded over the whole surface, which lost its luster, and the corrosion products of the local zinc layer began to fall off. The exposed substrate surface began to corrode and form a brown rust layer, mixed with the corrosion products of the white galvanized layer. When exposed for 16 d, most of the surface of the sample was covered by the brown rust layer. In addition to the loose and easy-to-shed rust layer on the surface, the brown-red rust layer still covered most of the surface, but the local area was still mixed with the white-coating corrosion products. When exposed for 24–40 d, the corrosion products of the coating completely peeled off, and the brown rust layer was regenerated, completely covering the entire surface. As the corrosion time increased, the thickness of the surface rust layer gradually increased and the color gradually deepened. The sampling areas for SEM and EDS are shown in **Figure 3**.

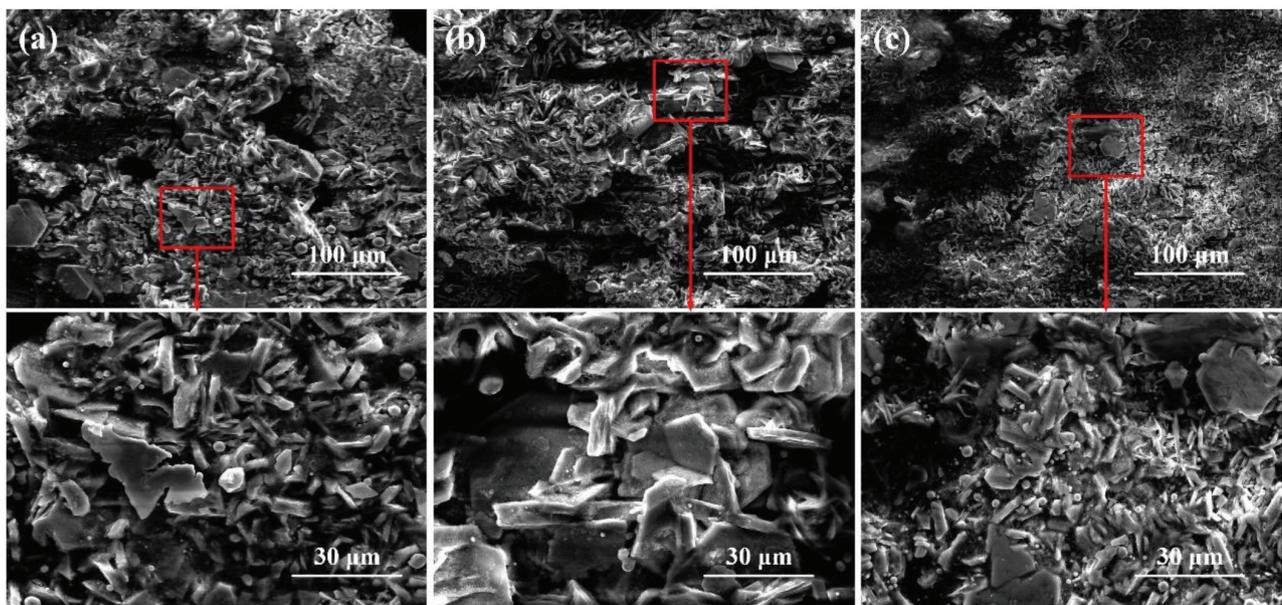
Figure 3: Microstructure of a galvanized X80 pipeline steel welded joint in an accelerated corrosion environment for 4 d: a) weld metal, b) heat-affected zone, c) base metal

Figure 3 shows the microstructure of a welded joint of galvanized X80 pipeline steel kept in an accelerated corrosion environment for 4 d. It can be seen that the broken zinc layer in the base metal region was relatively flat compared with the HAZ and BM regions, and the whole region had a regular strip shape. The fractured zinc layer plane in the weld area began to accumulate to a certain extent, but the whole area still had a regular lath shape. The broken zinc layer in the heat-affected zone began to accumulate obviously, and the corrosion products were mostly broken zinc layers, showing irregular polygons. At the same time, due to the irregularity of the

corrosion products, there were many pits on the surface of the heat-affected zone.

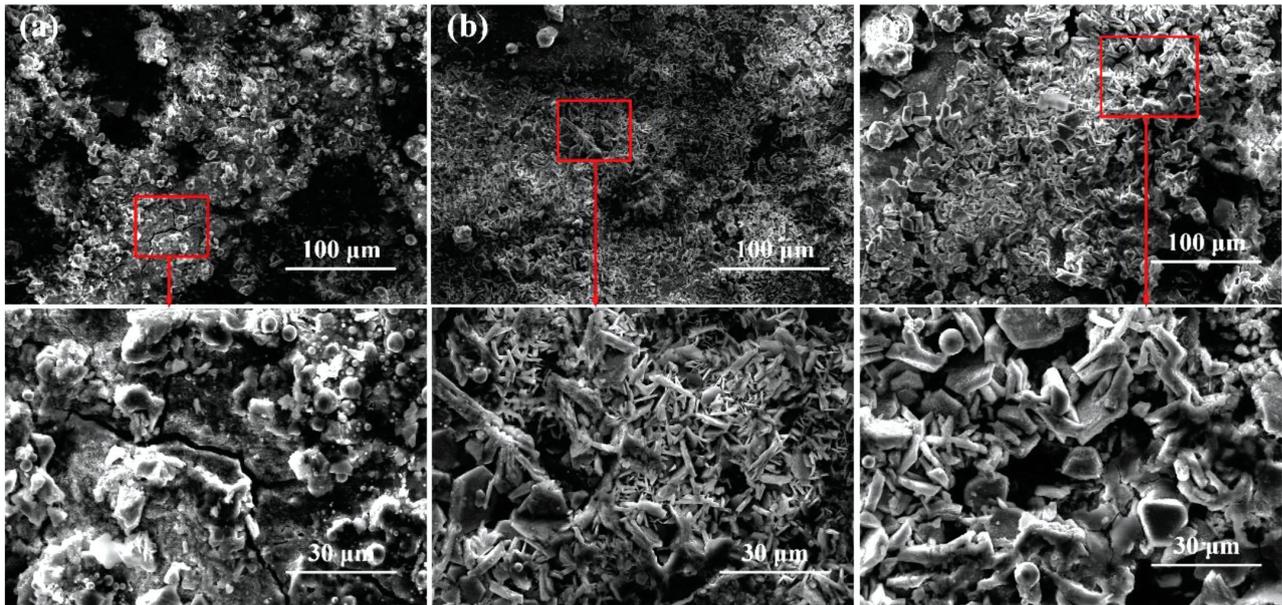
Figure 4: Microstructure of a galvanized X80 pipeline steel welded joint in an accelerated corrosion environment for 8 d: a) weld metal, b) heat-affected zone, c) base metal

Figure 4 shows the microstructure of a galvanized X80 pipeline steel welded joint kept in an accelerated corrosion environment for 8 d. It can be seen that the corrosion products on the surface of the entire welded joint were denser than those after 4 d, but they were still dominated by bright galvanized layer corrosion products. The accumulation of corrosion products also began to occur in the base metal area, but the corrosion products on the surface of the base metal still mainly belonged to the zinc layer. The strip-like corrosion products in the weld area were gradually connected to form a dense 'protective layer', but it began to crack in some parts. The zinc layer on the surface of the heat-affected zone represented a dense 'protective layer'. At this time, the zinc layer ruptured more seriously, and the corrosion products were mostly fine needles.

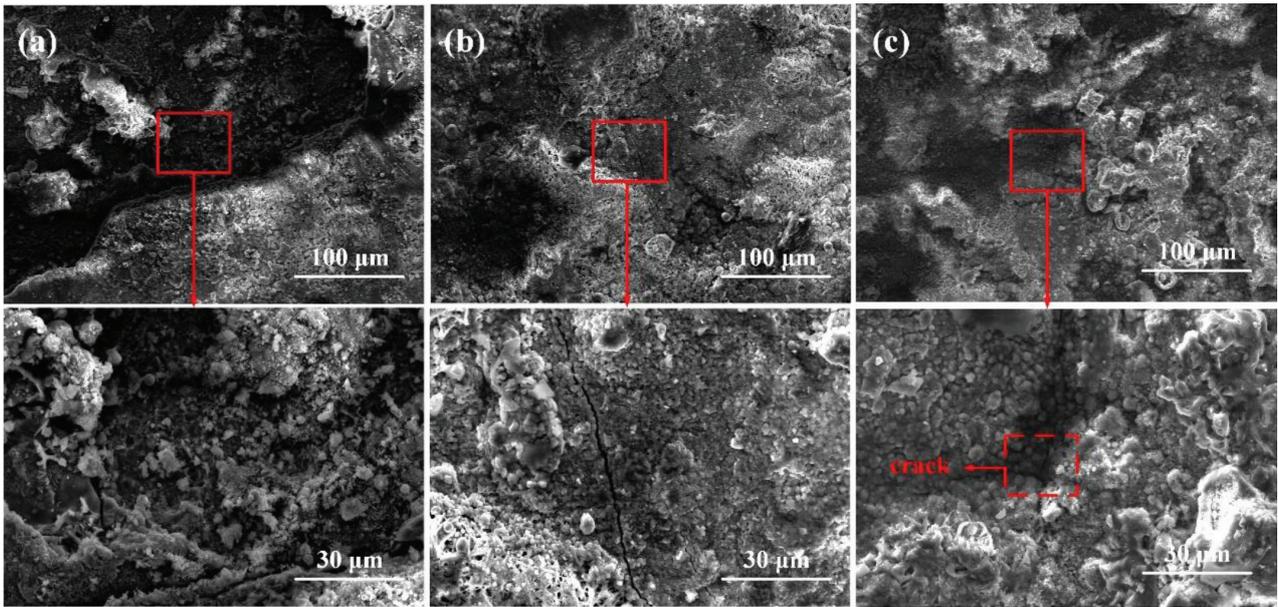
Figure 5: Microstructure of a galvanized X80 pipeline steel welded joint in an accelerated corrosion environment for 16 d: a) weld metal, b) heat-affected zone, c) base metal

Figure 5 shows the microstructure of a galvanized X80 pipeline steel welded joint kept in an accelerated corrosion environment for 16 d. At this time, the corrosion products of the local galvanized layer began to fall off, and the exposed part of the substrate began to corrode and produce a rust layer, having a mixed and inclusion morphology with the corrosion products of the white coating. The boundary between the zinc layer and the substrate in the weld zone was most obvious because the surface mixed rust layer was loose and cracked, falling off under the action of corrosive media such as Cl⁻. Fine cracks with low brightness began to appear in the matrix. The remaining coating on the surface of the heat-affected zone was evenly distributed across the exposed substrate, but serious cracks appeared. In addition to the local inclusion of white coating corrosion products

in the base metal area, most of the surface was mixed and replaced by the rust layer formed by the corrosion of the substrate, while fine cracks began to appear at the junction.

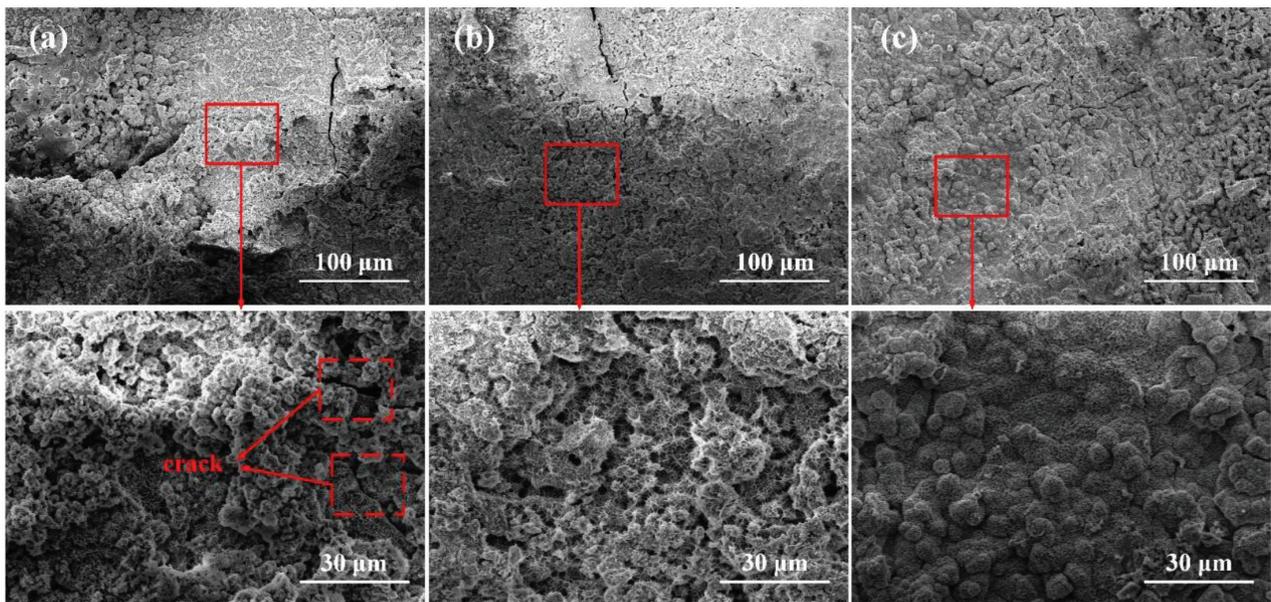
Figure 6: Microstructure of a galvanized X80 pipeline steel welded joint in an accelerated corrosion environment for 24 d: a) weld metal, b) heat-affected zone, c) base metal

Figure 6 shows the microstructure of a galvanized X80 pipeline steel welded joint kept in an accelerated corrosion environment for 24 d. When exposed for this period, the corrosion products of the galvanized layer were basically peeled off; the rust layer on the surface of the substrate was regenerated and it expanded across the surface of the whole welded joint. At this time, the gran-

ular corrosion products in the base metal area began to appear and were scattered across the surface. The granular corrosion products in the weld area began to accumulate; at the same time, small cracks began to appear in the rust layer on the surface of the substrate and large cracks appeared in the whole weld area. The granular corrosion products in the heat-affected area were seriously accumulated, and honeycomb dense granular products gradually covered the cracks on the surface.

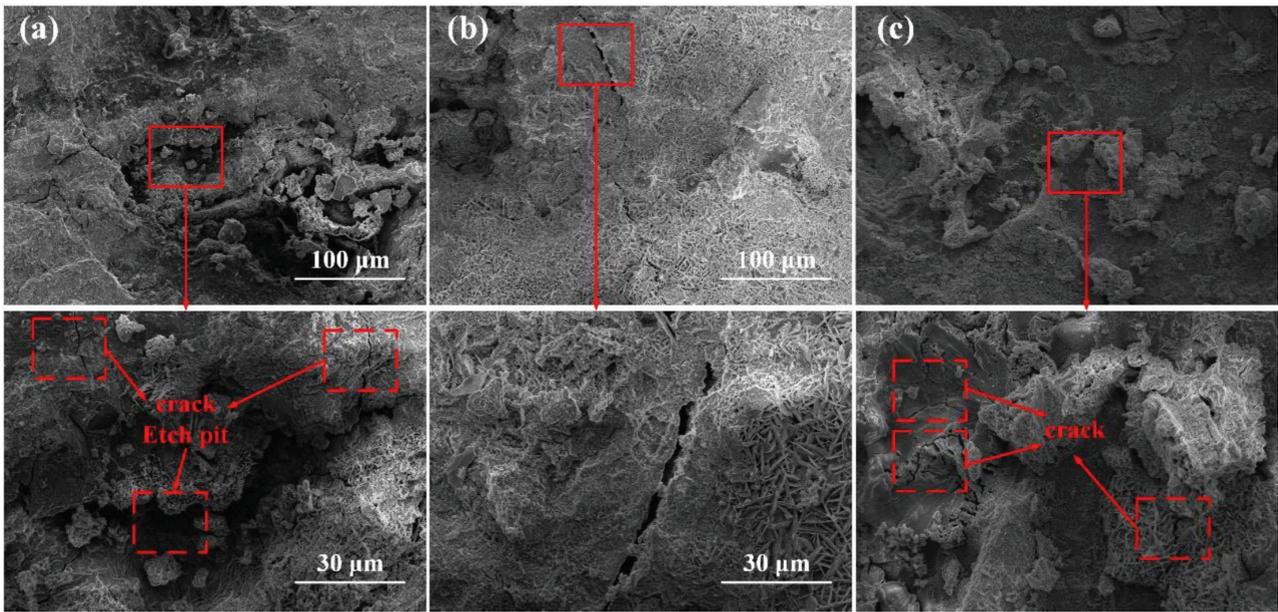
Figure 7: Microstructure of a galvanized X80 pipeline steel welded joint in an accelerated corrosion environment for 32 d: a) weld metal, b) heat affected zone, c) base metal

Figure 7 shows the microstructure of a galvanized X80 pipeline steel welded joint kept in an accelerated

corrosion environment for 32 d. It can be seen that the accumulation rate of corrosion products in the heat-affected zone was much smaller than the process of rust layer rupture and spalling in this area. Cracks were still there, showing a more serious trend. When exposed for 32 d, the rust layer in the weld area gradually became dense due to the corrosion liquid, penetrating deep into the cracks. Some areas began to show pitting pits, accompanied by small cracks. The corrosion degree of the base metal area was lower than that of the other two areas. Although the accumulation of the surface corrosion products was more serious, only small cracks appeared.

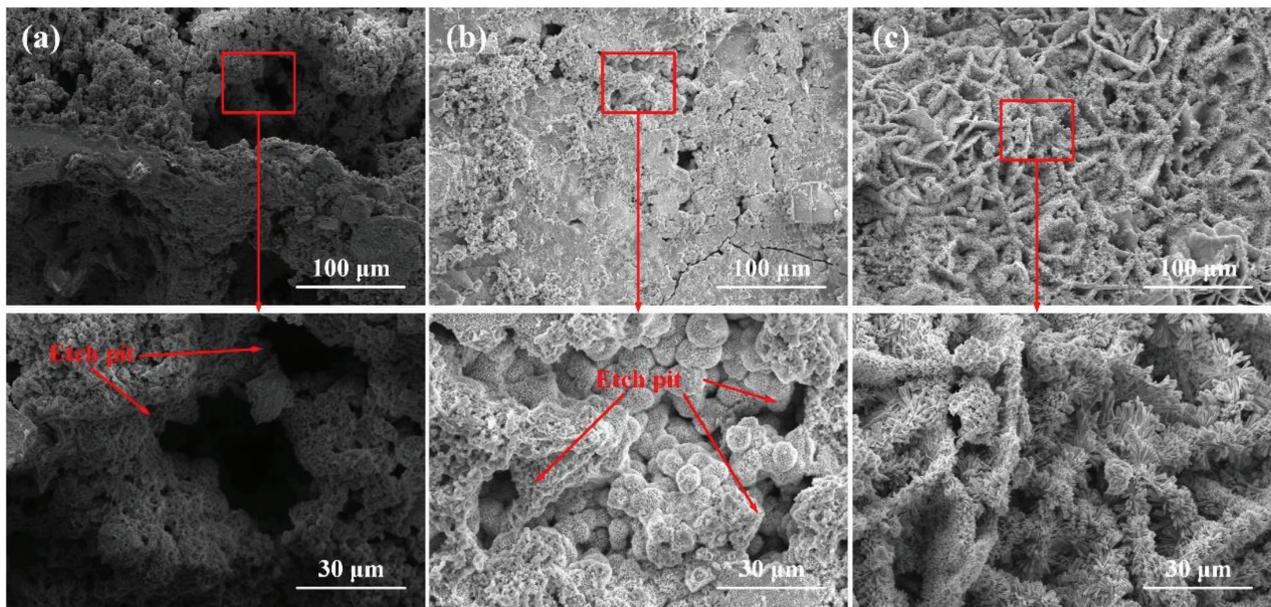
Figure 8: Microstructure of a galvanized X80 pipeline steel welded joint in an accelerated corrosion environment for 40 d: a) weld metal, b) heat affected zone, c) base metal

Figure 8 shows the microstructure of a welded joint of galvanized X80 pipeline steel kept in an accelerated corrosion environment for 40 d. At this stage, the pitting corrosion pits at the weld gradually expanded, and the entire weld area was covered with dense pitting corrosion pits. In the heat-affected zone, pitting pits began to appear when cracks still existed and occupied nearly half of the area. The corrosion products in the base metal area began to show regular floccules, and no obvious cracks or pitting pits appeared.

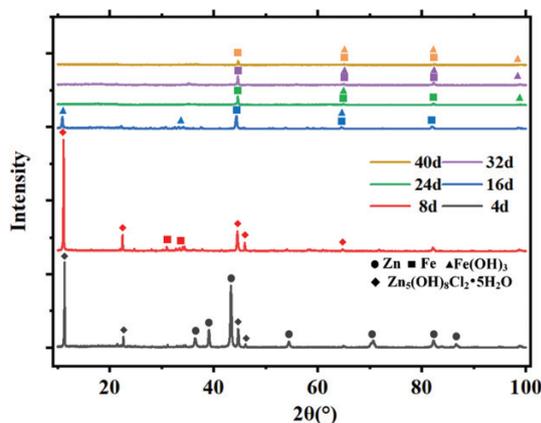
Figure 9: XRD results for corrosion products of galvanized X80 pipeline steel welded joints exposed for different times

EDS results for corrosion products in different regions of the welded joints of galvanized X80 pipeline steel after exposure to different cycles are shown in **Tables 3, 4** and **5**. From the EDS results and XRD diagrams, it can be seen that the corrosion products generated during the corrosion process gradually transitioned from the galvanized layer to the substrate rust layer. The corrosion products on the surface of the samples exposed for 4–8 d were mainly ZnO. When exposed for 16 d, the corrosion products of the coating fell off locally, and an Fe oxide rust layer of the matrix gradually appeared. When exposed for 24–40 d, the corrosion products of the galvanized layer were basically peeled off and replaced by the rust layer, and the content of Fe gradually increased with the increase in the thickness of the rust layer. In addition, the corrosion products contained certain amounts of Cl, Na and other elements, mainly due to the deposition of the salt solution sprayed during the test.
