# Pressures and Protection of the Underground Karst Cases from Slovenia and Croatia

Editors / Urednika: Mitja Prelovšek, Nadja Zupan Hajna

Published by / Izdal in založil: Inštitut za raziskovanje krasa ZRC SAZU, Postojna /  
Karst Research Institute ZRC SAZU, Postojna

**The publication was published within the Karst Underground Protection project which is financially supported by the Slovenia-Croatia Operational Programme 2007-2013.**

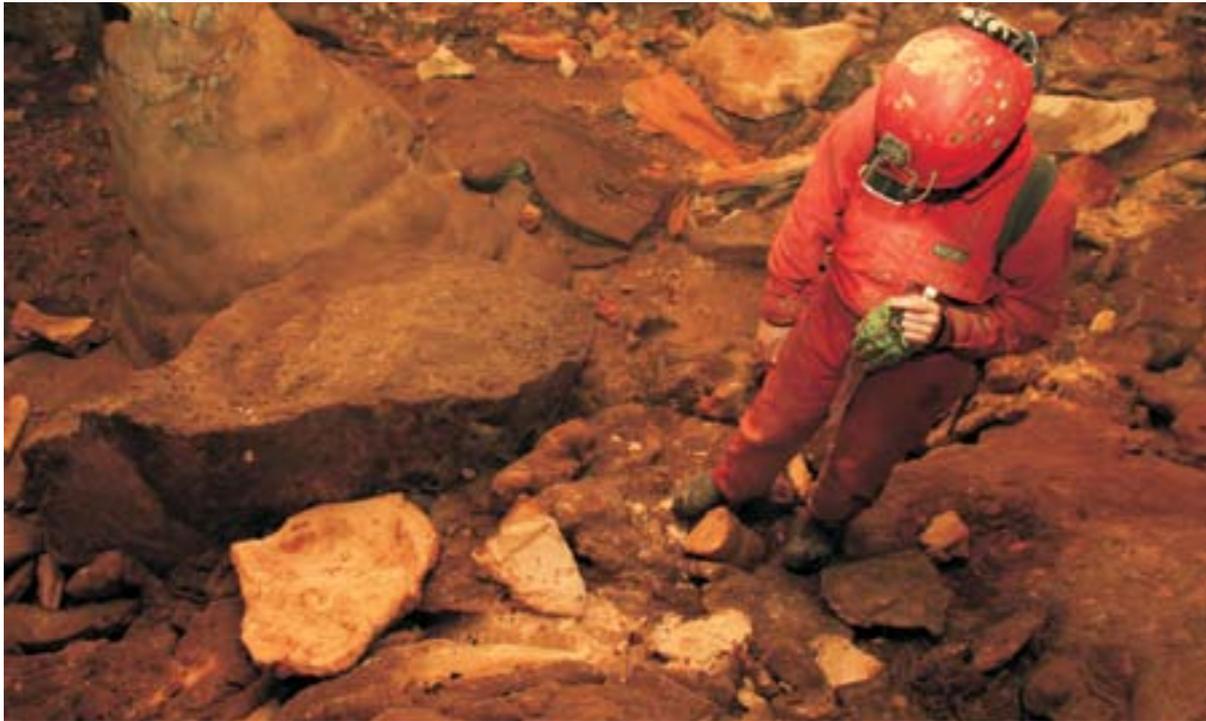
**Fig. 1:** Broken flowstone formations in the Polina Peč cave in the Matarsko Podolje area – caused by illegal collectors of cave fauna searching for specimens. In a similar way, some tens of square metres of cave floor have been dug up in the cave (photo: M. Prelovšek).

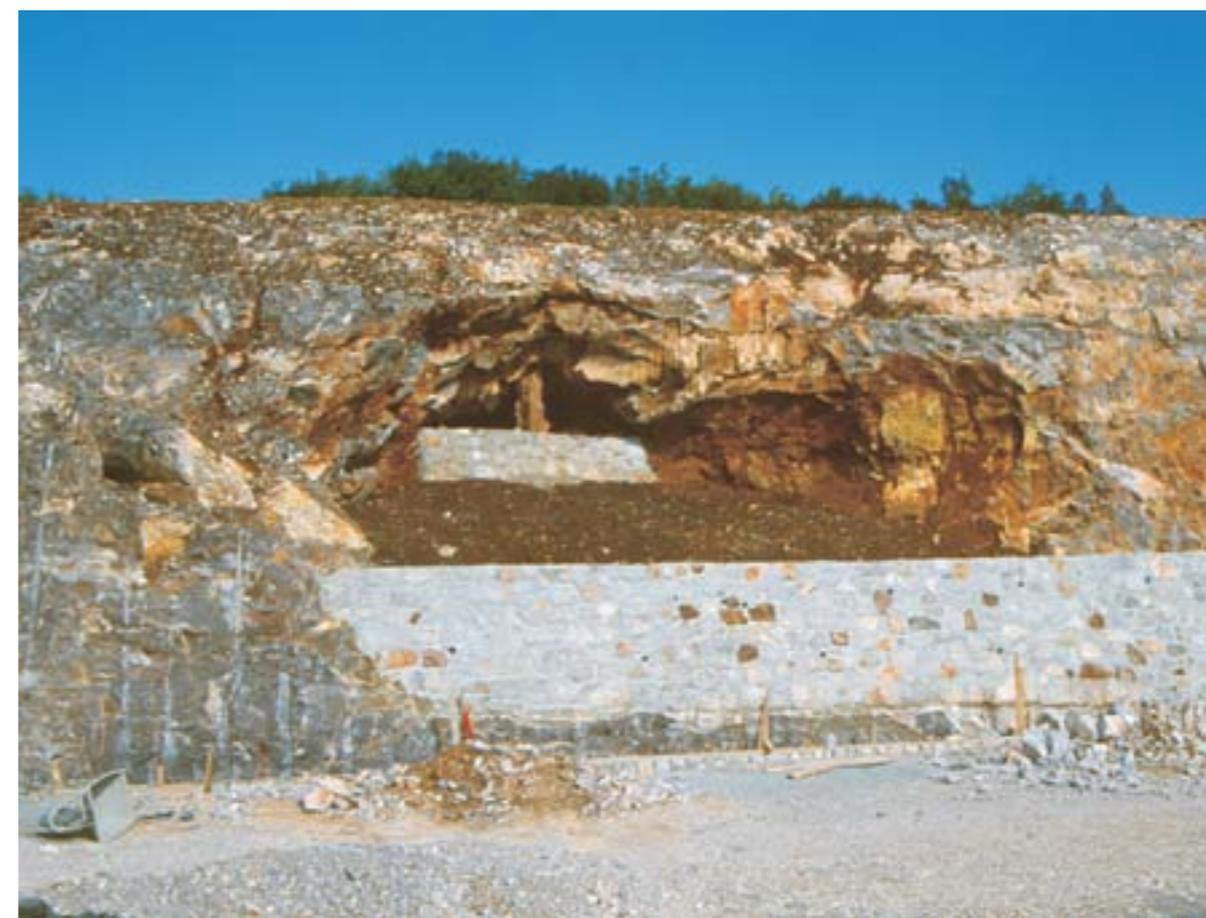
**Fig. 2:** Preservation of the cave in the road cut near Sežana.

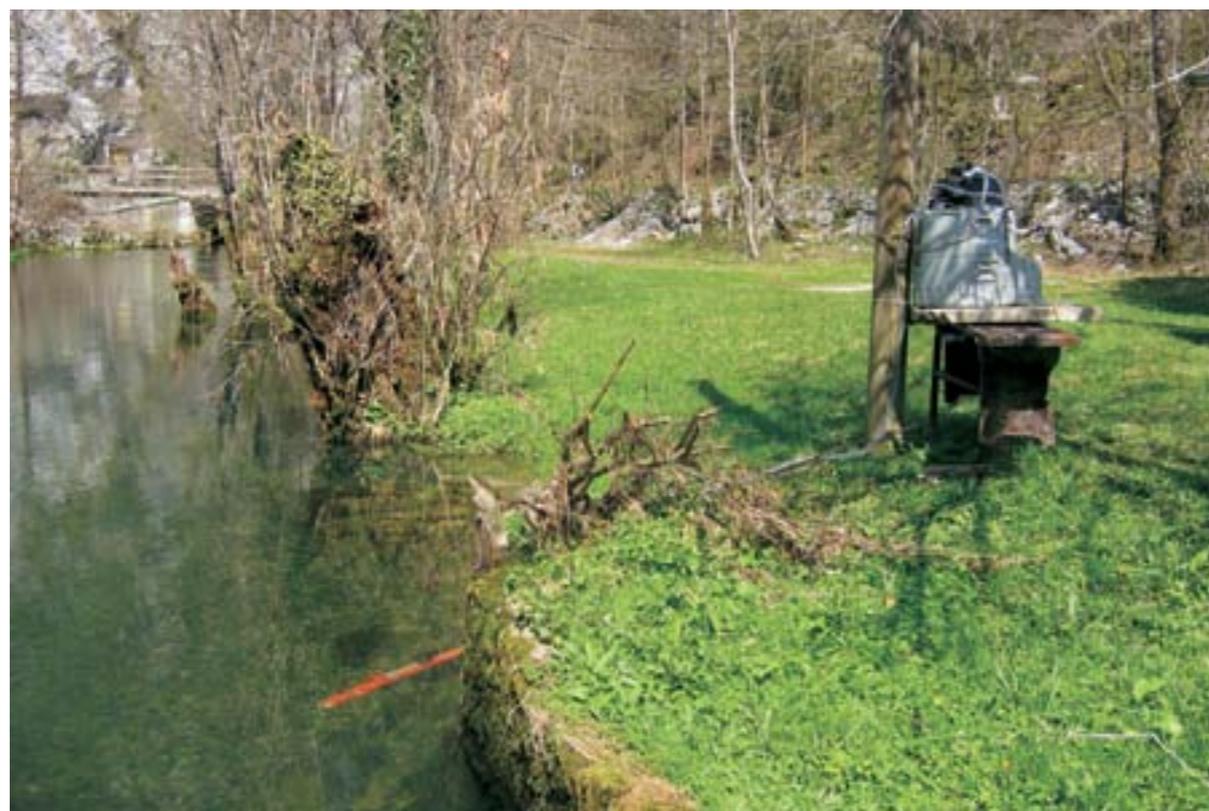
Fig. 3: An automatic sampler was set up at the Bilpa spring to collect samples.

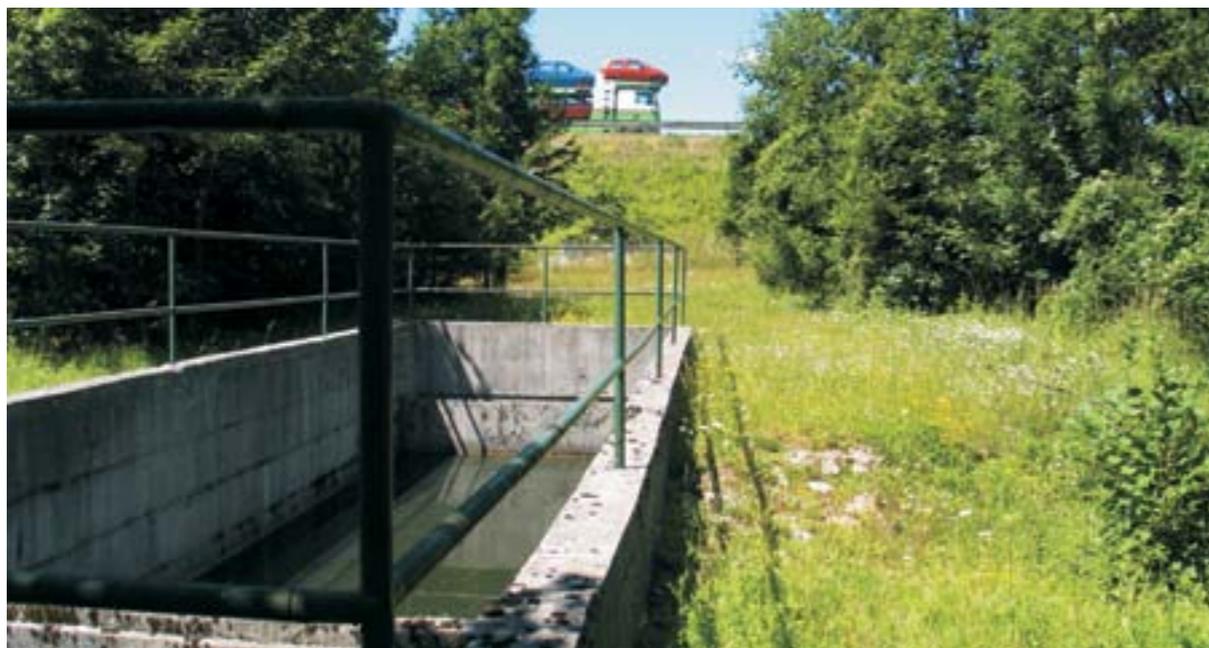
Fig. 1: Rainwater that washes the roadway of the motorway runs off into the oil collector, where in favourable conditions of small inflows sedimentation occurs. On the other side of the oil trap the water drains directly into the karst. Fluorescent tracer was injected into the drainage shaft of the oil trap (Gabrovšek et al. 2010).
