# The innovation trap: modular neck in total hip arthroplasty

Samo K. Fokter,<sup>1</sup> Vesna Levašič,<sup>2</sup> Simon Kovač<sup>2</sup>

hip arthroplasty;  
modular neck  
fracture; titanium-  
alloy; complications  
of arthroplasty;  
arthroplasty registries

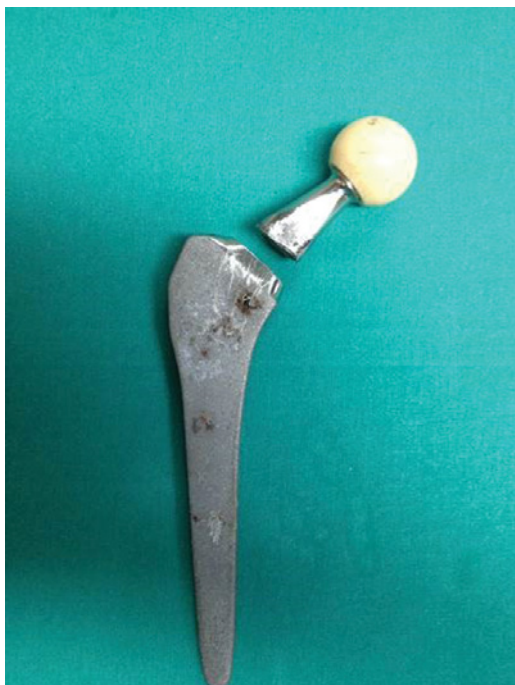
**Figure 1:** A Profemur Z implant femoral stem after explantation at the revision total hip arthroplasty. The fractured modular neck with a ceramic femoral head still attached.

The taper-cone coupling between the femoral stem and modular neck is not ailment-free. It is subject to mechanically supported crevice corrosion, which is a combination of fretting corrosion and crevice corrosion, and may lead to failure of the modular neck (5). The first case report on the Profemur Z modular femoral neck failure was published in 2010, and the first case of the GSP modular femoral neck failure in Slovenia was reported in 2012 (6,7). A doubled revision rate of fully modular THA due to dislocation and aseptic loosening was documented by the Australian Orthopaedic Association National Joint Replacement Registry (AOANJRR) in 2010. After a 10-year follow-up, the rate of revisions due to prosthesis fracture was higher with modular designs than with conventional models (1.3 % vs. 0.8 %) (8). Such sudden fracture of the modular femoral neck represents a catastrophic failure of the previously normally functioning THA. Also, it represents a most stressful experience for the patient, as it usually necessitates a complete exchange of the femoral component of the prosthesis (Figs. 1 and 2).

The analysis of modular neck fractures pointed out that the complication was due to similar factors: corrosion at the modular neck-stem junction and overload of the modular neck, that undoubtedly accelerated the corrosion processes, causing larger bending of the neck in the taper. Thus it is not surprising that our patients who sustained modular neck fracture had increased BMI. In addition, a higher torque is known to accelerate fracture, so the majority of the fractures occurred in THA using a long neck component. The bending moment with a long neck is 32 % higher than with a short neck (14). A study published in

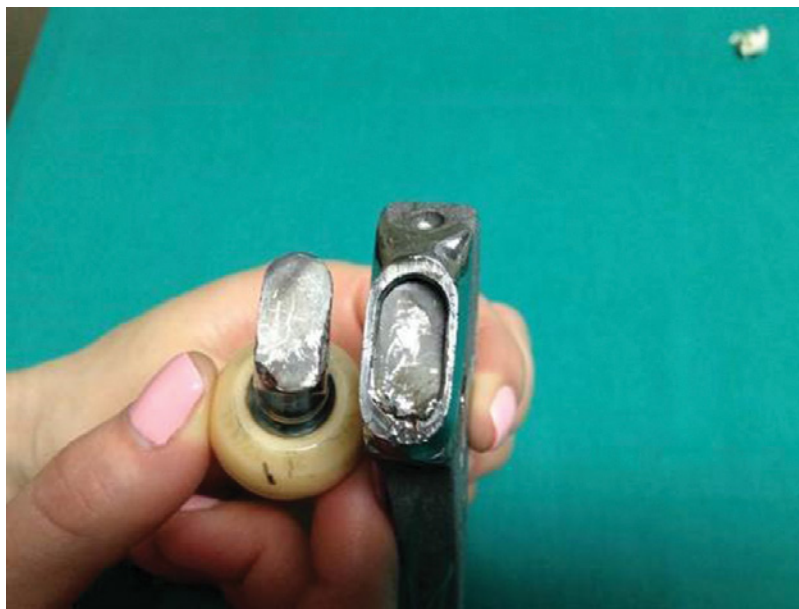
**Figure 2:** A fractured modular femoral neck. The distal part is still in the female part of the Morse taper of the femoral stem.
