## BUCKING OF CONIFERS USING THE WOODY H60 PROCESSOR ON THE SYNCROFALKE 3 T CABLE YARDER IN THE ALPINE FOOTHILLS

Jurij MARENČE<sup>1</sup>, Jernej VADNJAL<sup>2</sup> and Boštjan KOŠIR<sup>3</sup>

### Abstract

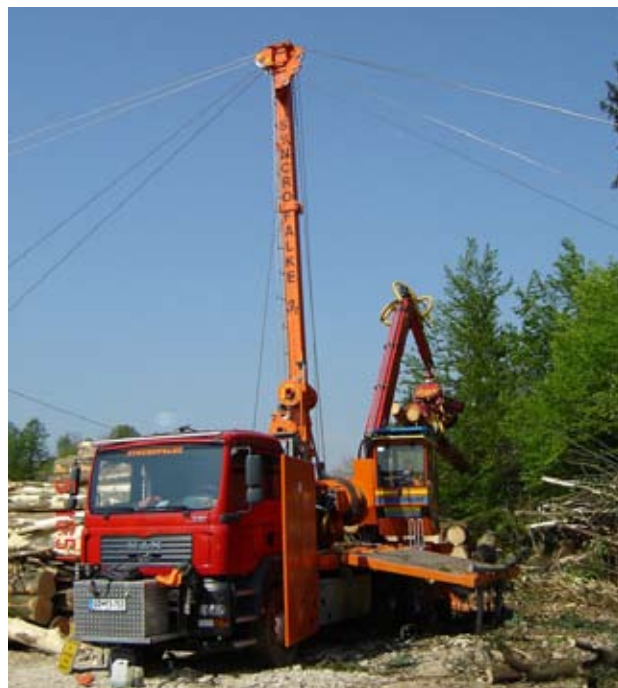
Fig. 1: Syncrofalke cable crane 3 t

The trees marked for felling were felled by chain saw and yarded to the landing using the Syncrofalke mobile tower cable crane (Figure 1) type 3 t. Further processing of felled trees was carried out on the site with the Woody H 60 processor (Figure 2), mounted on the crane LIV 24.94. Woody H 60 is a harvester head which can – when mounted on an all-terrain vehicle – fell trees (measuring up to 65 cm in diameter) and process them. The harvester head is designed for delimiting (stems up to 60 cm thick), measure and buck (cross-cut) the tree. When Woody H60 is mounted on a cableway it operates as a processor which makes logs out of whole trees, sorts and moves wood products (Tables 2 and 3). Processor has twin chain blades where frontal is smaller and designed for cutting thicker branches when processing hardwoods or topping when processing softwood. The processor is a self-propelled machine with a hydraulic drive system fed by the hydraulic pump, and is computer-controlled. The harvester head can measure lengths and diameters and determine the point of cross-cutting with computer parameters that can be changed rapidly. In bucking conifer products, the cross-cutting points are pre-determined with regard to the target log type, although the point of cross-cutting can subsequently be changed by the operator if so required by the properties of the tree. In bucking non-conifers, which often cause problems in delimiting and bucking brought about by the thickness of branches, the machine operator normally performs bucking in accordance with the estimated quality of the tree, i.e. cuts the wood to lengths suitable for further transport. In order to ensure uninterrupted bucking of conifers, computer settings need to be checked regularly, normally prior to the actual beginning of works at the site.

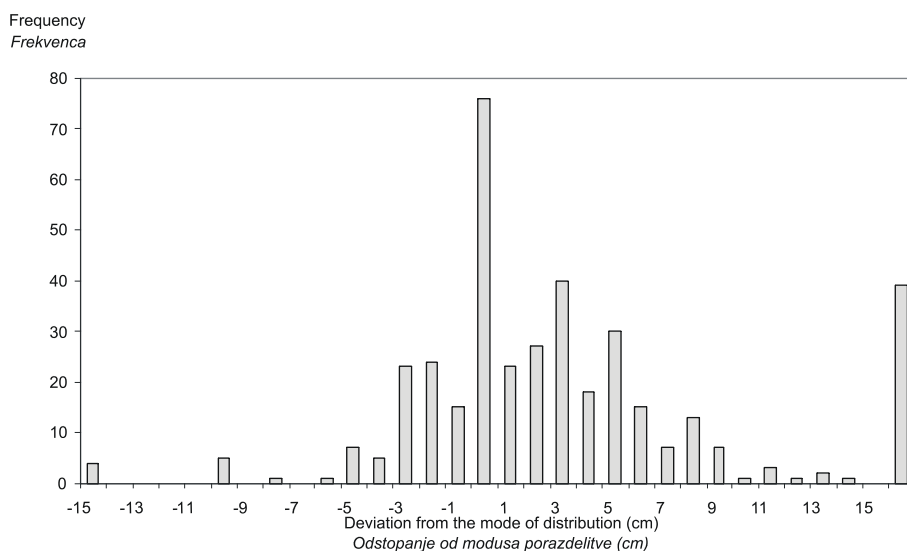
Fig. 3: Frequency distribution of conifer log lengths

In order to establish the accuracy of cross-cutting carried out by the processor head in the course of bucking operations, several indicators were used that had already been applied in other similar studies (CONRADIE *et al.* 2004, SONDELL *et al.* 2002). The indicators used in this study were frequency distribution of log lengths and the share of logs in the five-centimetre interval, with the modus of frequency distribution located in its centre (the best five). Frequency distribution of conifer log lengths is given in Figure 3.

Figure 3 shows a distinctively asymmetrical distribution of log lengths. Logs which are longer than required by the provisions of the standard dominate the sample. The value of

the modus is higher than the value of the required length set on the machine. Evidently, this is a systematic error which is consciously tolerated during harvester operation, which is largely due to the already mentioned fact that the economic loss is lower for excessively long logs than in short logs, as has also been reported by other authors (HAMISH *et al.* 2006).

The calculated share of logs within the interval of  $\pm 5$  cm, at whose center lies the modus of distribution (the best five), is 54.3%. Other similar studies indicate similar results for length measurement accuracy in mechanized bucking (TOPLITSCH 1991). It was established that the Woody H60 processor produces a systematic error on account of which cross-cut tree sections are 6 cm longer than the pre-determined length value. The error, which is in fact unnecessary as

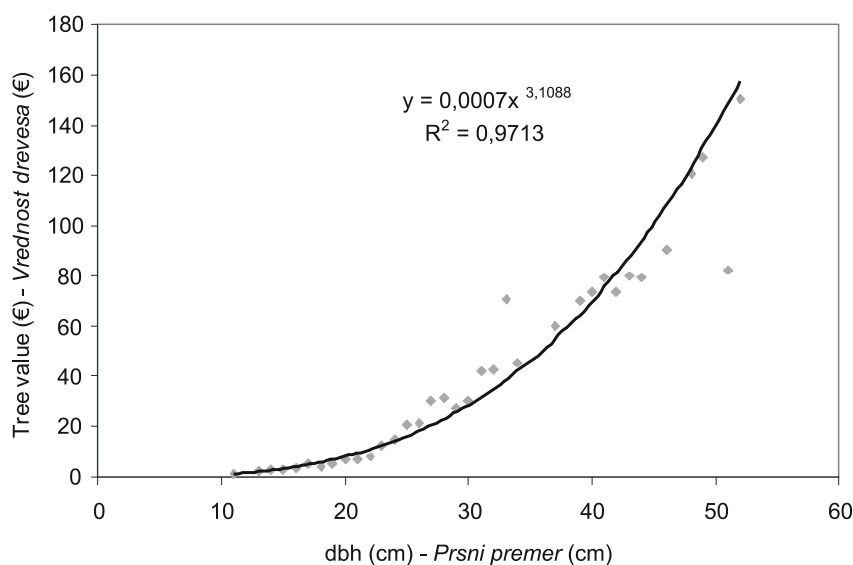
Figure 4: Value of the tree in relation to diameter at breast height

peak at a thickness of 40 to 50 cm. The present research focused on thinner stems, and the ratio between the value of wood and diameter at breast height is presented in Figure 4.

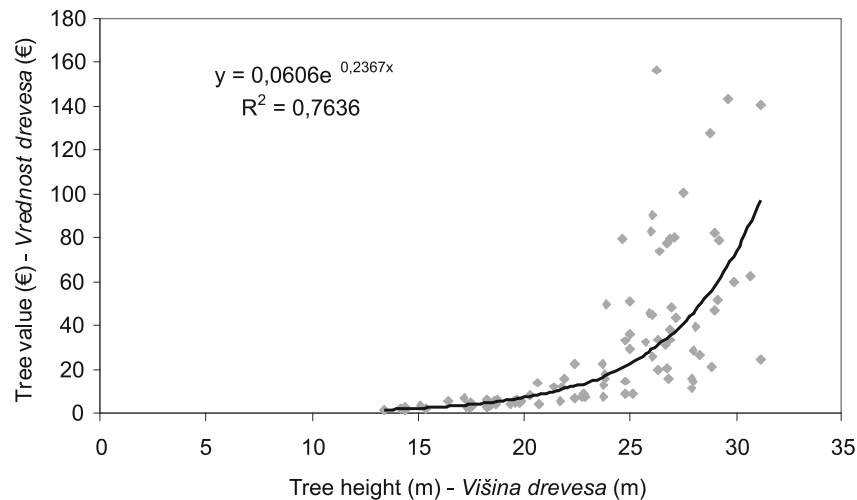
Fig. 5: Tree value in relation to tree height

Tree value also increases with tree height. REBULA (1996) states that with increasing length the value of the stem rises progressively at the same diameter of the tree. The relation between tree height and tree value (from present research) is given in Figure 5.
