The innovation trap: modular neck in total hip arthroplasty

hip arthroplasty; modular neck fracture; titanium-alloy; complications of arthroplasty; arthroplasty registries

Zdrav Vestn. 2017; 86: 115–26.

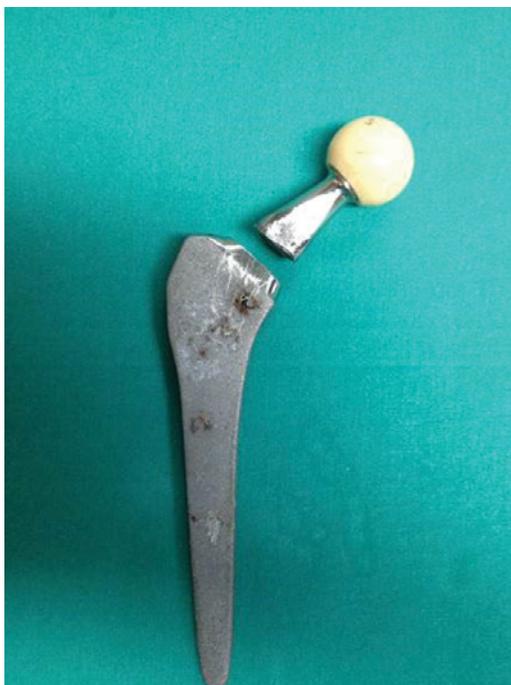
Figure 1: A Profemur Z implant femoral stem after explantation at the revision total hip arthroplasty. The fractured modular neck with a ceramic femoral head still attached.

The taper-cone coupling between the femoral stem and modular neck is not ailment-free. It is subject to mechanically supported crevice corrosion, which is a combination of fretting corrosion and crevice corrosion, and may lead to failure of the modular neck (5). The first case report on the Profemur Z modular femoral neck failure was published in 2010, and the first case of the GSP modular femoral neck failure in Slovenia was reported in 2012 (6,7). A doubled revision rate of fully modular THA due to dislocation and aseptic loosening was documented by the Australian Orthopaedic Association National Joint Replacement Registry (AOANJRR) in 2010. After a 10-year follow-up, the rate of revisions due to prosthesis fracture was higher with modular designs than with conventional models (1.3 % vs. 0.8 %) (8). Such sudden fracture of the modular femoral neck represents a catastrophic failure of the previously normally functioning THA. Also, it represents a most stressful experience for the patient, as it usually necessitates a complete exchange of the femoral component of the prosthesis (Figs. 1 and 2).

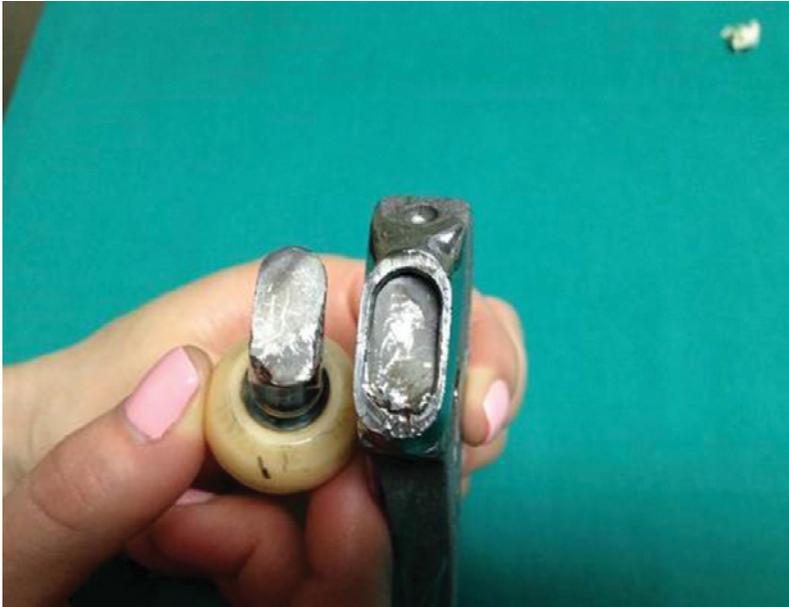
Figure 2: A fractured modular femoral neck. The distal part is still in the female part of the Morse taper of the femoral stem.
